Technical Memorandum

January 22, 2022

To: Lisa Cornutt
Oregon Department of Transportation
3500 NW Stewart Parkway
Roseburg, OR 97470

RE: South Coast Site Reconnaissance Report

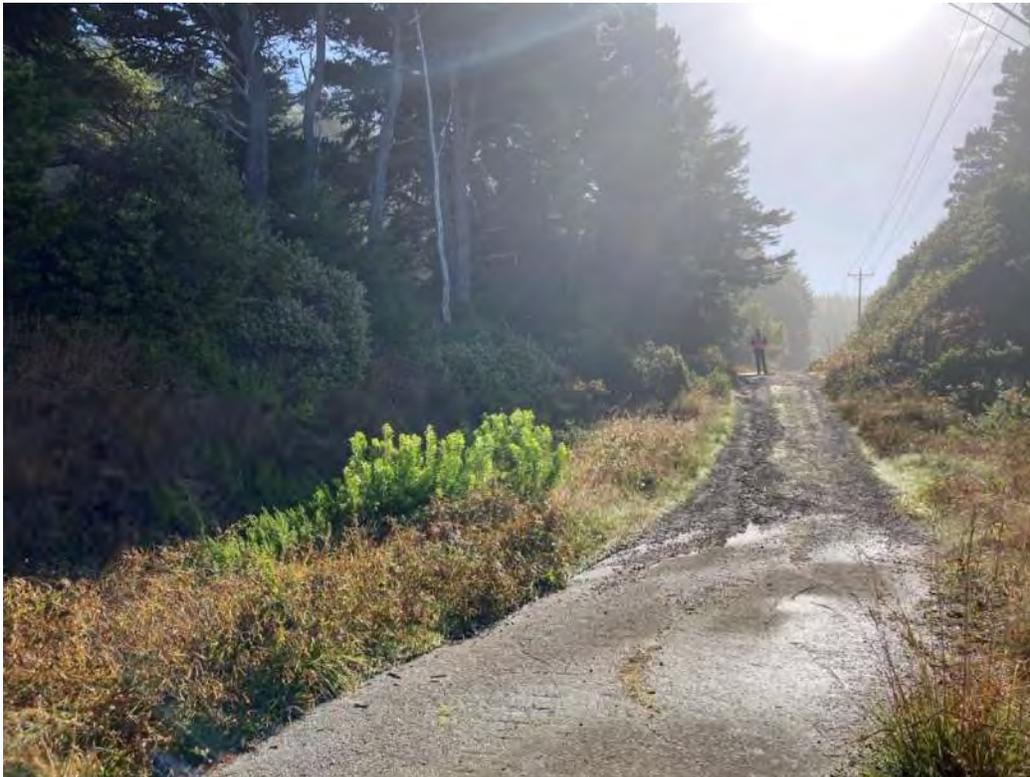
Exhibit 1: Vertical offset and pavement damage on Old US 101 along the southern margin of the slide.

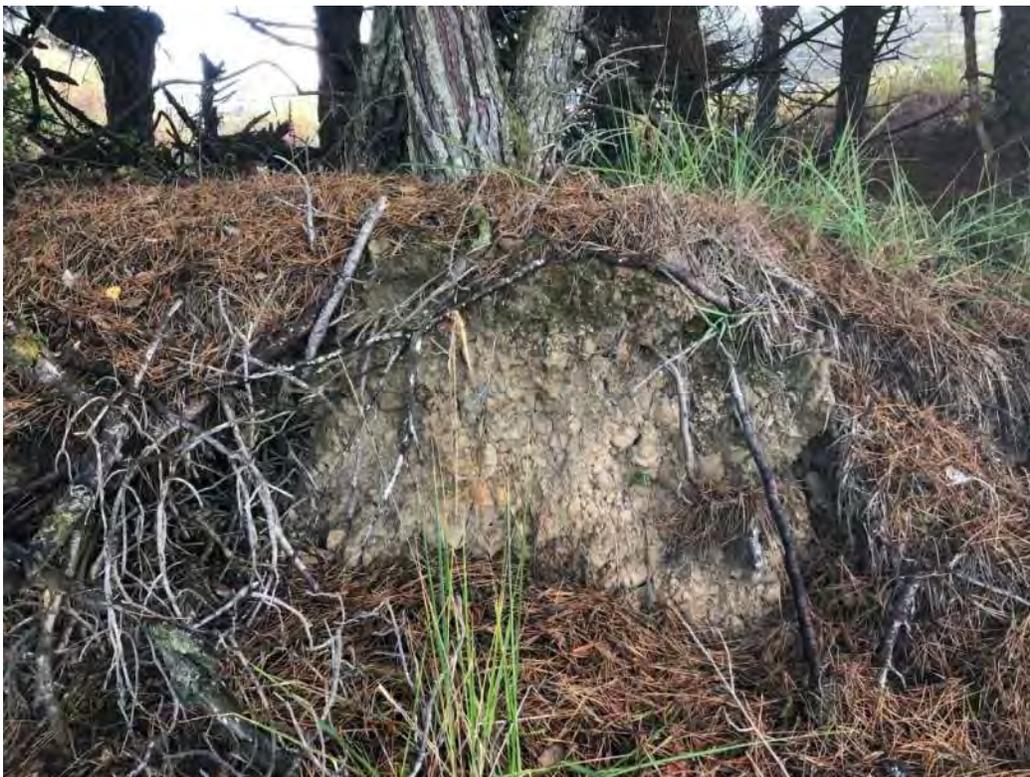
Exhibit 2: Recent scarp movement observed downslope from US 101.

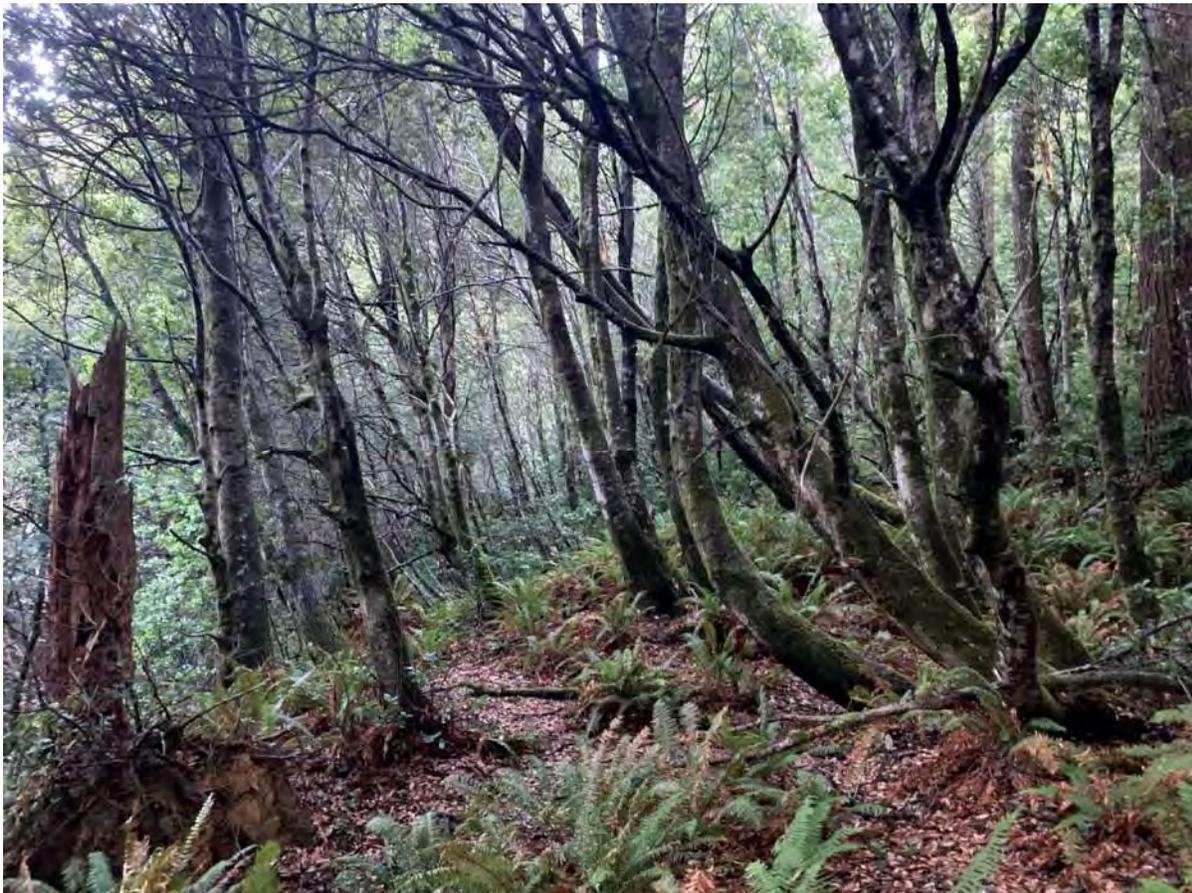
Exhibit 3: Disturbed, hummocky ground and pistol butted trees observed in the upper portion of the Coal Point slide near the head scarp.

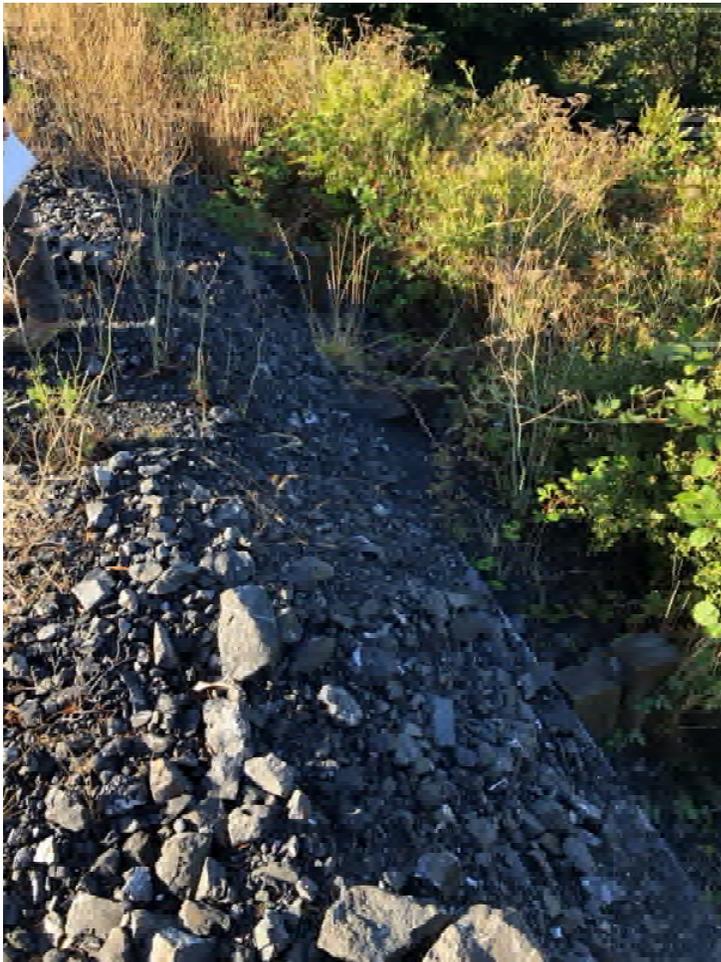
Exhibit 4: Old guardrail with several feet of vertical offset along US 101 southbound.

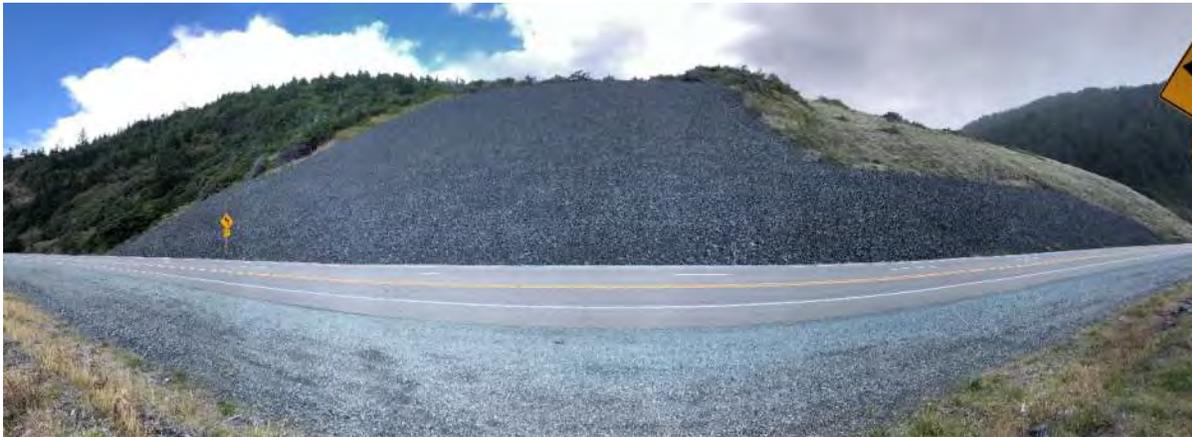
Exhibit 5: Rock buttress along US 101 northbound constructed by ODOT in 2011.

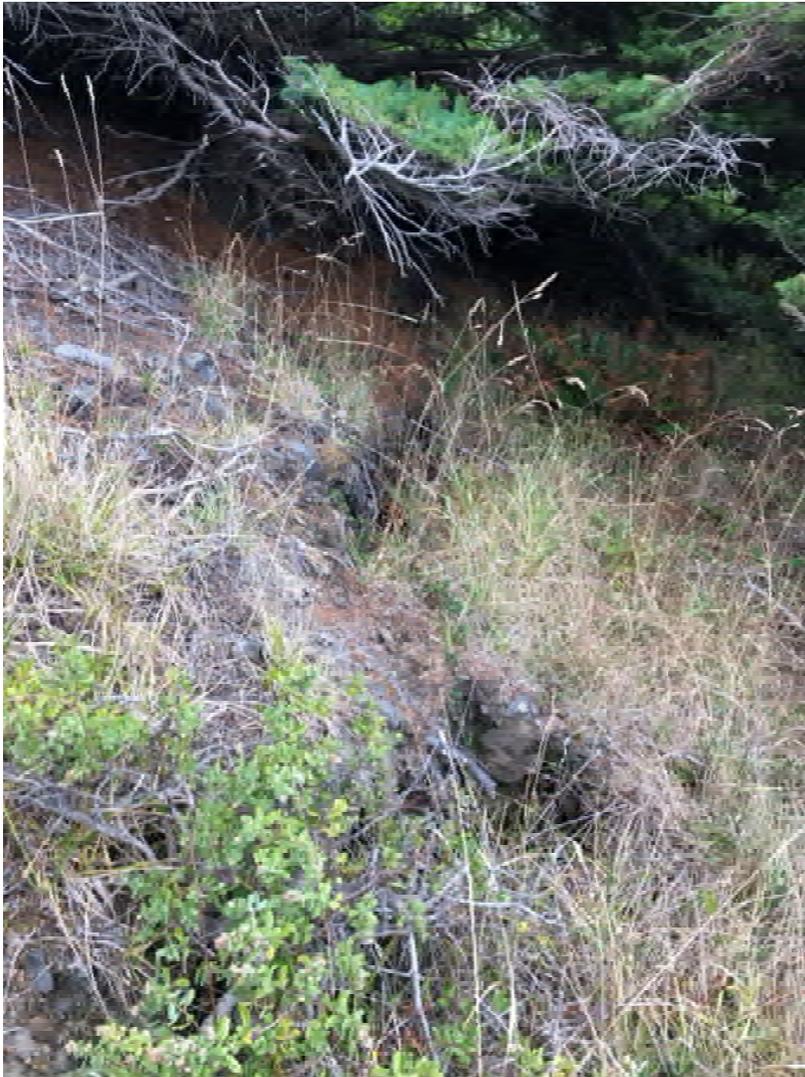
Exhibit 6: Tension cracking located approximately 20 to 30 feet upslope from the top of the rock buttress.

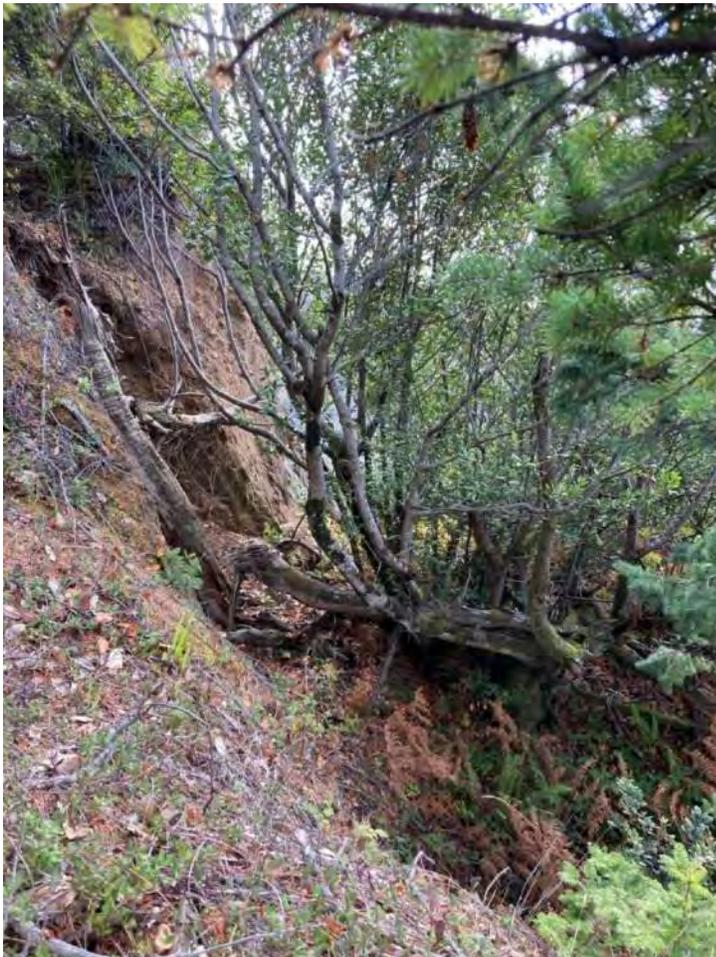
Exhibit 7: Active scarp on the cliff facing the coastline (on back side of cut along US 101 southbound).

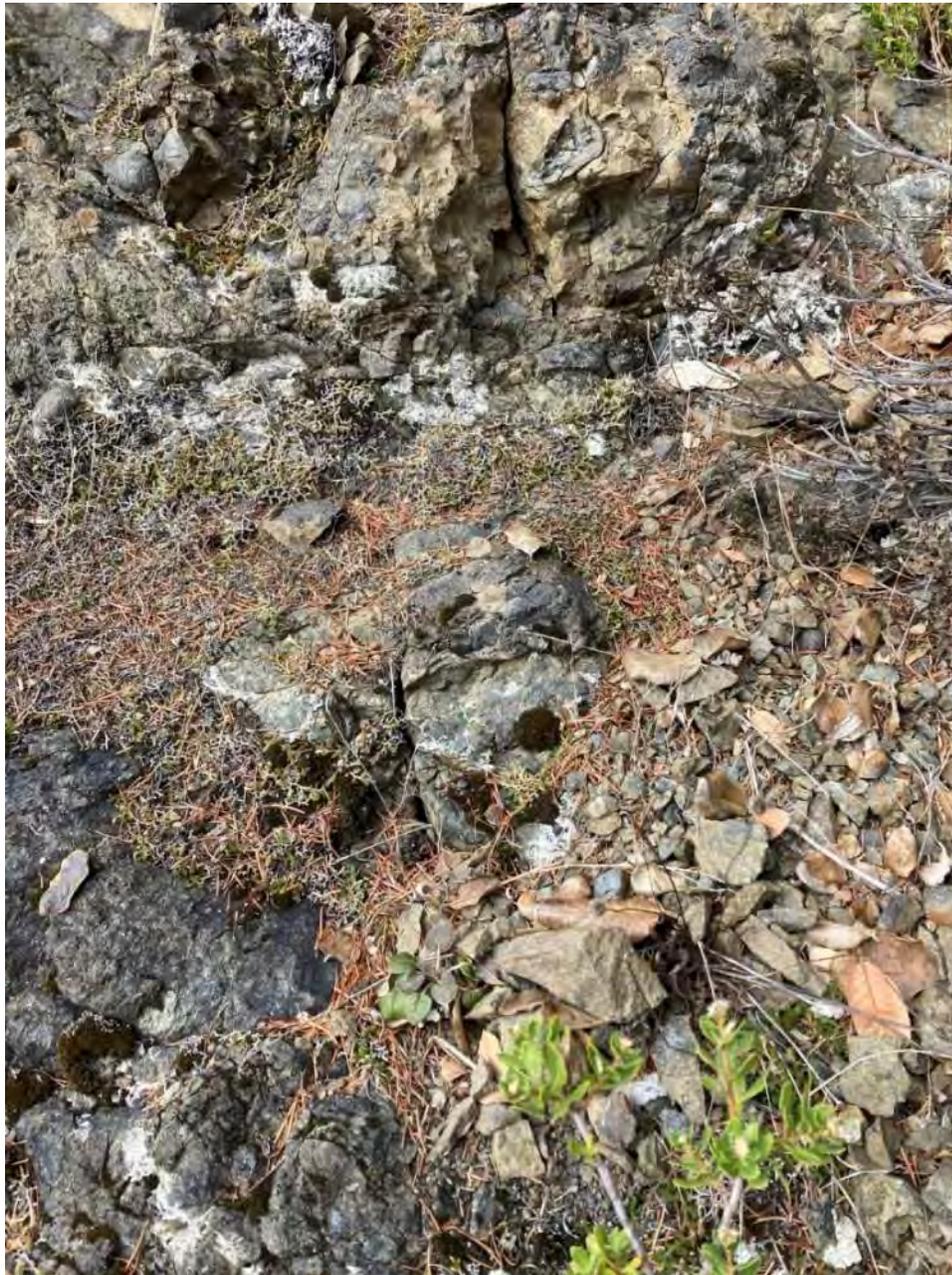
Exhibit 8: Tension cracking in rock outcrops on cliff facing the coastline.

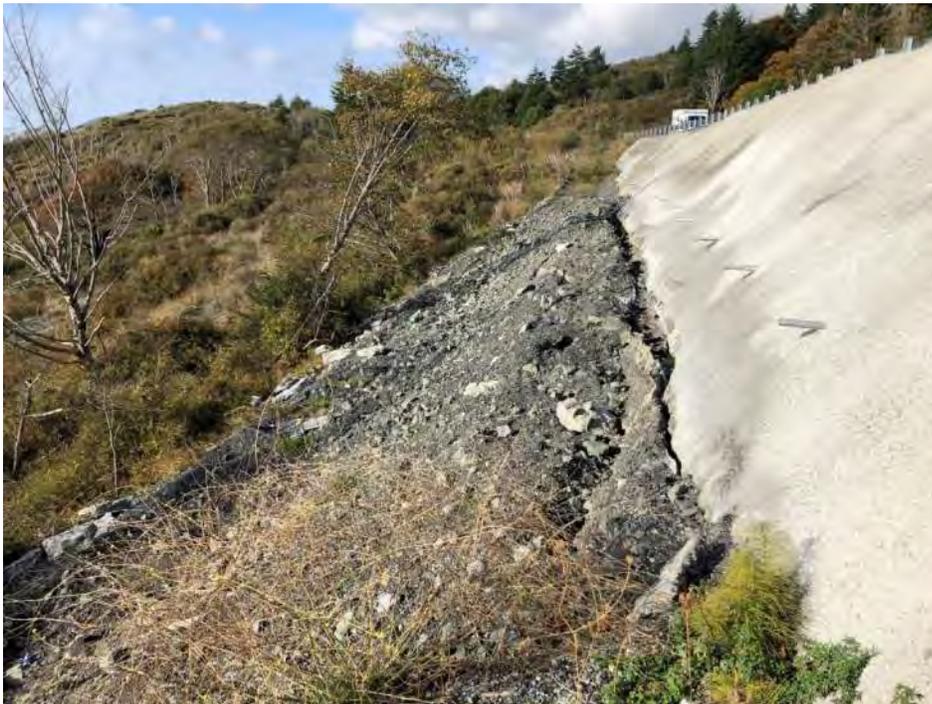
Exhibit 9: Localized failure of the slope below US 101 southbound. The failure caused damage to the existing soil nail stabilization including an approximate 1-foot gap at the bottom of the shotcrete facing.

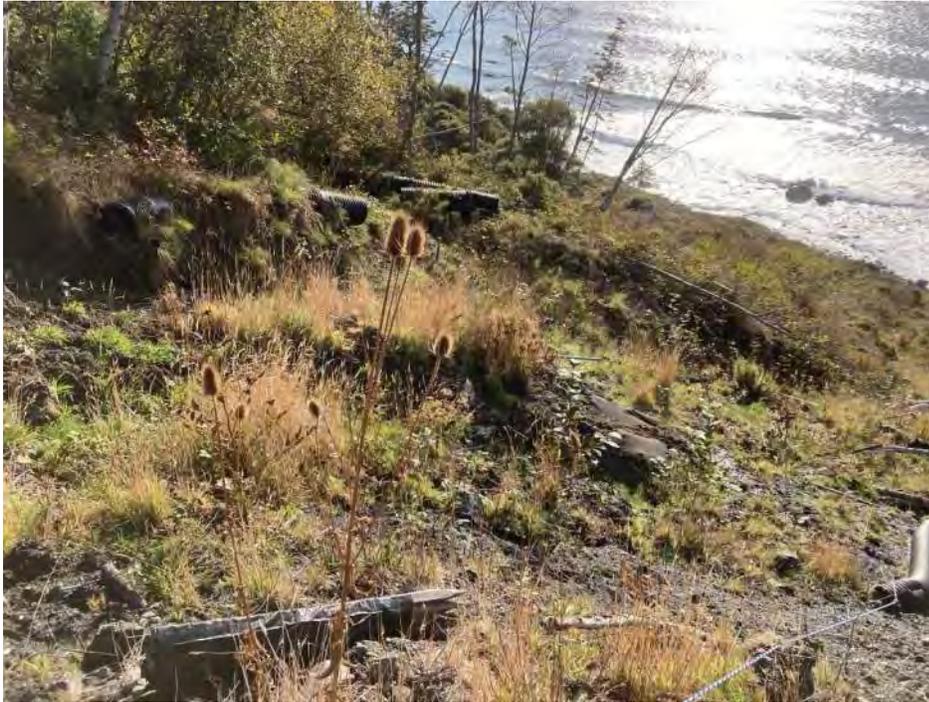
Exhibit 10: Recent secondary slope failure below US 101 that has damaged existing drainage pipes.

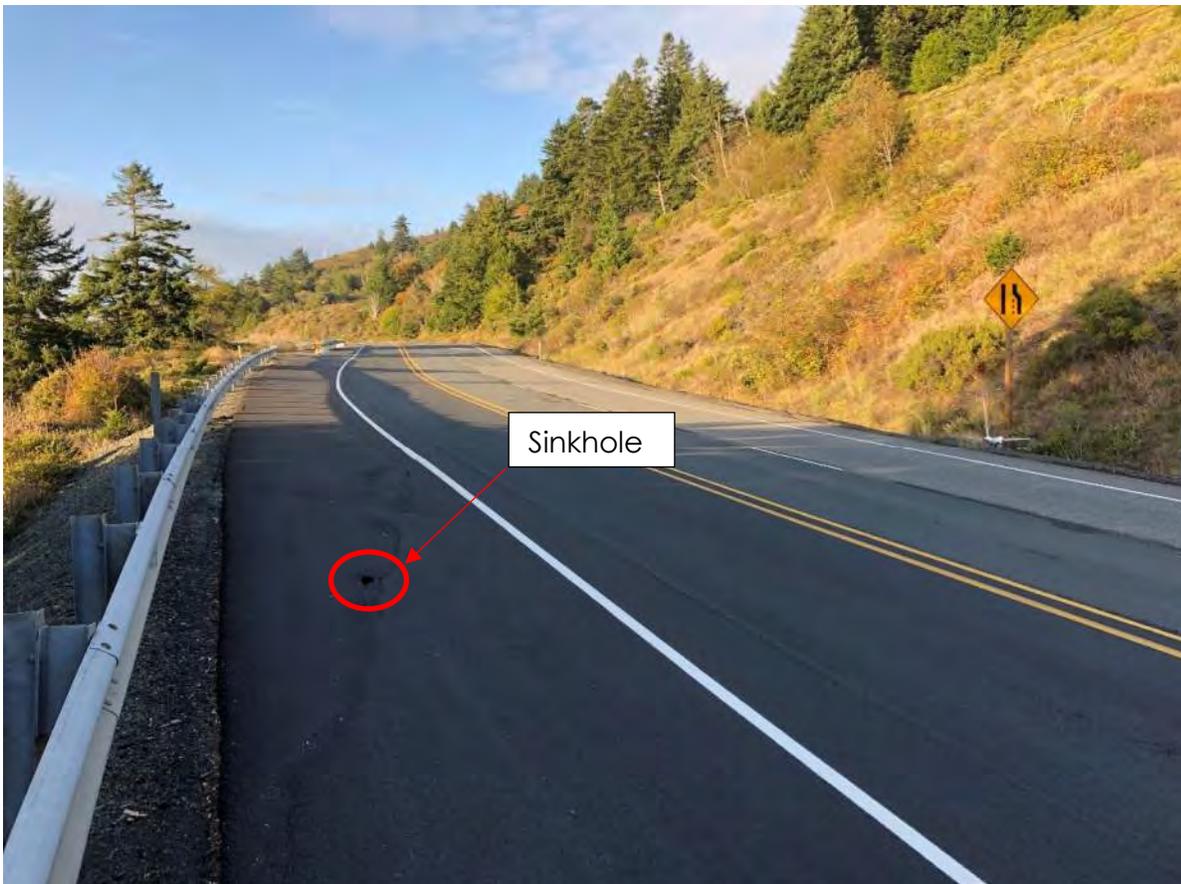
Exhibit 11: Cracking and sinkhole along US 101 southbound indicative of head scarp.

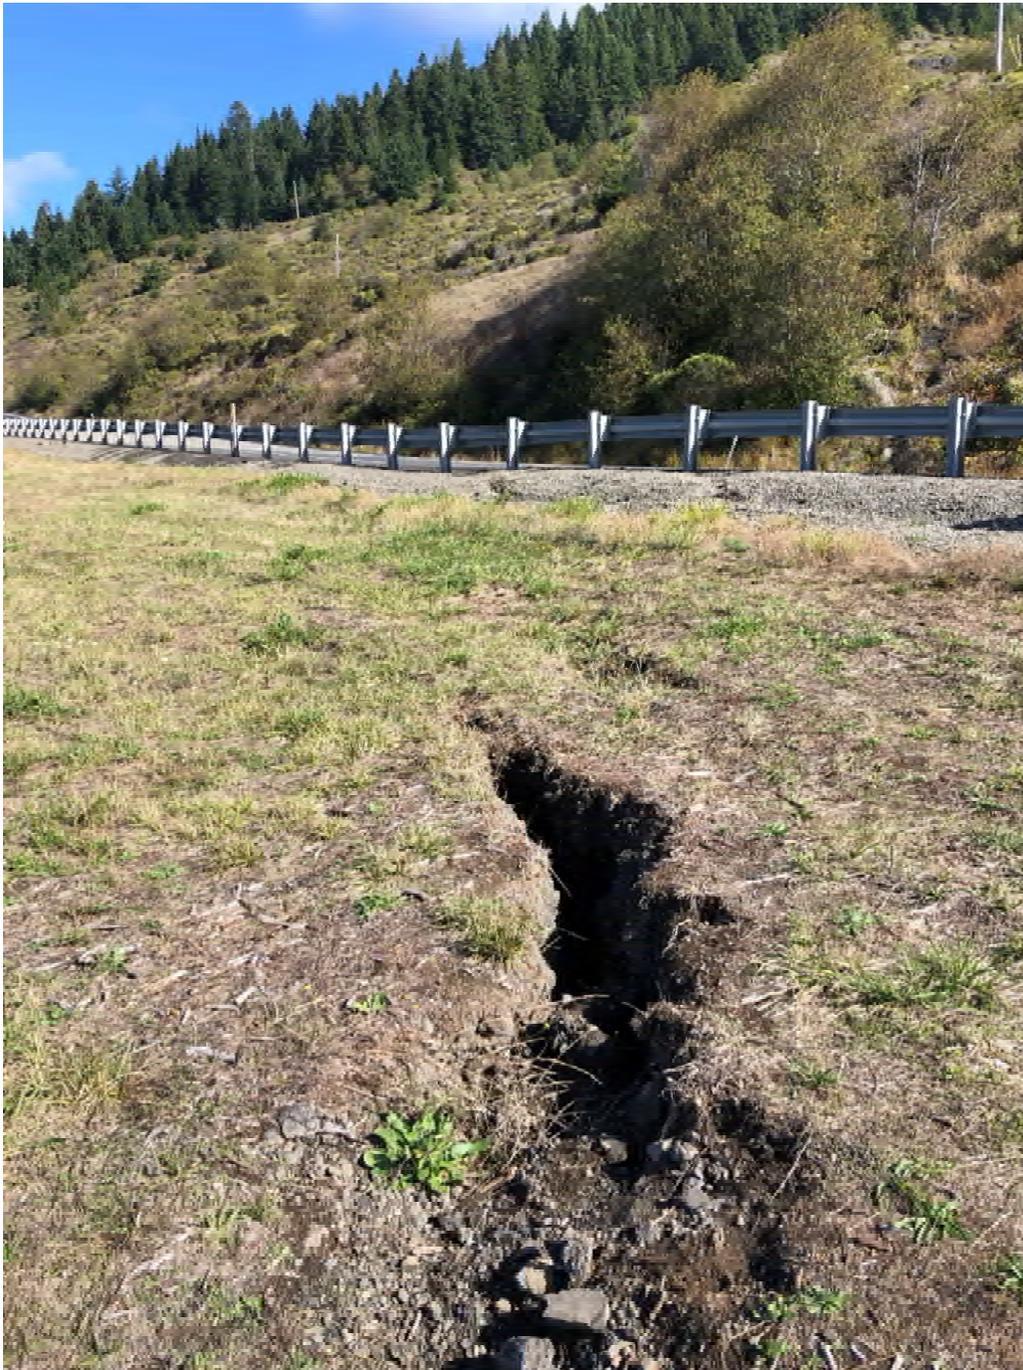
Exhibit 12: Large tension crack at the southern margin of the active slide area, along US 101 southbound shoulder.

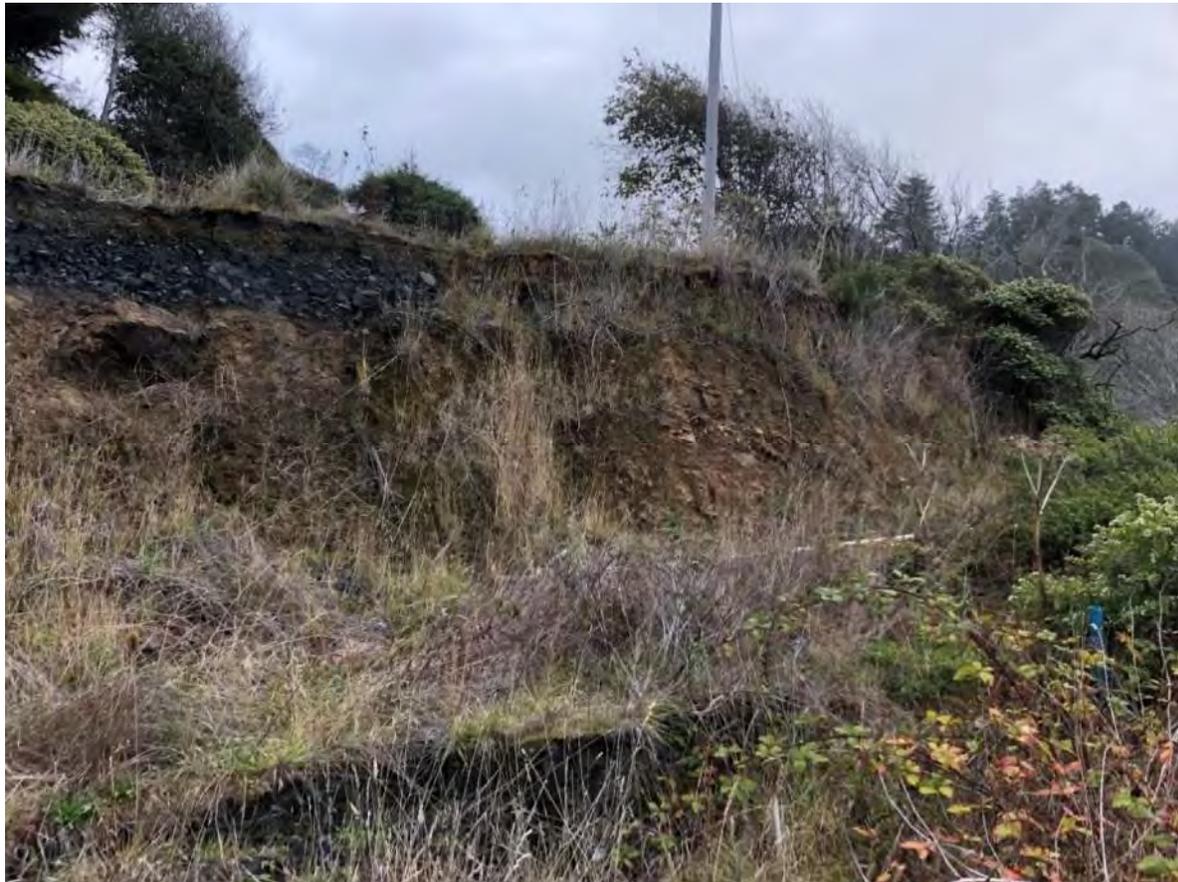
Exhibit 13: Slope failure cutting access road in the southwestern portion of the slide downslope of US 101.

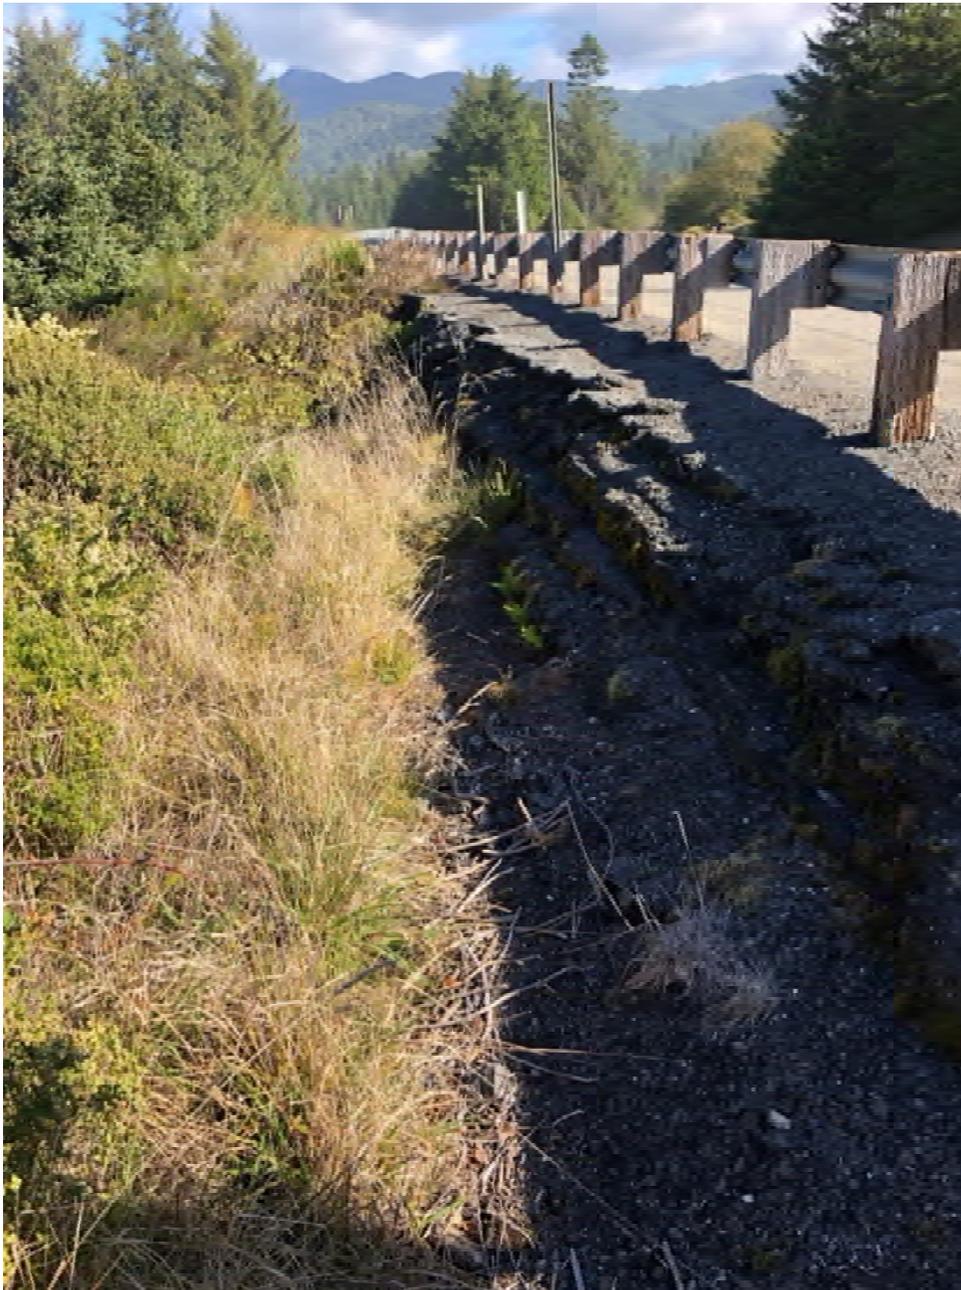
Exhibit 14: Multiple layers of asphalt pavement on US 101 southbound shoulder indicating ongoing displacements.

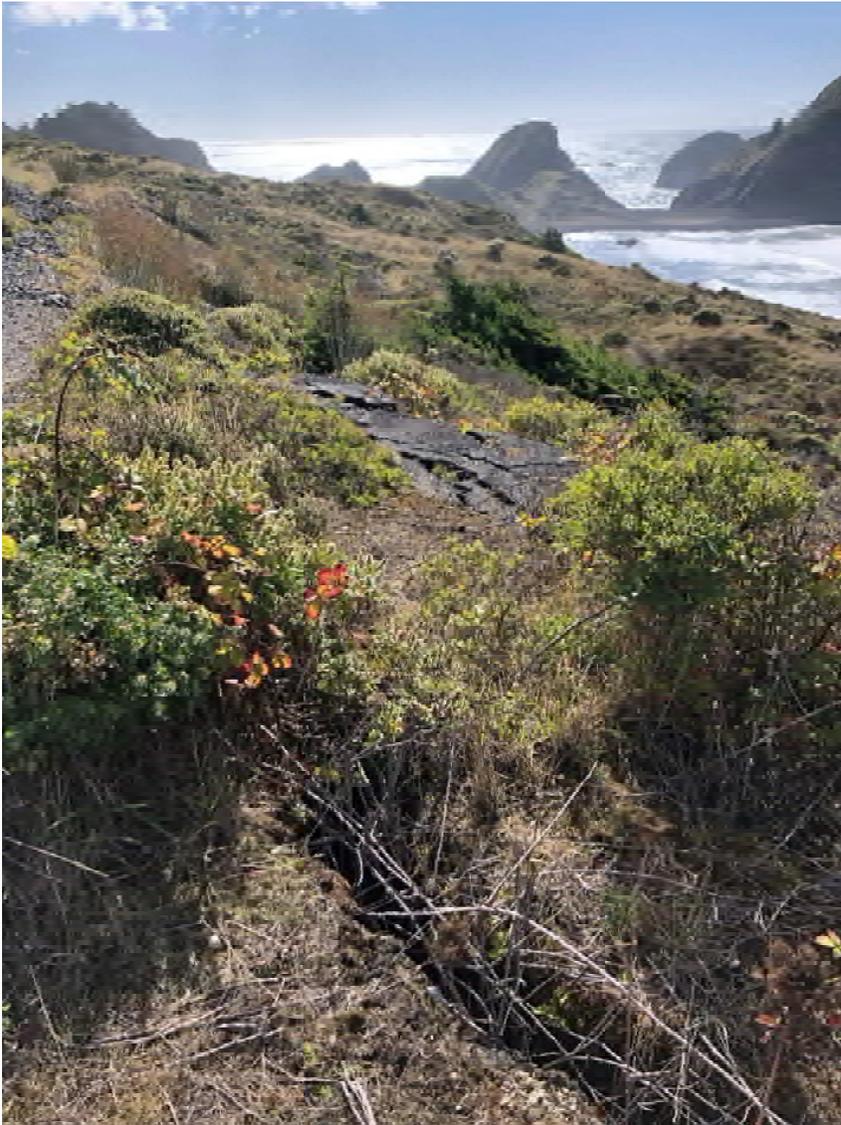
The reconnaissance of the Sisters Rock Sink slide area was performed on October 14, 2021. This slide area has a well-defined head scarp along the north slide flank with vertical offsets ranging from 1 to 5 feet near the Old US 101 alignment which is just west of the current US 101 alignment. Large sections of asphalt with significant tension cracking were observed downslope of the US 101 southbound shoulder which may be the old highway (Exhibit 15). Pavement distress along the US 101 southbound shoulder,

Exhibit 15: Large sections of asphalt with tension cracking downslope of US 101 southbound, potentially the old highway.

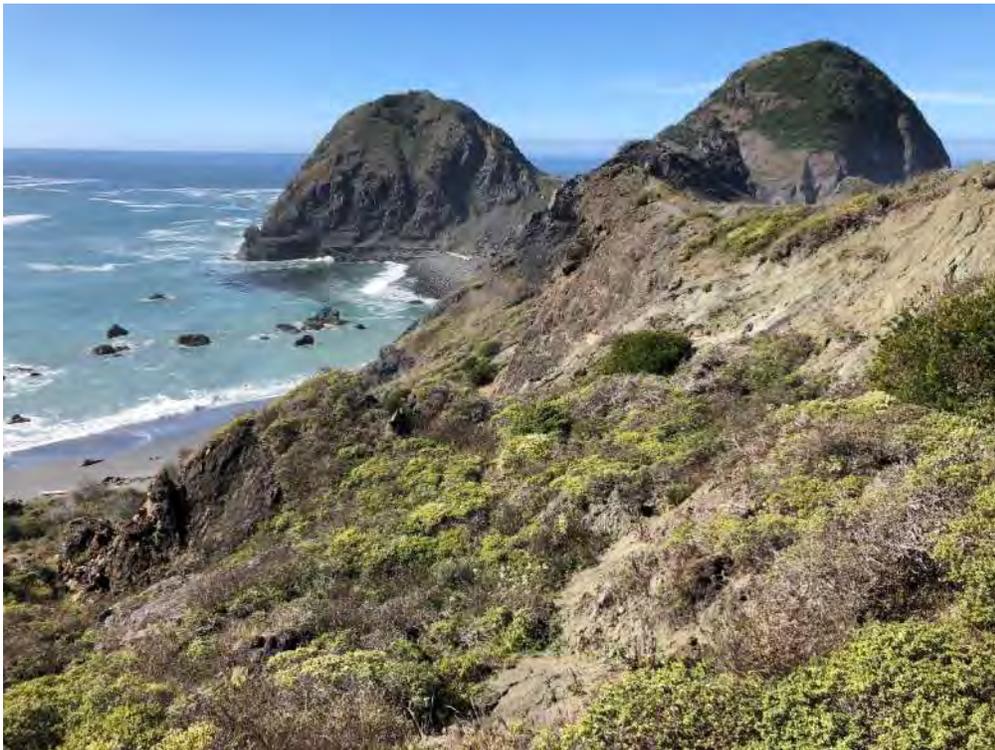
Exhibit 16: Potential recent slope failure along north margin of slide area.

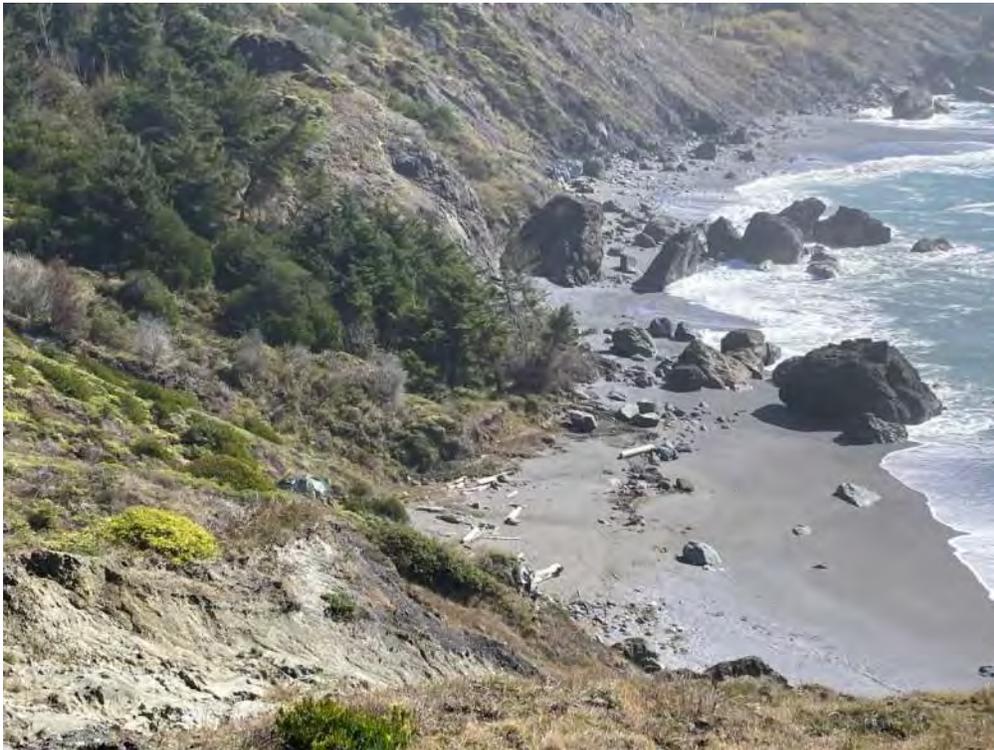
Exhibit 17: Toe of the landslide in the central portion of the photo with slumped trees and disturbed ground.

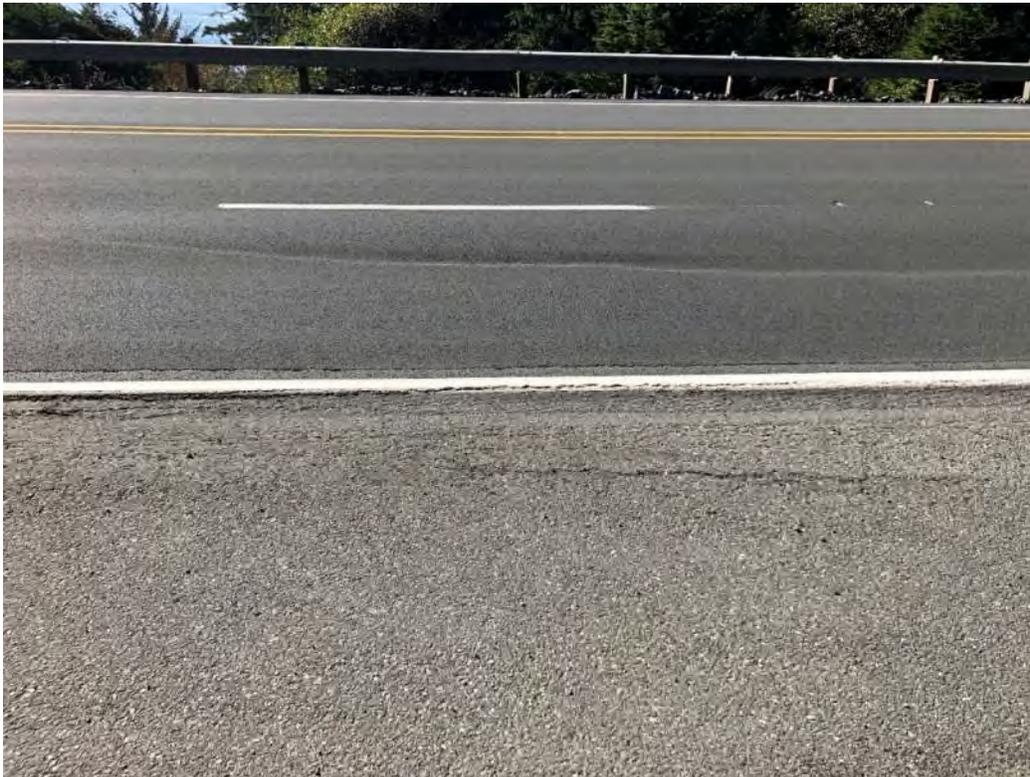
Exhibit 18: Paved over head scarp within US 101 northbound travel lanes.

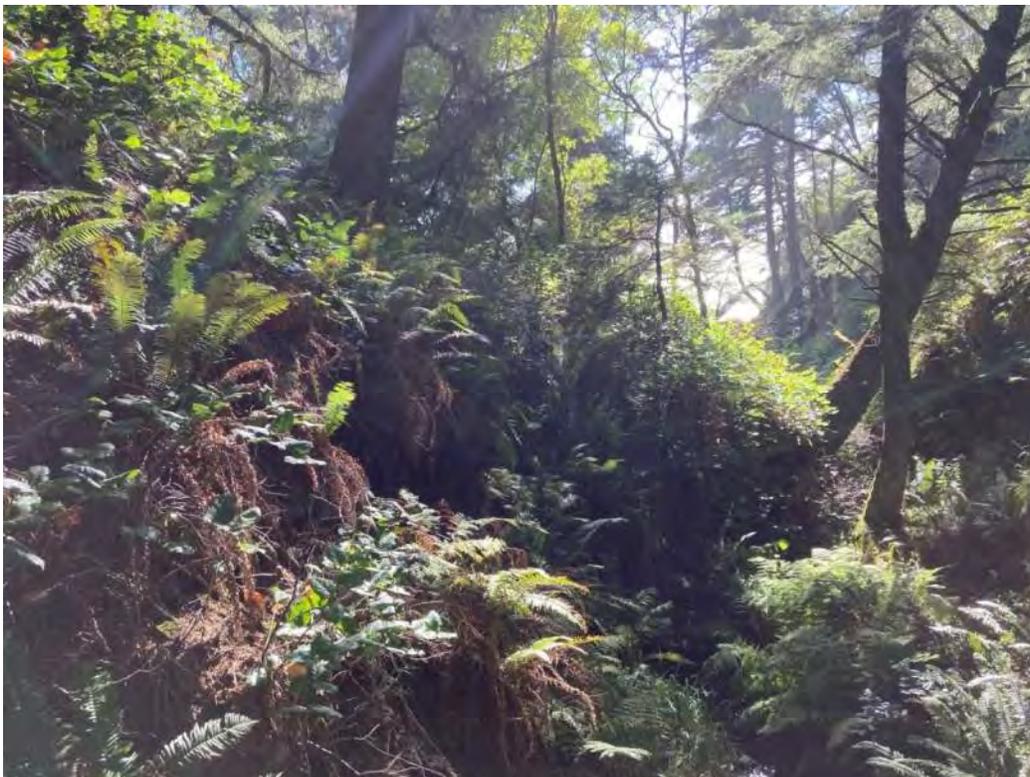
Exhibit 19: Toe of the landslide up against the steep channel of Woodroof Creek

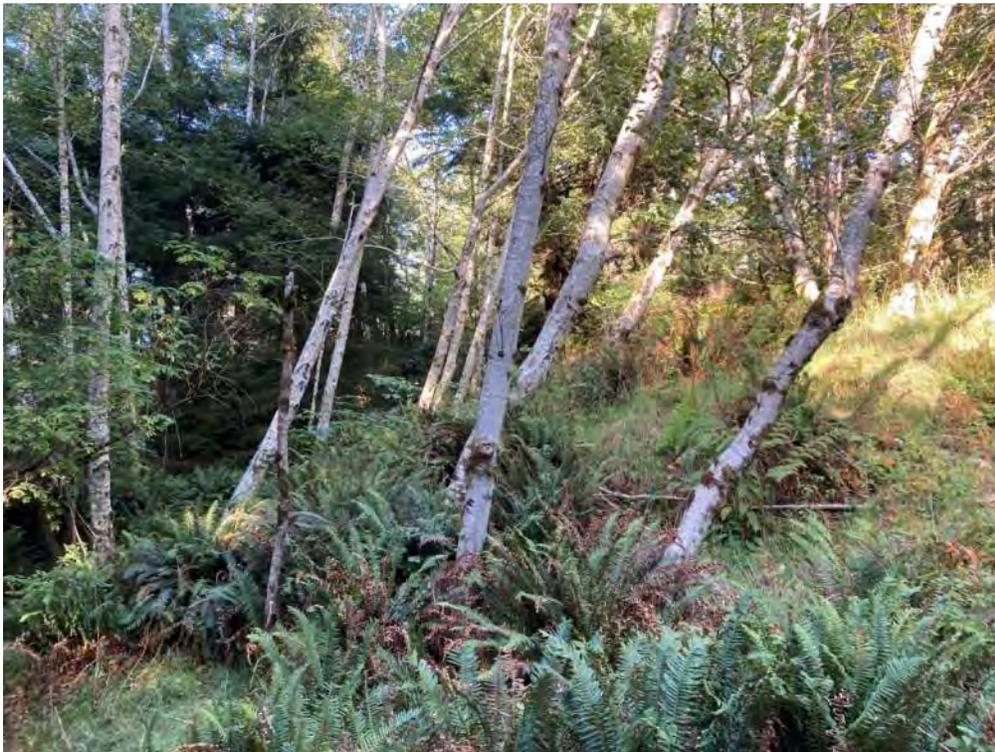
Reconnaissance of the Eighty Acres slide area was performed on October 14, 2021. Tension cracks within the US 101 southbound shoulder were observed, which indicate the active slide is affecting approximately 250 lineal feet of US 101. ODOT indicated that an approximate 12-foot-deep French drain was constructed along the US 101 northbound shoulder to intercept and lower groundwater levels within the slide mass. Almost yearly closures of US 101 were required within the slide limits prior to the construction of the French drain, but since it's construction ODOT has only had to close the southbound lane of US 101 once. The top of the slide and main head scarp appears to be located within in the southbound lane of US 101. The slide is flanked from the north and south by two creek drainages which merge near the bottom of the slope below US 101. The main toe of the landslide runs in between these drainage channels downslope and appears to be pinned where the channels merge. A smaller landslide toe is in the central portion of the landslide and was indicated in previous mapping by ODOT. The southern flank of the slide has multiple small and relatively recent slope failures along the creek channel and the area along the southern drainage is highly unstable. Hummocky ground and pistol butted/distorted trees were observed throughout the slide mass below US 101 (Exhibit 20).

Exhibit 20: Slumped trees in the central portion of the slide area

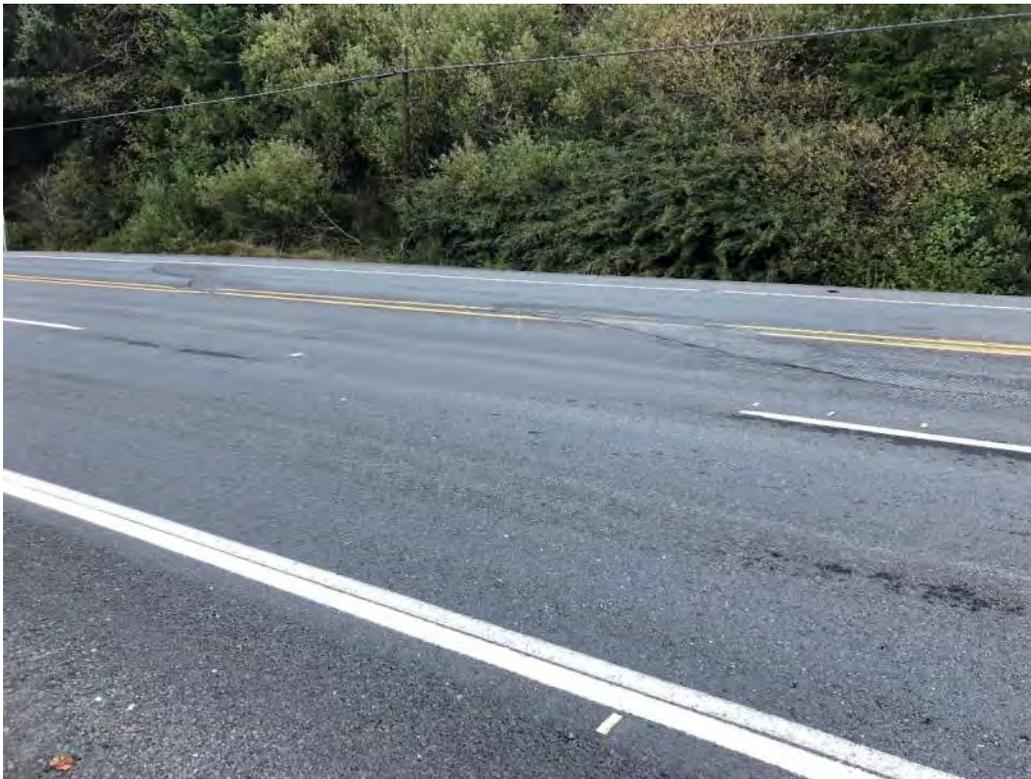
Exhibit 21: Tension cracks along south flank of slide running through all lanes of US 101

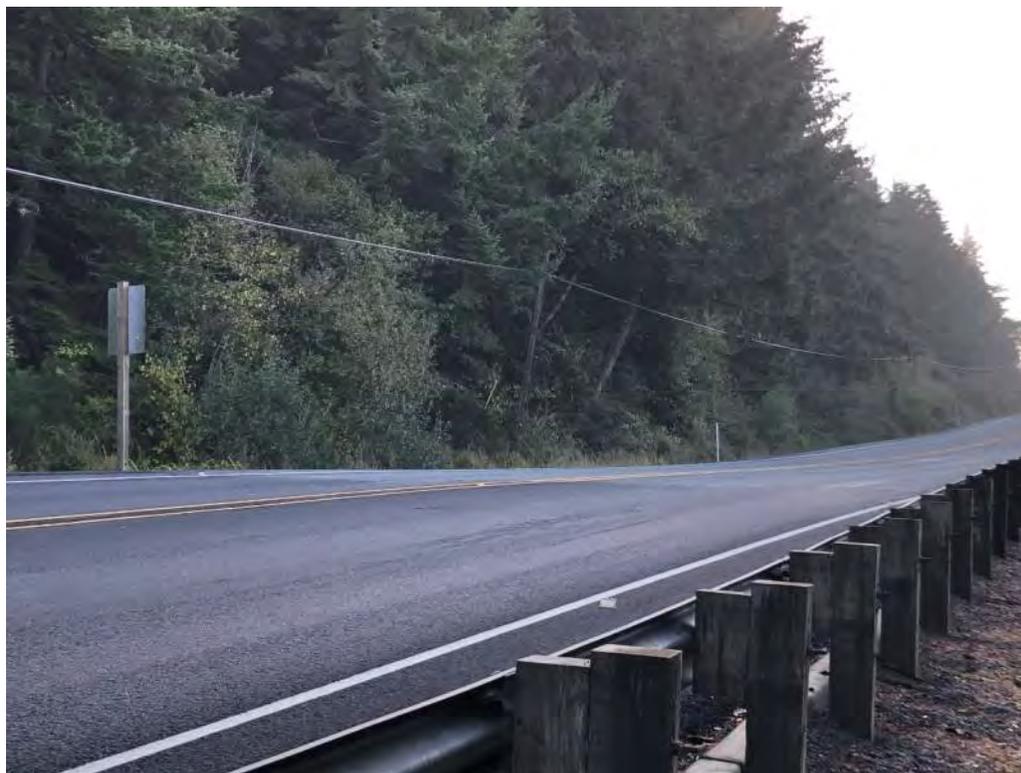
Exhibit 22: Leaning power pole and pistol butted trees just upslope of US 101 northbound

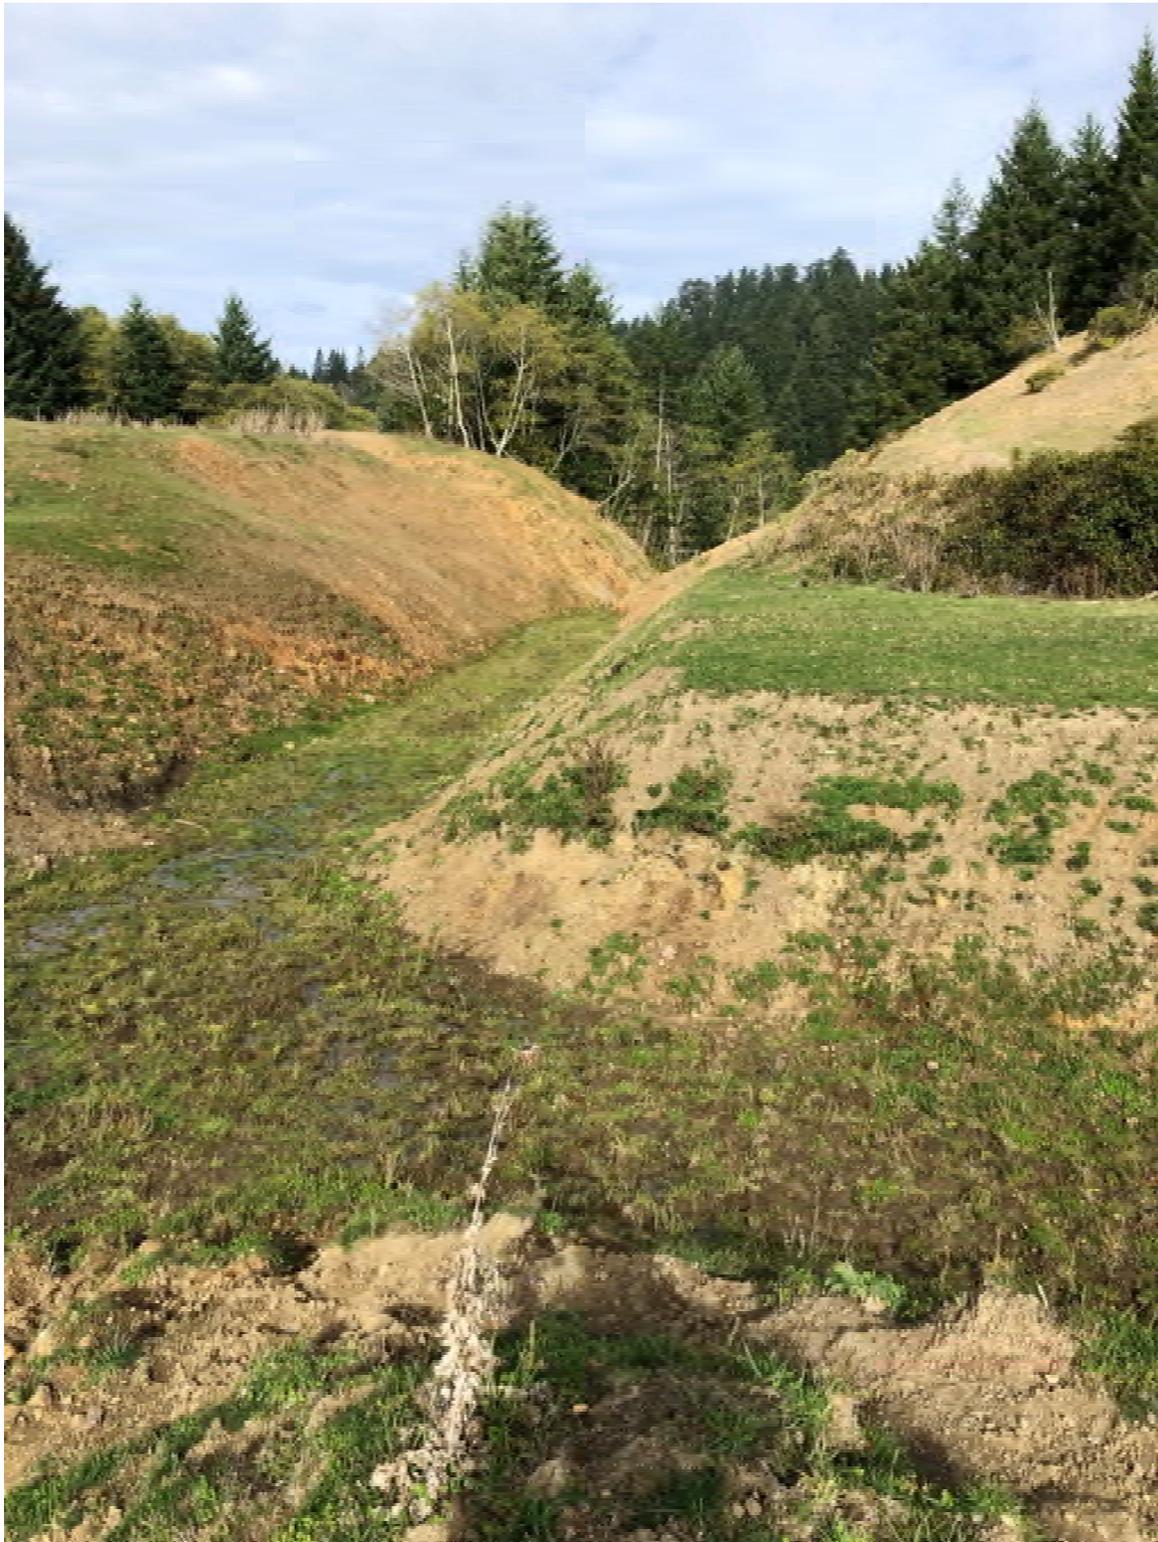
Exhibit 23: Drainage channels within the upper head of the slide constructed by ODOT

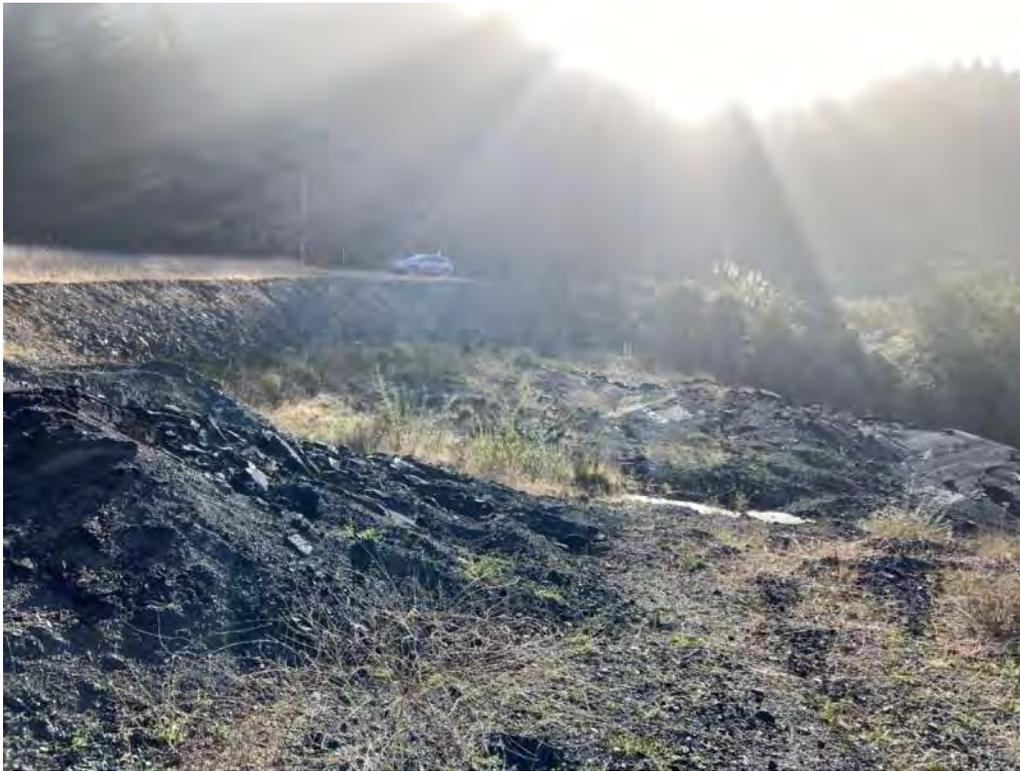
Exhibit 24: Large sections of pavement and road debris below US 101 southbound
