Technical Memorandum

January 22, 2022

To: Lisa Cornutt
Oregon Department of Transportation
3500 NW Stewart Parkway
Roseburg, OR 97470

RE: South Coast Site Reconnaissance Report

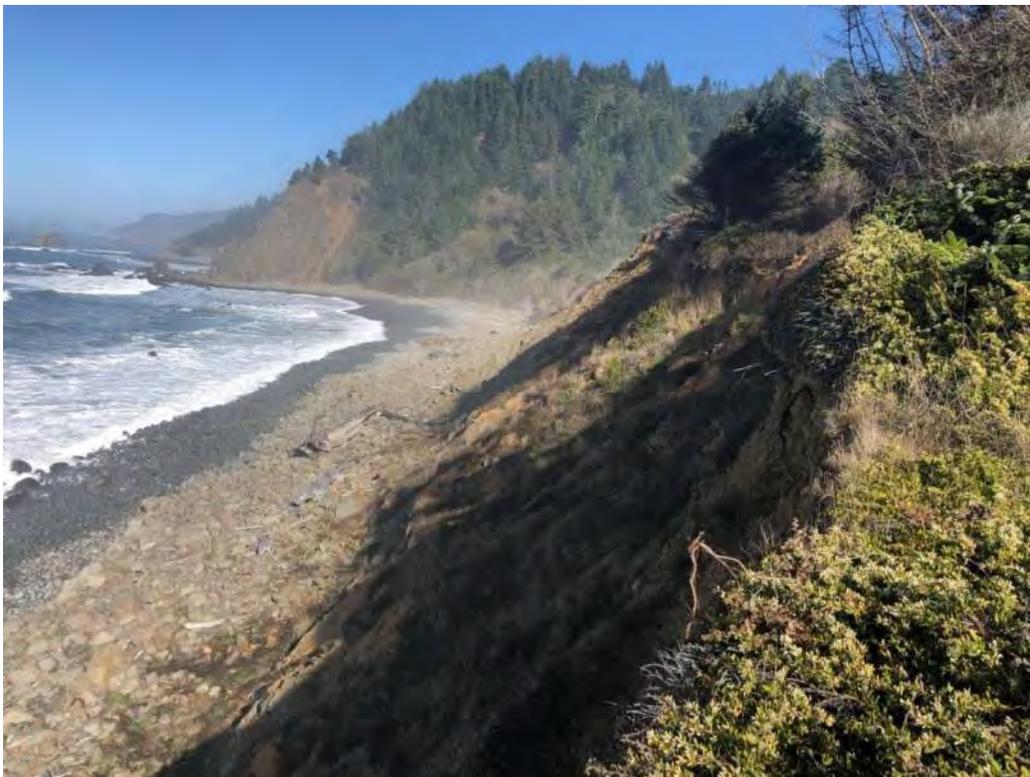
Landslide features were observed and mapped where visible, and with the time granted, key areas of interest within the slide were assessed. The area immediately downslope and west of US 101 southbound at the gravel turnout area is riddled with former road pavement surfaces and debris that are at least 100 feet downslope of the existing highway (Exhibit 24). Further downslope to the west, the ground surface is highly deformed and multiple secondary scarps and grabens were mapped and appear to have recent movement. Near the coastline, the ground is upheaved and cut where the upper portions of the toe meet the coastline and are being eroded (Exhibit 25).

Exhibit 25: Portion of the toe near the coastline being eroded

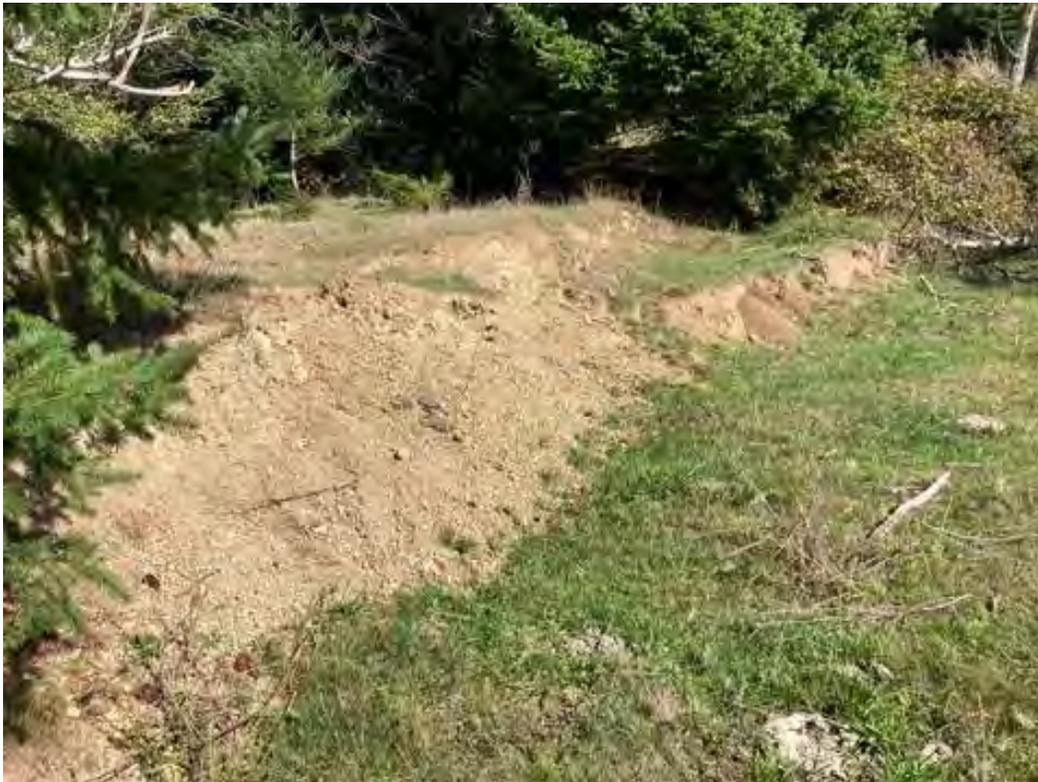
Exhibit 26: Recent scarping in the southeastern portion of the slide upslope of US 101

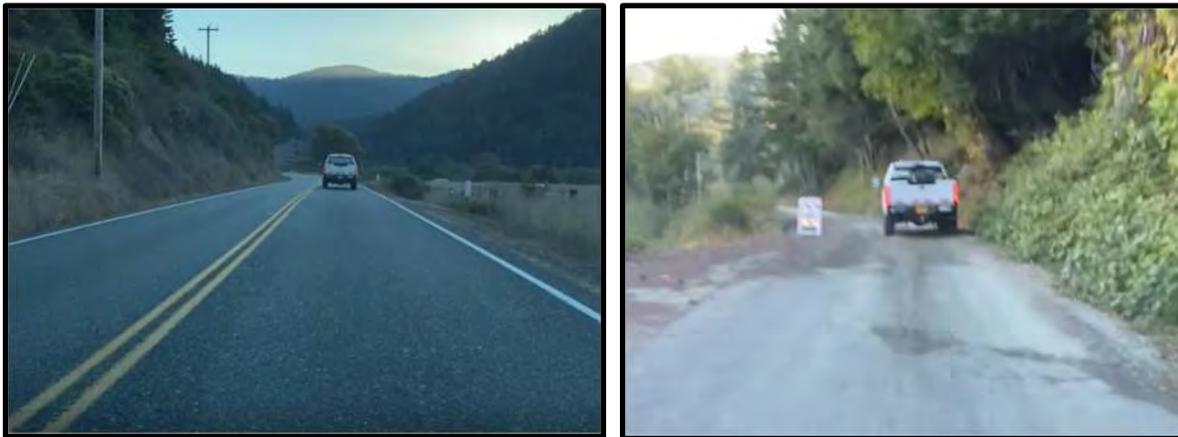
The final segment to connect back to US 101 at Ophir is also a paved County owned/maintained road, five miles in length. This segment is also in good condition aside from some slide damage near US 101 (see right image below).
