Technical Memorandum

RE: Final Technical Memorandum #2 Inventory

The purpose of the South Coast Slide Study project is to develop a plan for transportation resiliency along US 101, between the City of Port Orford and the City of Brookings. Study landslides and road failures, shown in Table 1 and Figure 1 along this segment have been an ongoing problem for decades. These events result in full or partial closures of travel lanes and require days or even weeks of maintenance work to be able to fully reopen to passenger car and heavy vehicle travel. As a result, these landslide and road movement incidents have a significant cost to Oregon Department of Transportation (ODOT), disrupt the local and regional economies, strain emergency services, and reduce the mobility of communities to reach critical services.

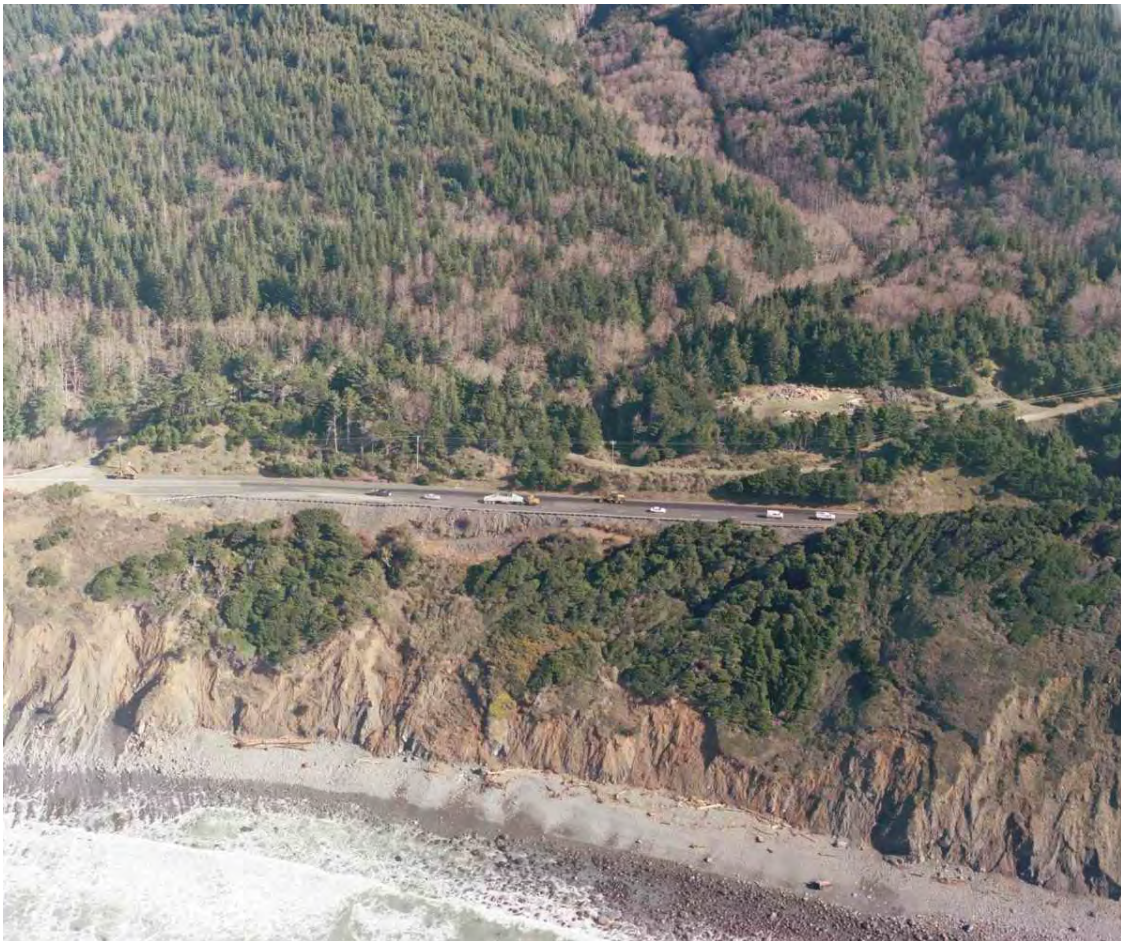
Retz Creek South inclinometers have encountered two slide planes, between 13 feet to 89 feet bgs. Inclinometers installed in the US 101 northbound lane at Retz Creek South observed movement during the monitoring period, and data indicates the slide extends east of US 101. The slide may toe out below sea level as indicated by ODOT.

Exhibit 1: Aerial photo looking east at US101 within the Retz Creek South slide limits. The photo shows recent repavement of US 101. Photo taken February 10, 2006.

Slide movement is likely attributed to high groundwater (including potential artesian conditions encountered in boring 13776-03), and erosion of the toe due to wave energy. Field observations of the project area indicate that slide movement in the upper decomposed, weathered and sheared zones of the Rocky Point Formation has been occurring in this area before the existing highway alignment was constructed, however depending on the geometry of failure plane, additional embankment fill could have induced additional driving forces (ODOT, 2011).

Excavation of the existing US 101 embankment and replacement with lightweight fill was conceptually considered at Retz Creek South, however no mitigation has been documented at this slide area.

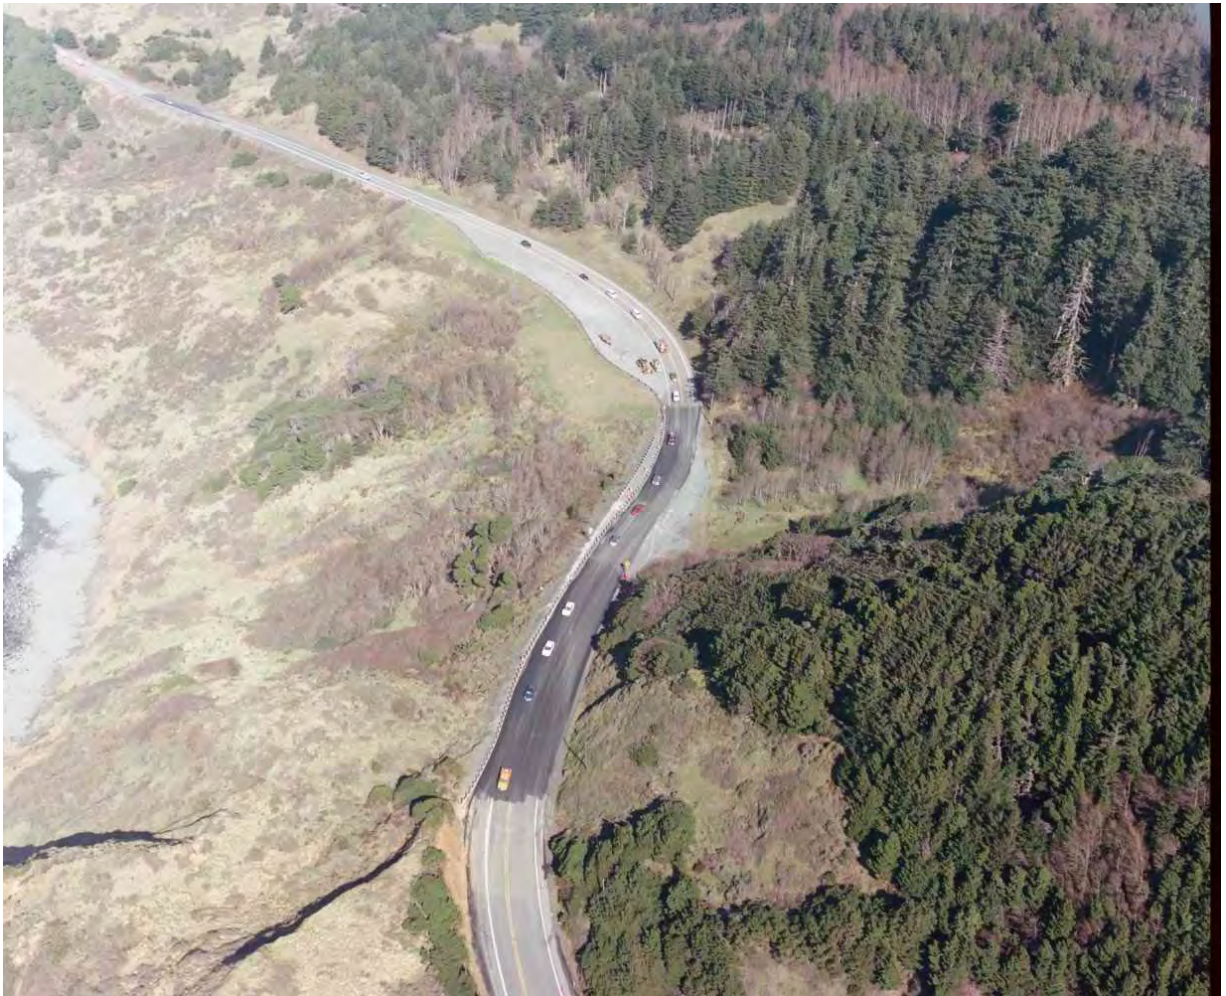
Slide planes have been observed in all completed borings (except 18896CP-06), from depths of approximately 28 feet to 83 feet below ground surface. Slide planes generally persist through contacts between the Residual Soil and Sandstone of the Rocky Point Formation. However, a deeper failure plane has been observed within the sheared Sandstone of the

Rocky Point Formation encountered in borings 15278CP-01, 02, 04, and 05. A 1986 interoffice memo states movement is observed at the base of the fill (noted at approximately 8 to 20 feet below roadway grade), in addition to deeper planes that are likely too expensive to mitigate (OSHD, 1986). October 2014 project charter summarizes the slide plane depth is about 35 feet below ground surface (bgs) on the north end, 80 to 90 feet bgs in the center, and 60 feet bgs on the south end (ODOT, 2014b).

Exhibit 1: Aerial photo looking northeast at US 101 within the Coal Point slide limits. The photo shows recent repavement of US101 due to slide activity. Photo taken February 10, 2006.

The Project Charter for Coal Point Slide Repair (ODOT, 2014b) proposed a shear key buttress where there is adequate room to stage traffic on the north end (250 feet long) and drilled stone columns on the middle and south end (300 feet long) where the depth of the slide plane and geometric constraints prevent extensive rerouting of traffic. The charter outlined a final Geotechnical Report submittal of Fall 2016, and a bid date of April 2017. We understand the project was ultimately dropped before a Geotechnical Report was prepared because the estimated mitigation cost exceeded the project budget. However we do understand two boreholes were drilled in 2015 per recommendation of the June 2014 PEGR.

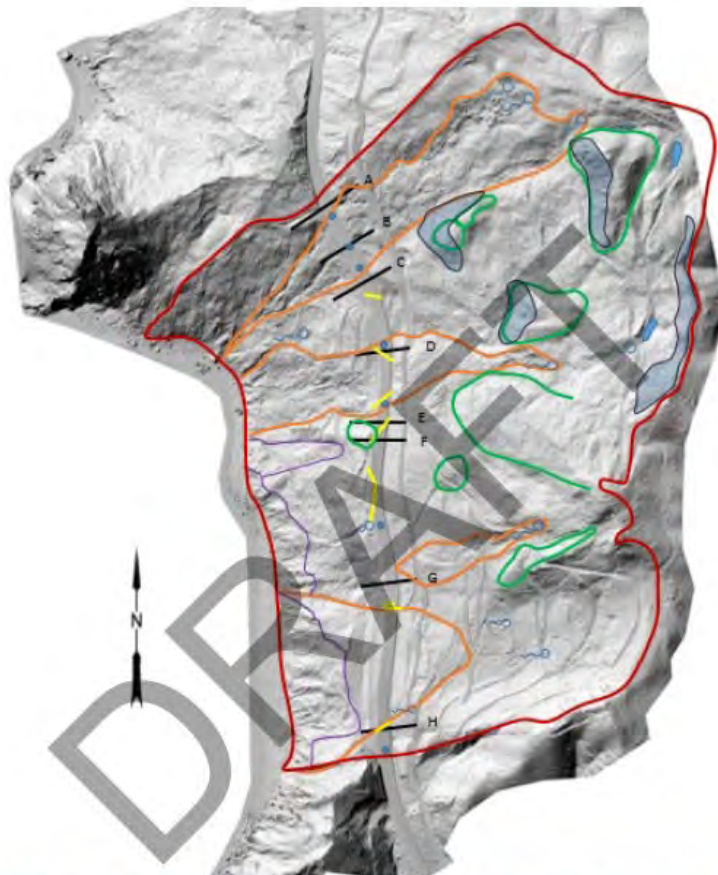
Figure 15: Hillshade Map with Landslide Features. This image shows the results of desktop evaluation and field reconnaissance. The 2021 bare-earth hillshade serves as the base map. Landslide limits are marked in red. Areas demonstrating higher rates of movement based on LiDAR imagery and features mapped in the field are shown in orange. These orange features coincide with areas of intermittent and perennial springs or seeps – shown with spring symbol. Mapped pavement cracks are shown in yellow. Areas mapped as blocks that may be static or entrained in the landslide are shown in green. Several more prominent scarps are highlighted with dark blue. Ponded water is mapped in light blue. Erosional features at the toe of the landslide are shown in purple. Culverts are shown in blue donuts. Black lettered lines coincide with sectors shown in C-Band Profile Displacement Rate Map – Figure 14.

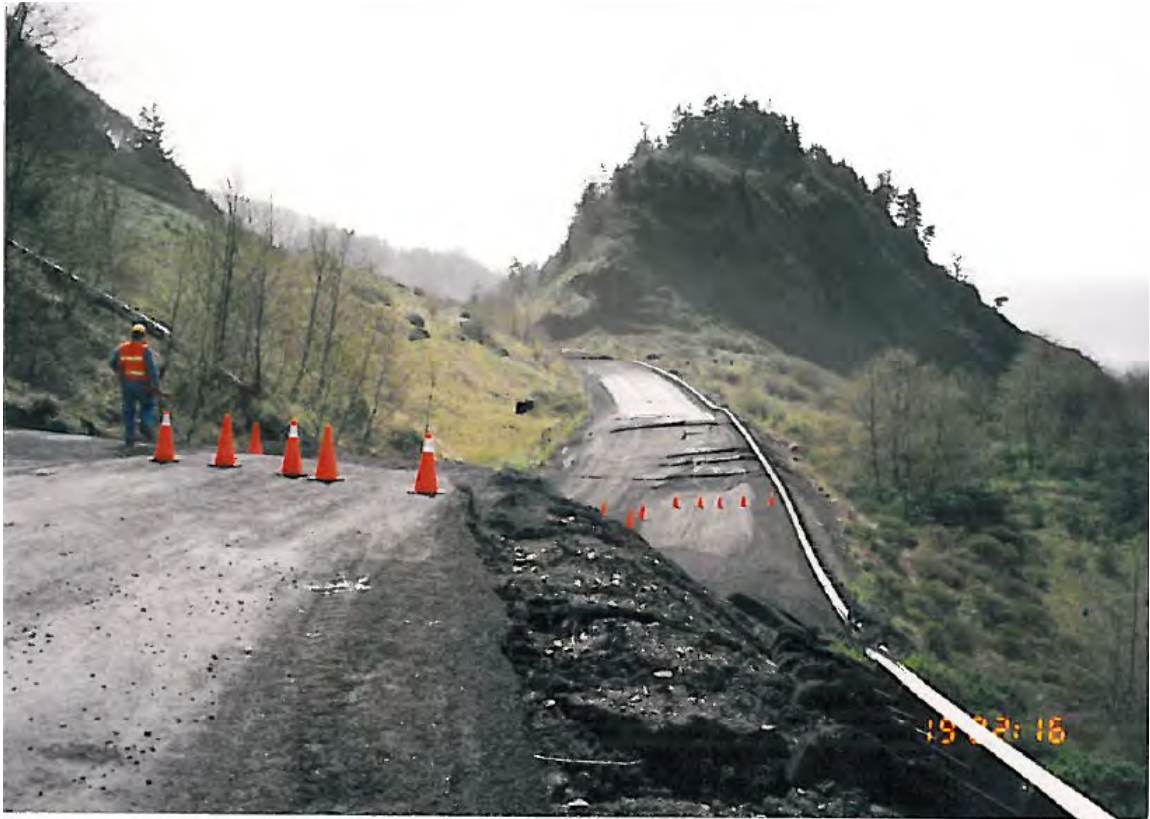
Exhibit 1: Photo looking south along US101 after the 1993 slide event.

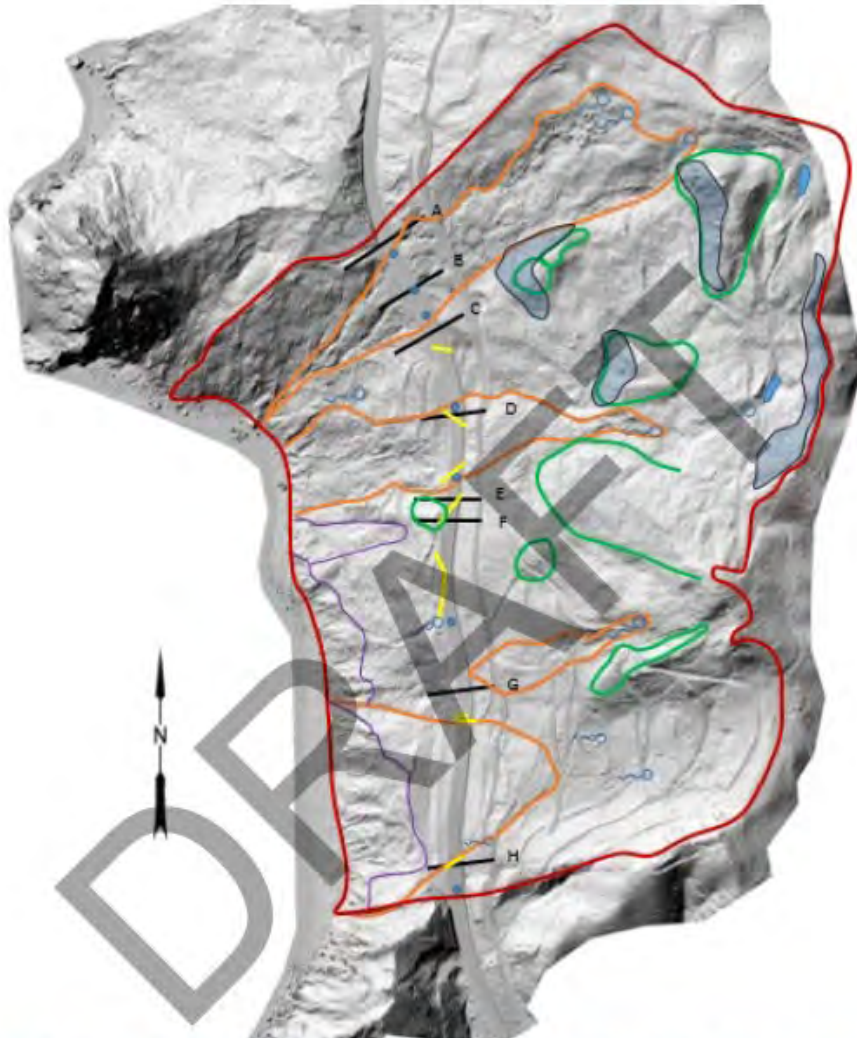
Figure 15: Hillshade Map with Landslide Features. This image shows the results of desktop evaluation and field reconnaissance. The 2021 bare-earth hillshade serves as the base map. Landslide limits are marked in red. Areas demonstrating higher rates of movement based on LiDAR imagery and features mapped in the field are shown in orange. These orange features coincide with areas of intermittent and perennial springs or seeps – shown with spring symbol. Mapped pavement cracks are shown in yellow. Areas mapped as blocks that may be static or entrained in the landslide are shown in green. Several more prominent scarps are highlighted with dark blue. Ponded water is mapped in light blue. Erosional features at the toe of the landslide are shown in purple. Culverts are shown in blue donuts. Black lettered lines coincide with sectors shown in C-Band Profile Displacement Rate Map – Figure 14.

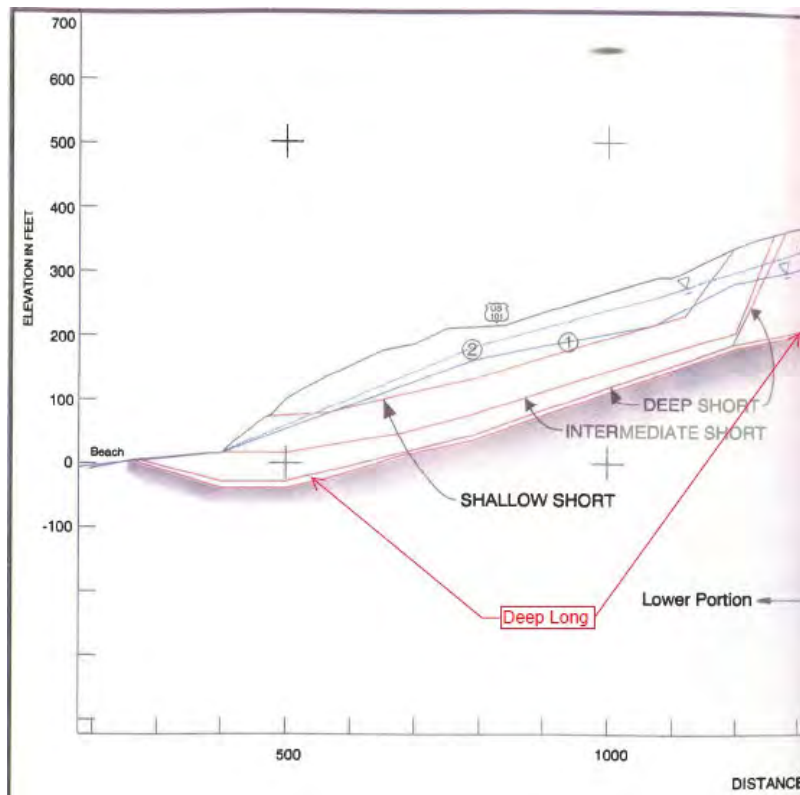
Exhibit 3: (Squier, 1994a) presents the four failure modes observed and analyzed in the Arizona Inn slide mass.

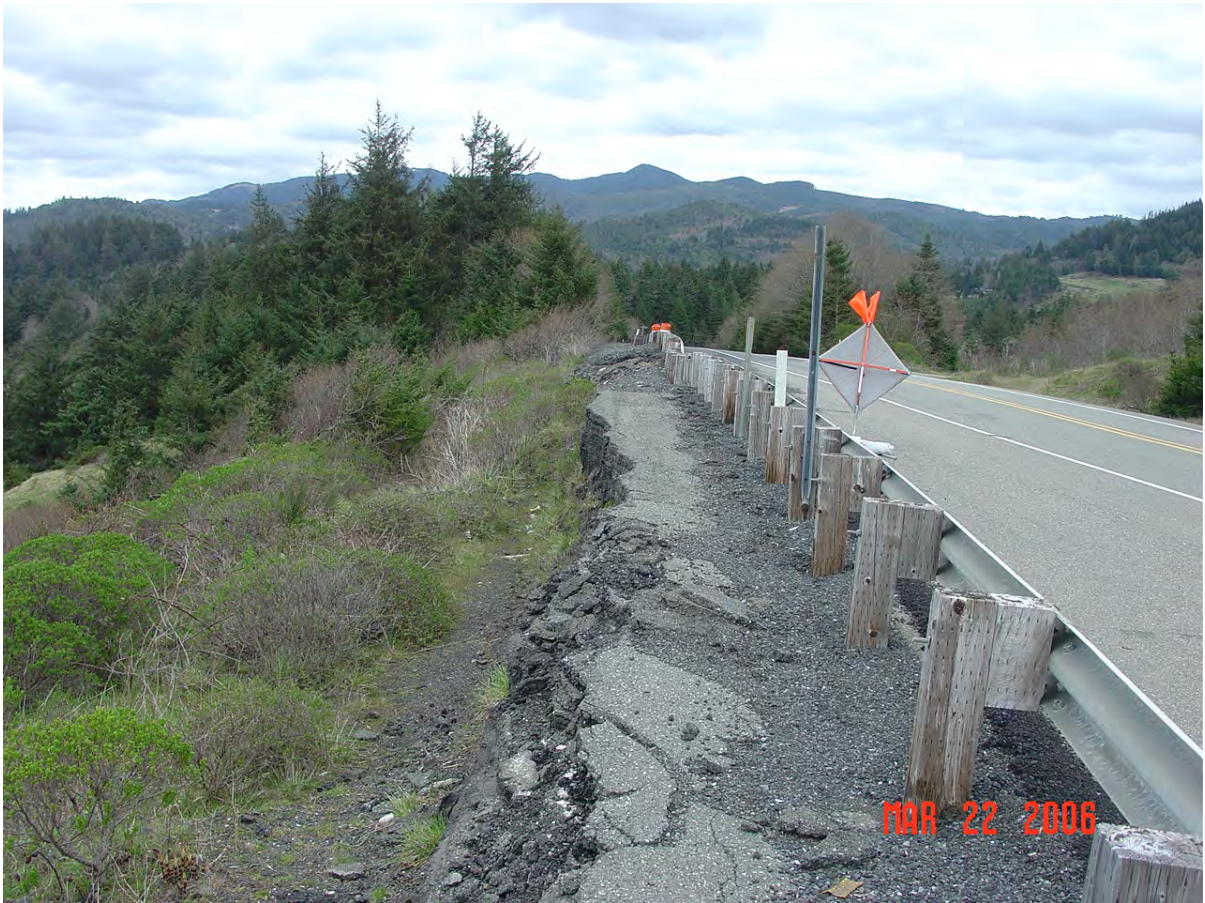
Exhibit 1: Photo looking northeast at the head scarp of the Frankport North slide. Photo taken March 22, 2006.

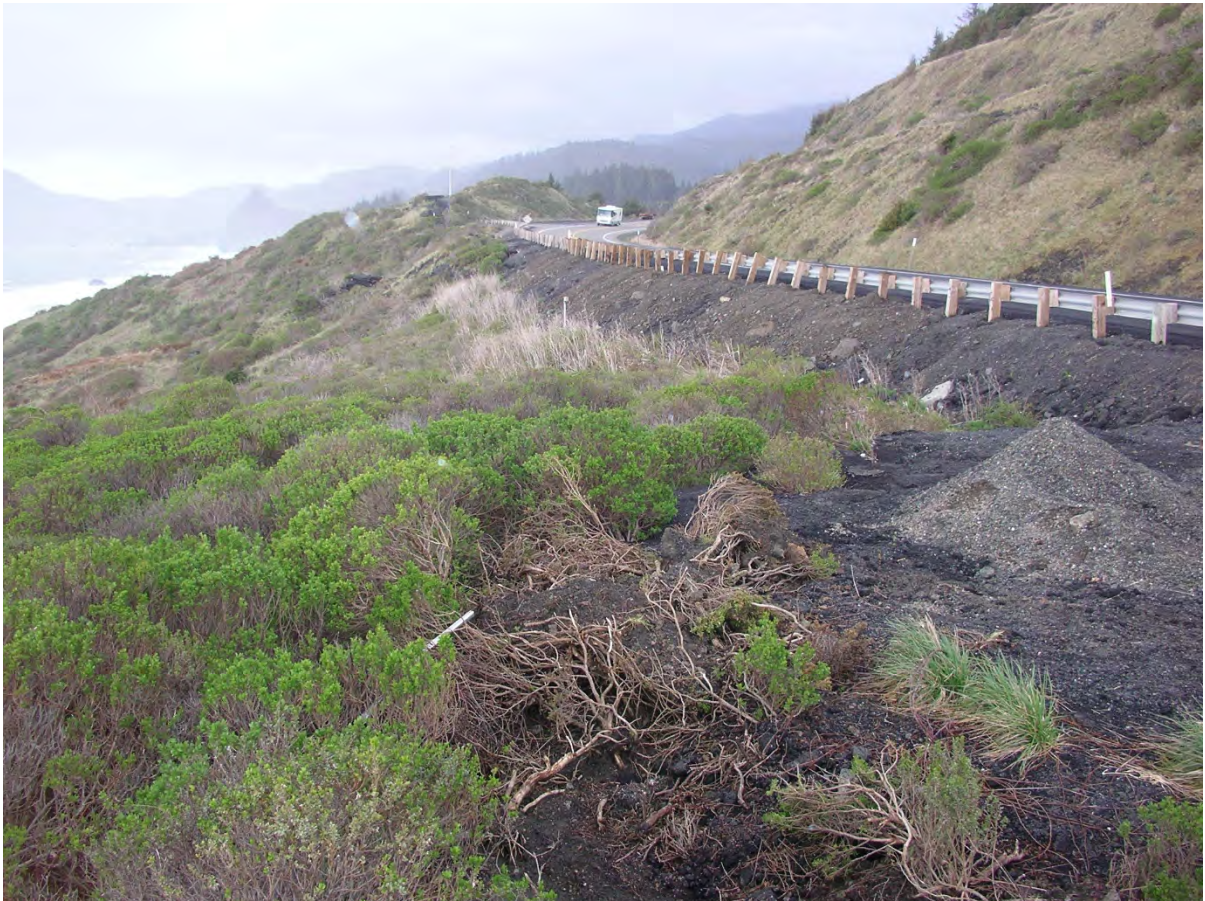
Exhibit 1: Photo looking northeast along US101 at the ground movement within the Sisters Rock Sink area. Photo taken March 16, 2007.

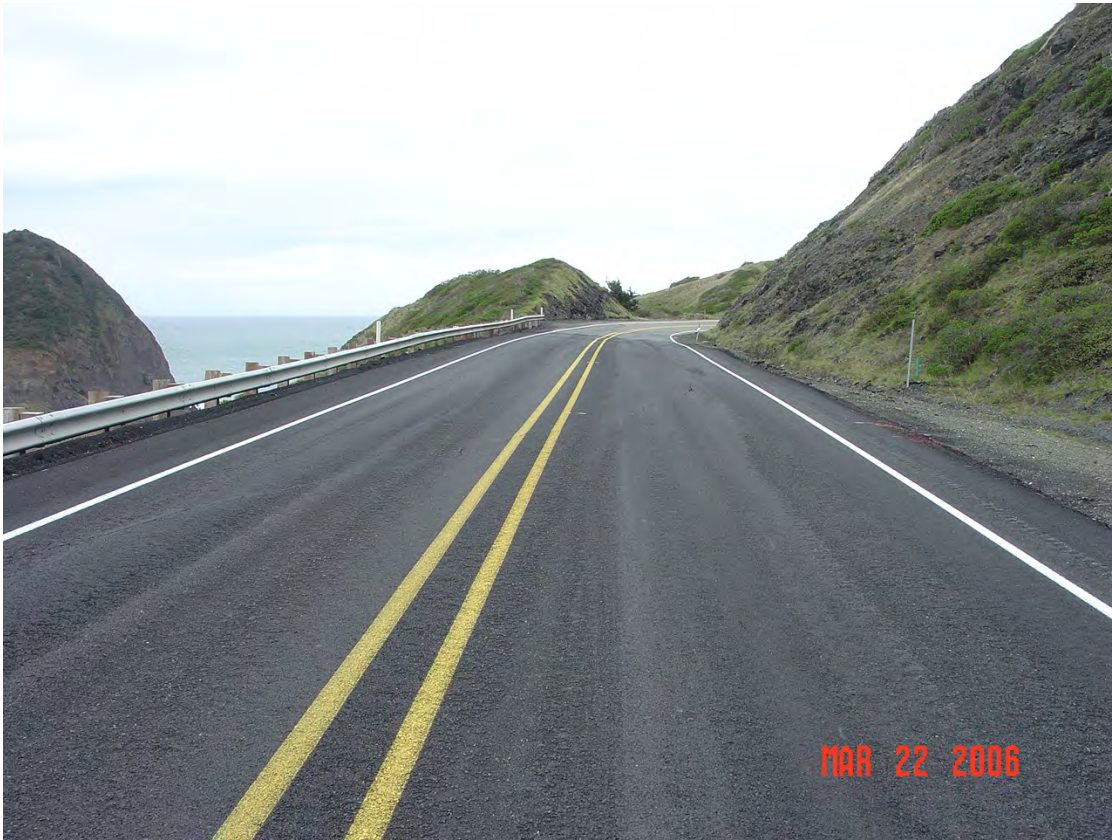
Exhibit 1: Photo looking north along US101, displaying pavement distress within the Frankport South slide limits. Photo taken March 22, 2006.

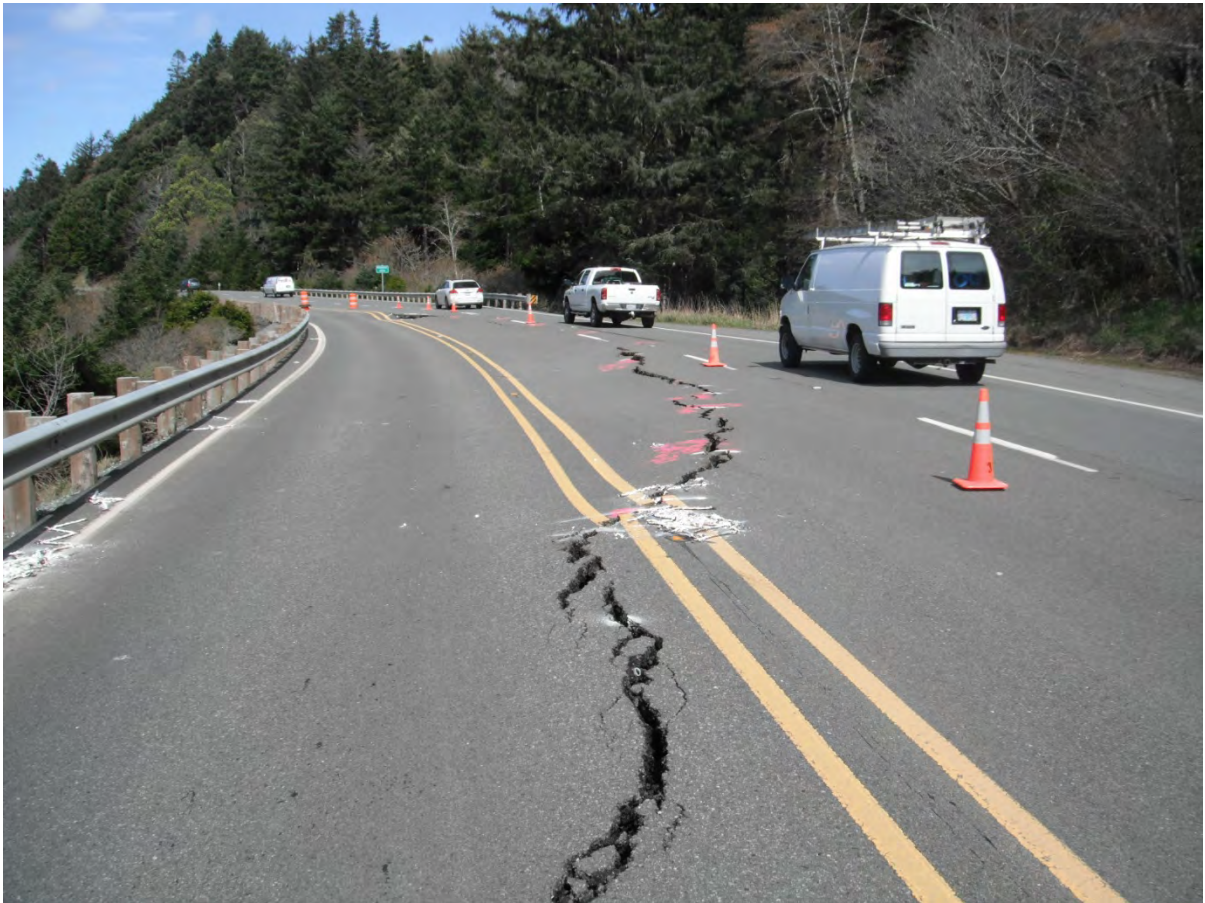
Exhibit 1: Photo looking north along US101 at the Woodroof Creek head scarp. Photo taken March 23, 2012.

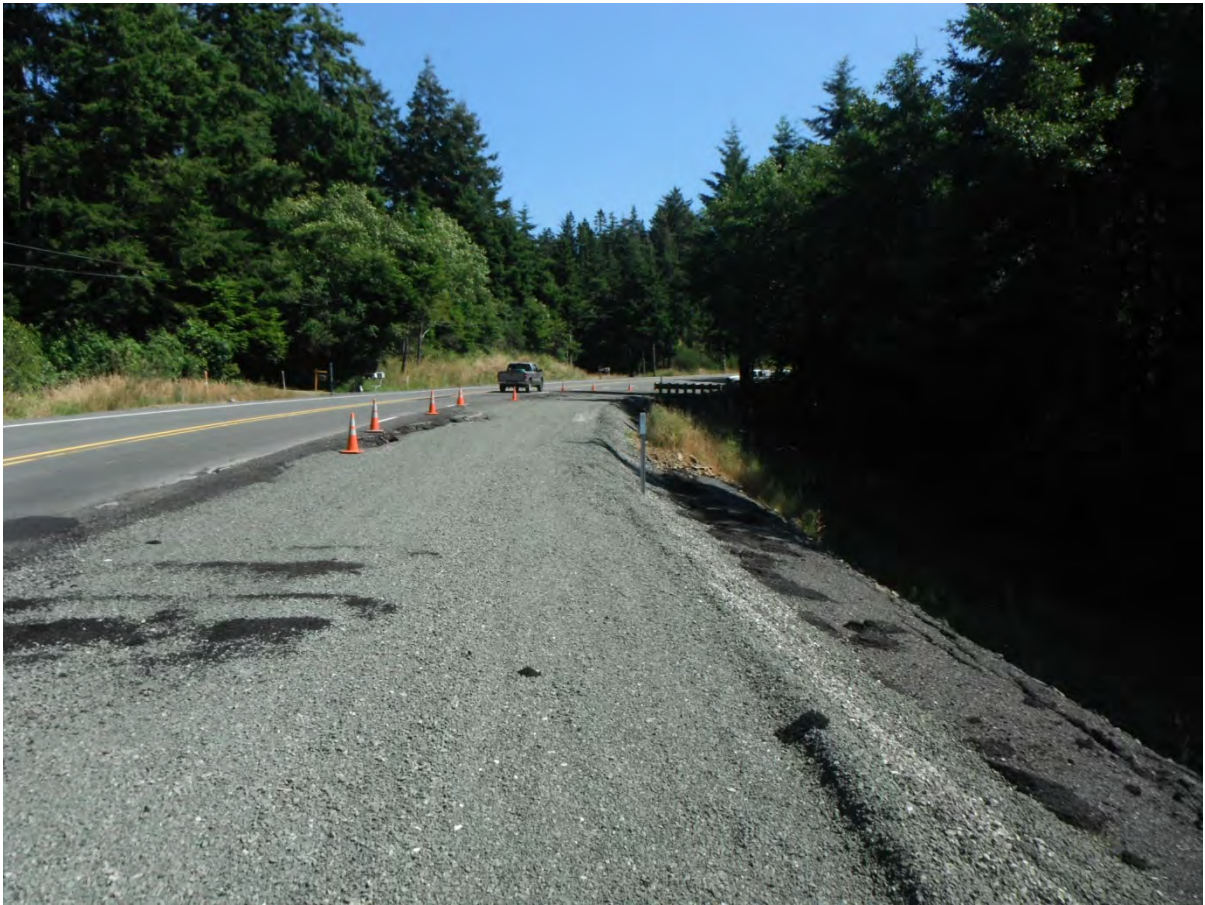
Exhibit 1: Photo looking south along US101 at the Eighty Acres head scarp. Photo taken July 30, 2012

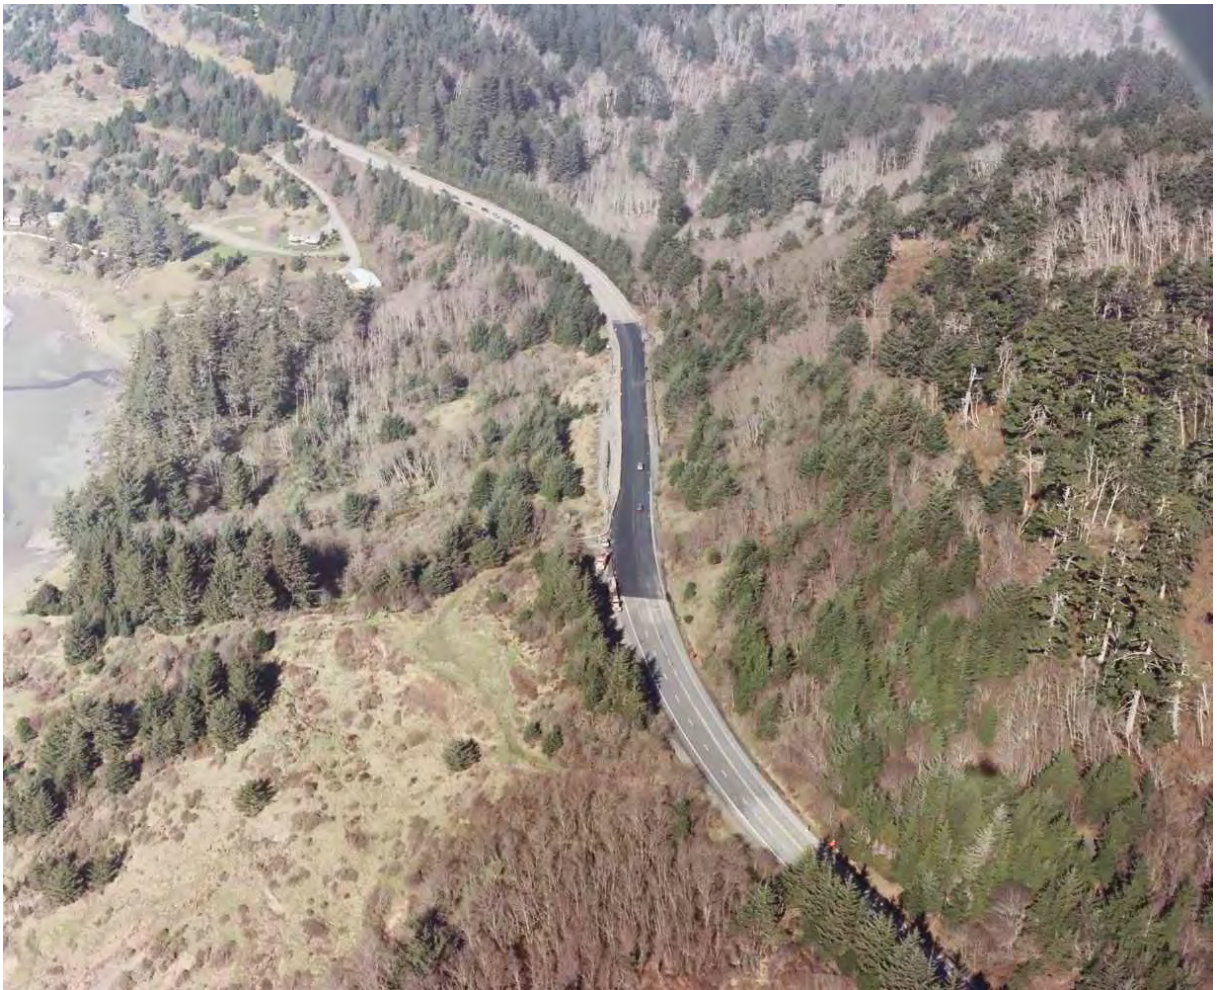
Exhibit 1: Aerial photo looking north at US101 within the Burnt Hill slide limits. The photo shows recent repavement of US101 due to slide activity. Photo taken February 10, 2006.
