Working with Customers to Successfully Respond to Summer-Fire Activities

“BPA System Operations Post-Summer Update”

BPA Transmission System Operations

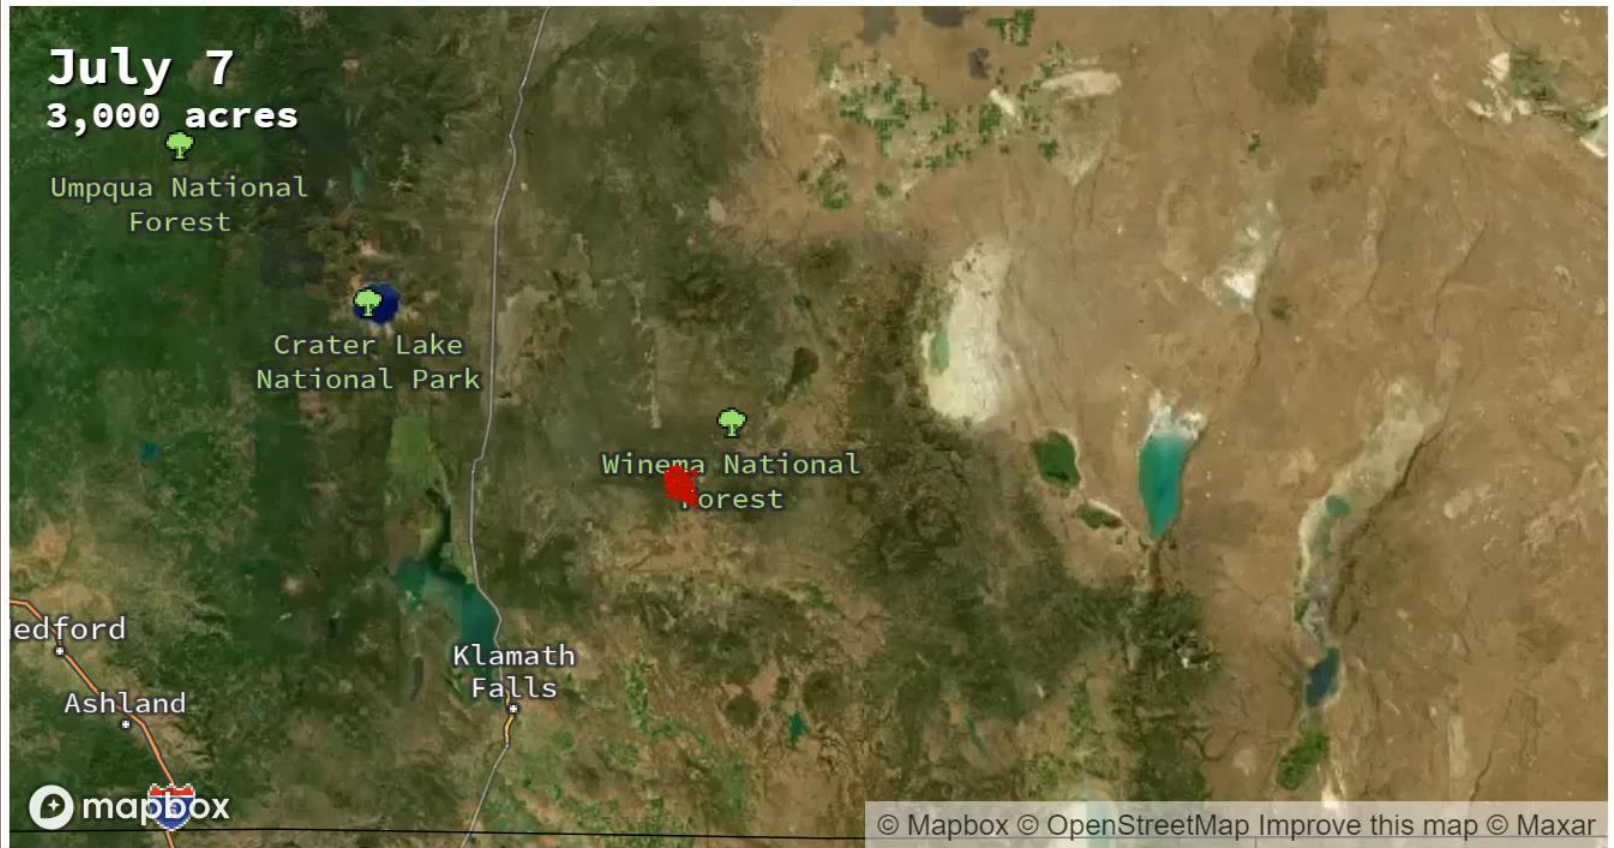
Sources: National Interagency Fire Center, NASA, NOAA, Oregon Department of Forestry
Map: Mark Friesen/staff

Bootleg Fire: Timeline

Date	Time	Details
7/6/2021		Bootleg Fire started
7/9/2021	13:00	Identification of credible multiple contingency, and associated studies and system adjustments
7/9/2021	15:33	Grizzly-Captain Jack #1 500kV line relayed out of service
7/9/2021	15:41	Grizzly-Malin #2 500kV line relayed out of service
7/9/2021	15:41	Summer Lake-Malin #1 500kV line relayed out of service
7/13/2021	14:03	Grizzly-Captain Jack 500kV line in service
7/13/2021	14:08	Summer Lake-Malin 500kV line in service
7/14/2021	16:36	Grizzly-Malin 2 500kV line in service
7/23/2021	13:24	Bootleg Fire restriction was removed

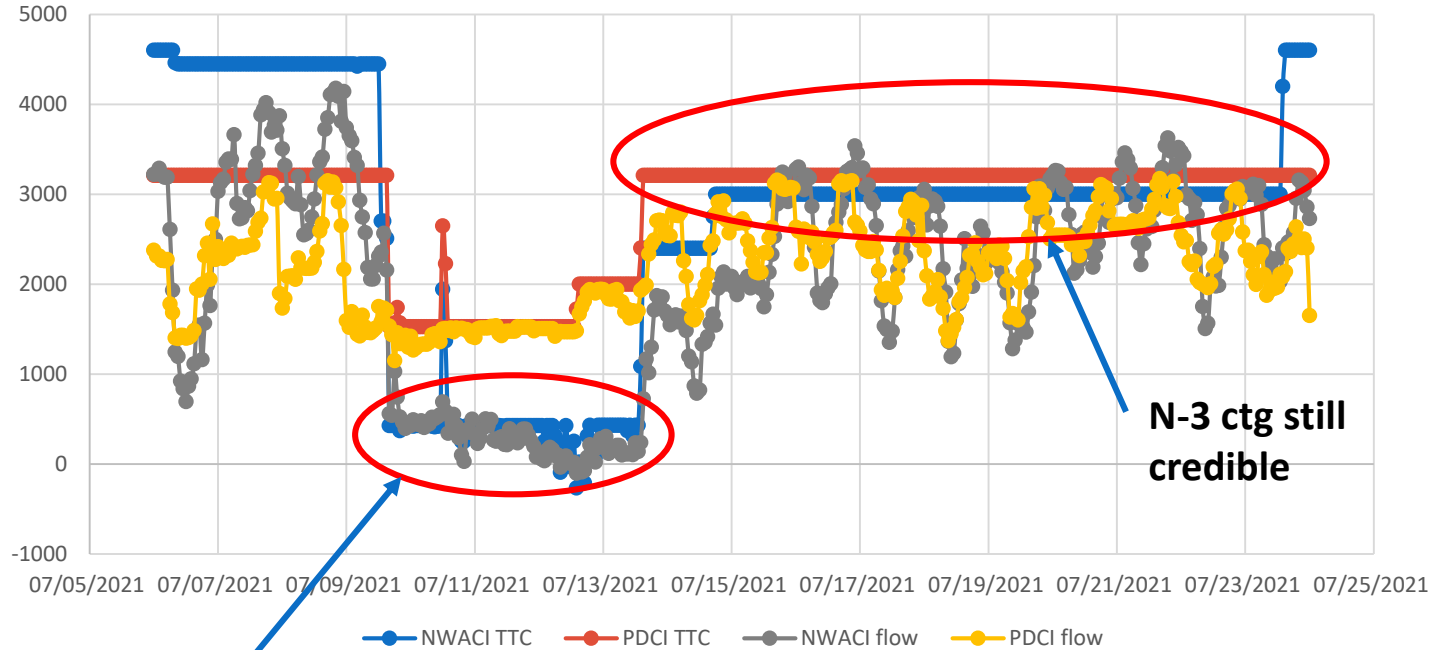
NWACI and PDCI flows and TTCs

All three corridor lines out of service

N-3 ctg still credible
