**STRAIN MONITORING FOR HORSETAIL FALLS AND  
SYLVAN BRIDGES**

**Final Report**

**SPR 304-081**

**May 2002**

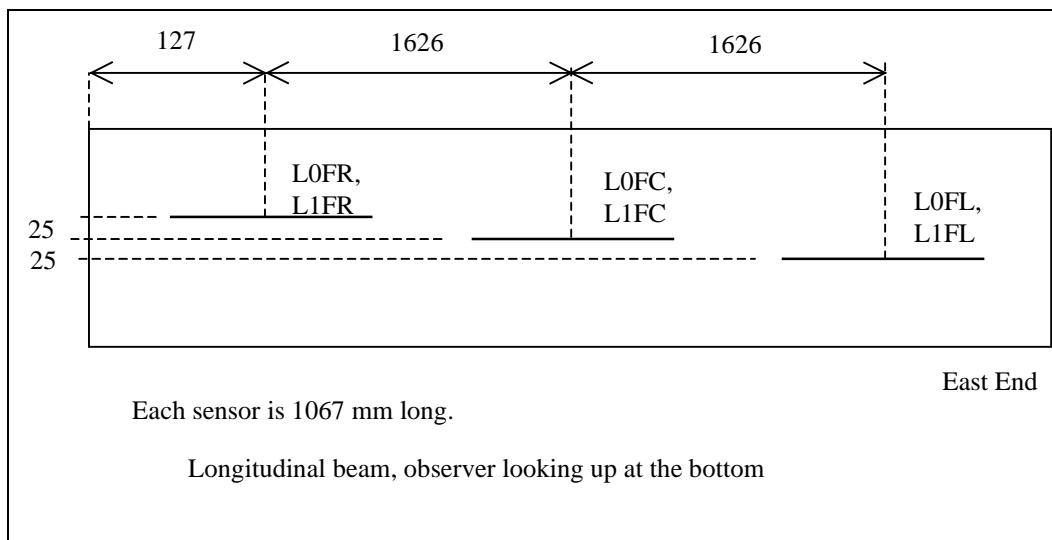
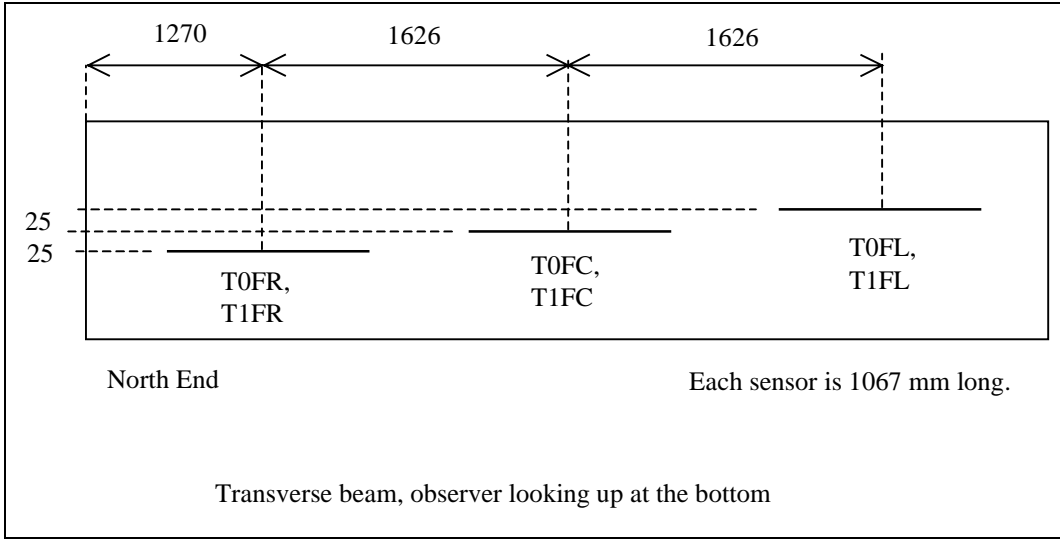
## Appendix C2: Fiber optic sensor positions

Each indicated location includes two sensors: one embedded in the concrete and one attached to the surface of the FRP composite. Specific sensor locations are distinguished with a four- or five-digit alphanumeric label (e.g., LOSRA, T1FC). All dimensions are in millimeters.

Appendix B explains how the sensors were installed on the bridges. For the Horsetail Falls Bridge, 16 sensors were placed at a 45° angle near the end of two beams, and 12 sensors were positioned along the main axis at the bottom of those beams (Appendix C). The intent of the 45°-angle sensors was to monitor the shear strain in the beams; the sensors on the bottom of the beams were to measure flexural strains. Each location had a sensor embedded in the concrete and a sensor attached to the surface of the composite.

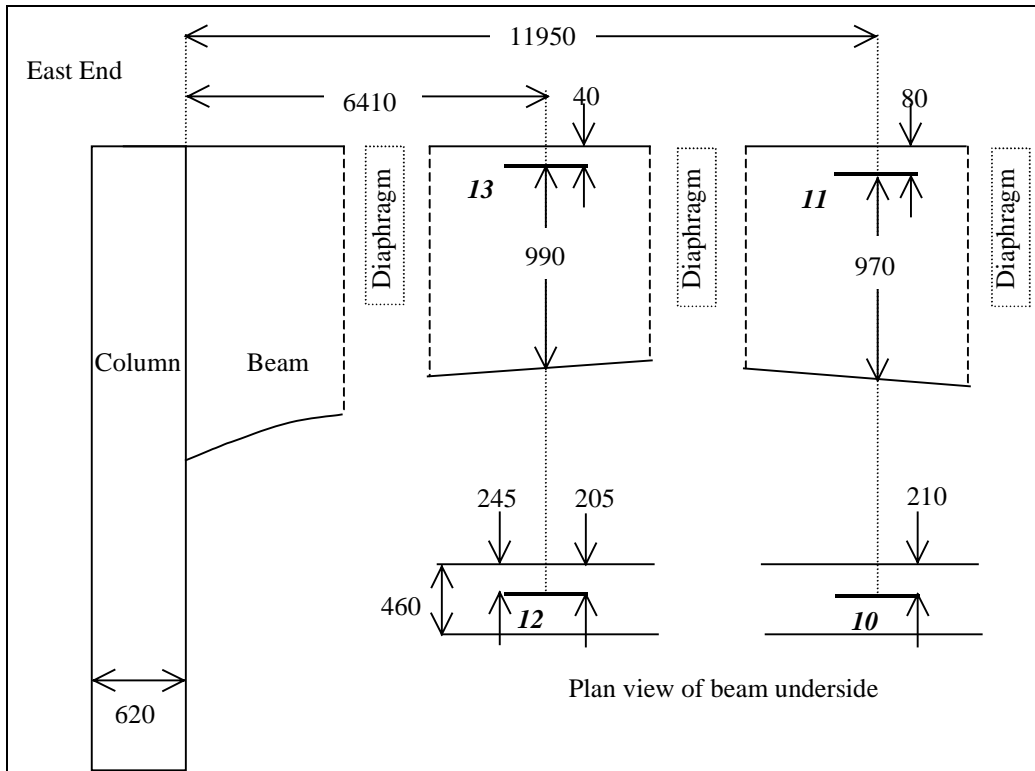
Position of 1000 mm sensors. All dimensions are in millimeters. The italicized numbers are sensor identification numbers.

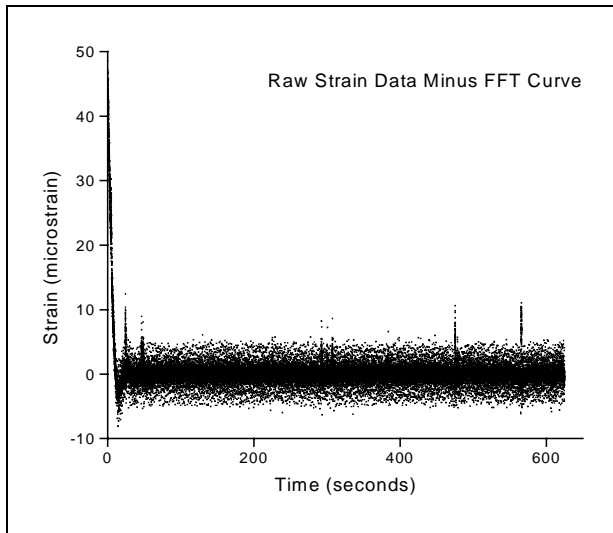
### Appendix D3: Data manipulation method

The data manipulation routine used for the Sylvan Bridge data is illustrated below for sensor 3, run 1. Generally, the raw strain data exhibited time-dependent drift. Fast Fourier Transform smoothing with 2000 points was used to construct a curve that represented the baseline for the data. The FFT curve was subtracted from the raw strain data to yield transformed data centered at zero. Savitzky-Golay smoothing with 51 points and a polynomial order of two was used to reduce the noise and define the strain signal due to traffic. The first 50 seconds were truncated in the completed plots to eliminate an artifact of the FFT smoothing process. The data manipulation was conducted with Origin 6.0.

It was not possible to close the Sylvan Bridge because of the high volume of traffic; therefore, the measurements were made under dynamic traffic conditions. The data were collected during periods of relatively low traffic volume and high traffic volume. Four sensors were monitored at one time for two periods of ten minutes. The data sets were noisy and exhibited time-dependent drift; however, the data were manipulated as described in Appendix D to reveal the strain signal.

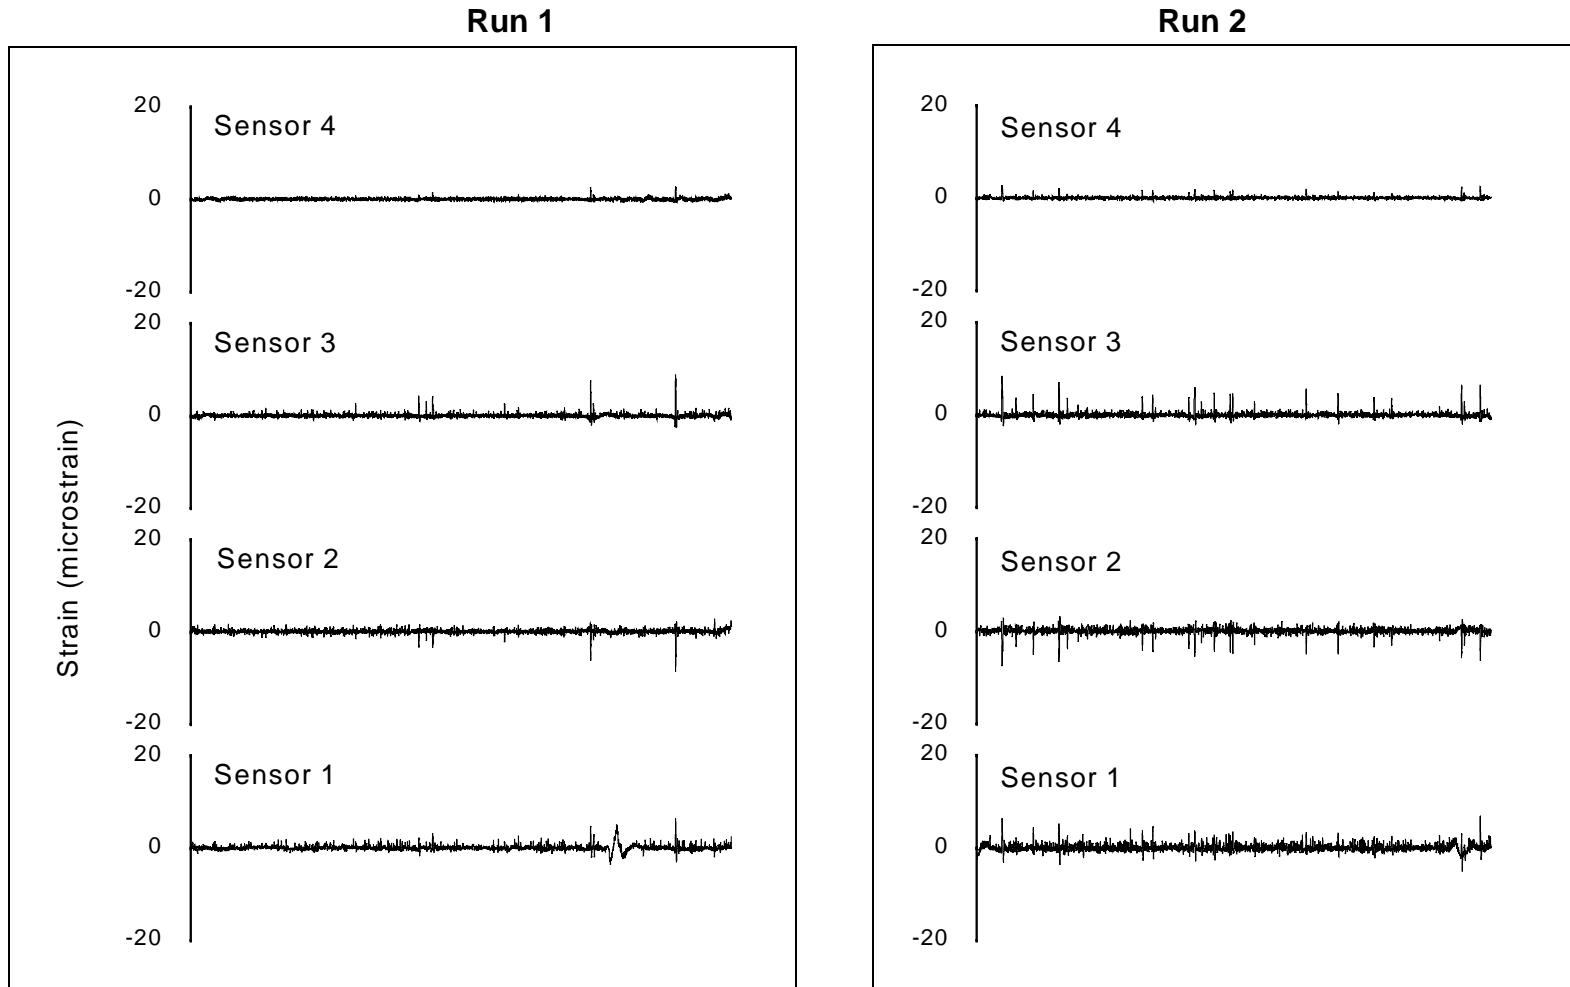
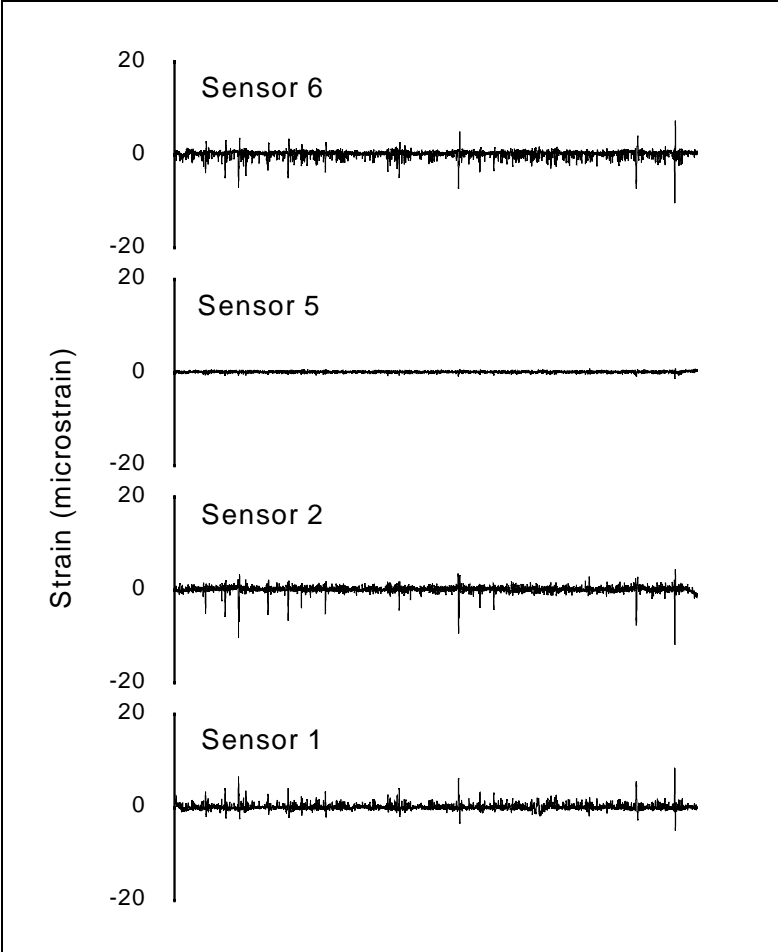
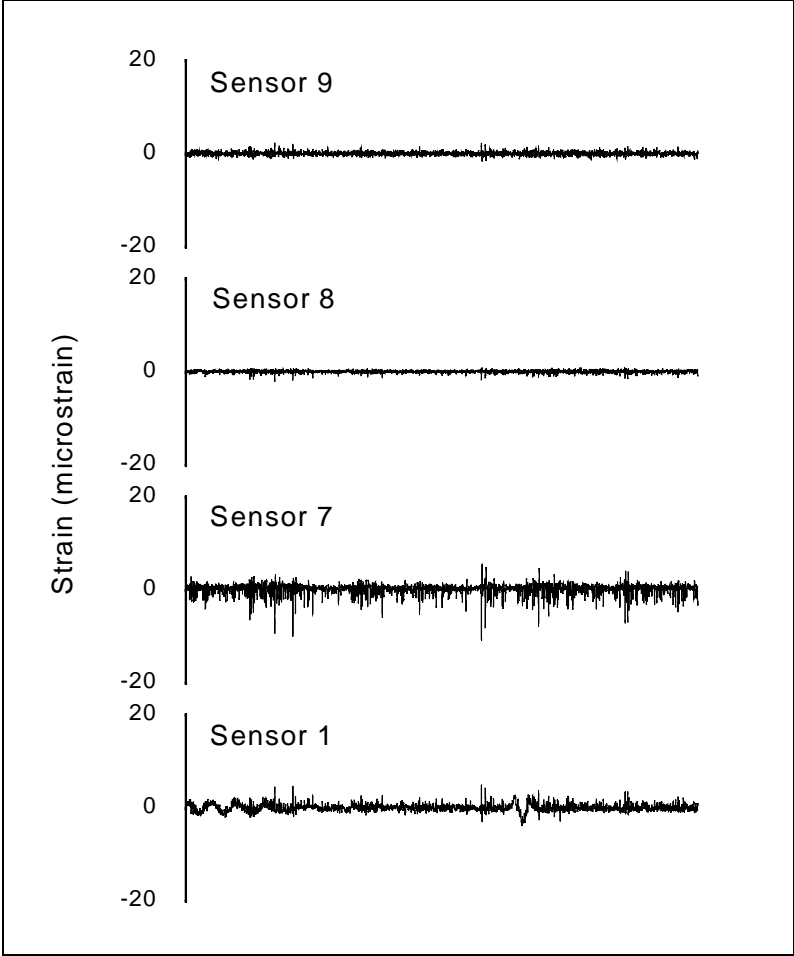
## Appendix D4: Strain results

Sets of four sensors were monitored for periods of ten minutes. The sensor numbers (refer to Appendix D) in each set were as follows: (1, 2, 3, 4); (1, 2, 5, 6); (1, 7, 8, 9); (10, 11, 12, 13). Sensor 0 was not operational. The data from the sensors after the data manipulation described in Appendix E are shown below.

The largest strain recorded during the monitoring was  $22 \mu\epsilon$ , well below the  $1400 \mu\epsilon$  typically associated with concrete fracture. As expected, the maximum strain was measured in the flexure zone at the bottom of a beam.
