**Title V and SM-80 Inspection Report
Air Quality Division**

State of Oregon
Department of
Environmental
Quality

Facility Name Zenith Energy Terminals Holdings LLC	Permit Number 26-2025-TV-01
Site Address 5501 NW Front Avenue, Portland, OR 97210	Permit Type Title V
Mailing Address (if different from above)	County Multnomah

Inspection Date(s): 11/13/2024	Inspection Arrival Date & Time: 11/13/2024; 09:30 PST	Inspection Departure Date & Time: 11/13/2024; 11:40 PST
--	---	---

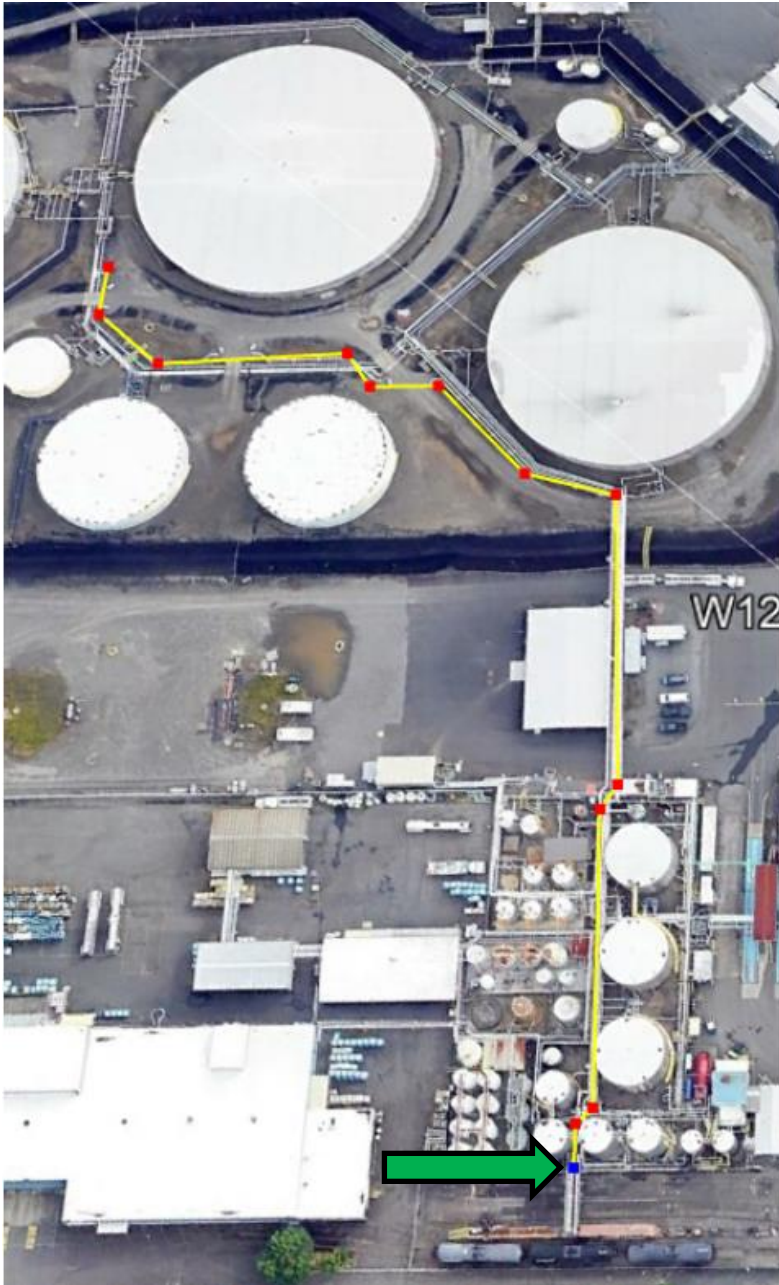
This image is from NoA application #35947 for the Zenith connection to the McCall Dock. The blue dot/square, highlighted by a green arrow) is referenced in responses to some of the questions on page 3 of this report.

- (1) Why does 2021 connection appear to terminate at McCall rail rack? **The rail rack location (blue dot in photo provided with NoA application [image is included on page 5 of this report]) is the location of an existing pipeline used to transport asphalt between McCall Oil and Zenith.**

- (2) What was existing and what work had to be performed? **The existing infrastructure was an asphalt pipeline used to transfer asphalt between McCall Oil and Zenith. Zenith paid for the pipeline that was constructed on McCall Oil’s property (yellow line in map submitted with the NoA application [image is included on page 5 of this report]) which runs from near McCall Oil’s rail rack and connects approximately 250 meters to the NNW to an existing diesel pipeline. Zenith also performed work on their property, as shown in photo #6, to route the distillate fuel to the distillate storage tanks because the existing pipeline connected to asphalt tanks.**

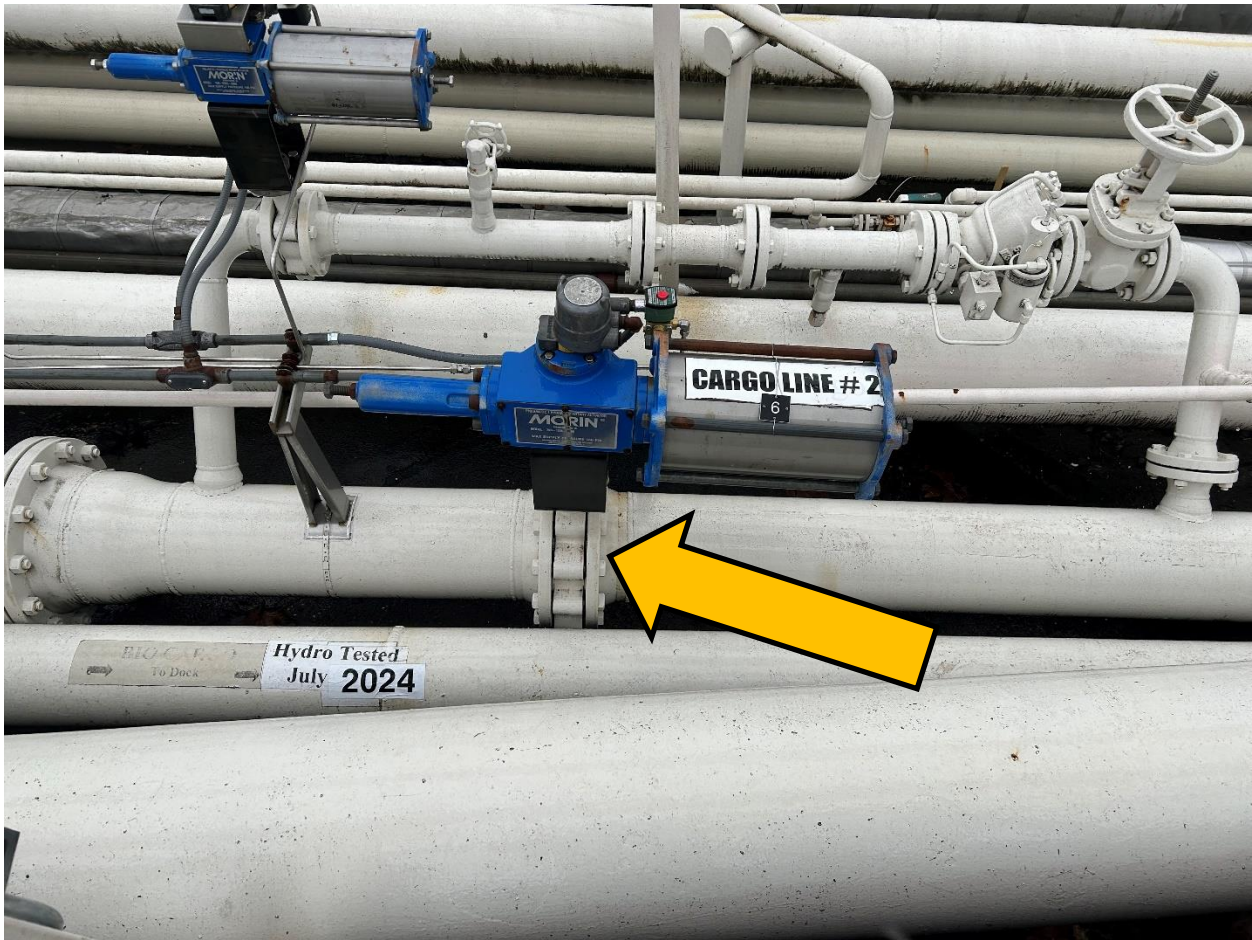
Photo #1 **2024-11-13, 10:15 PST**

This picture was taken at the Chevron dock. The orange arrow indicates the change of custody flange for Cargo Line #2, which transports crude oil.

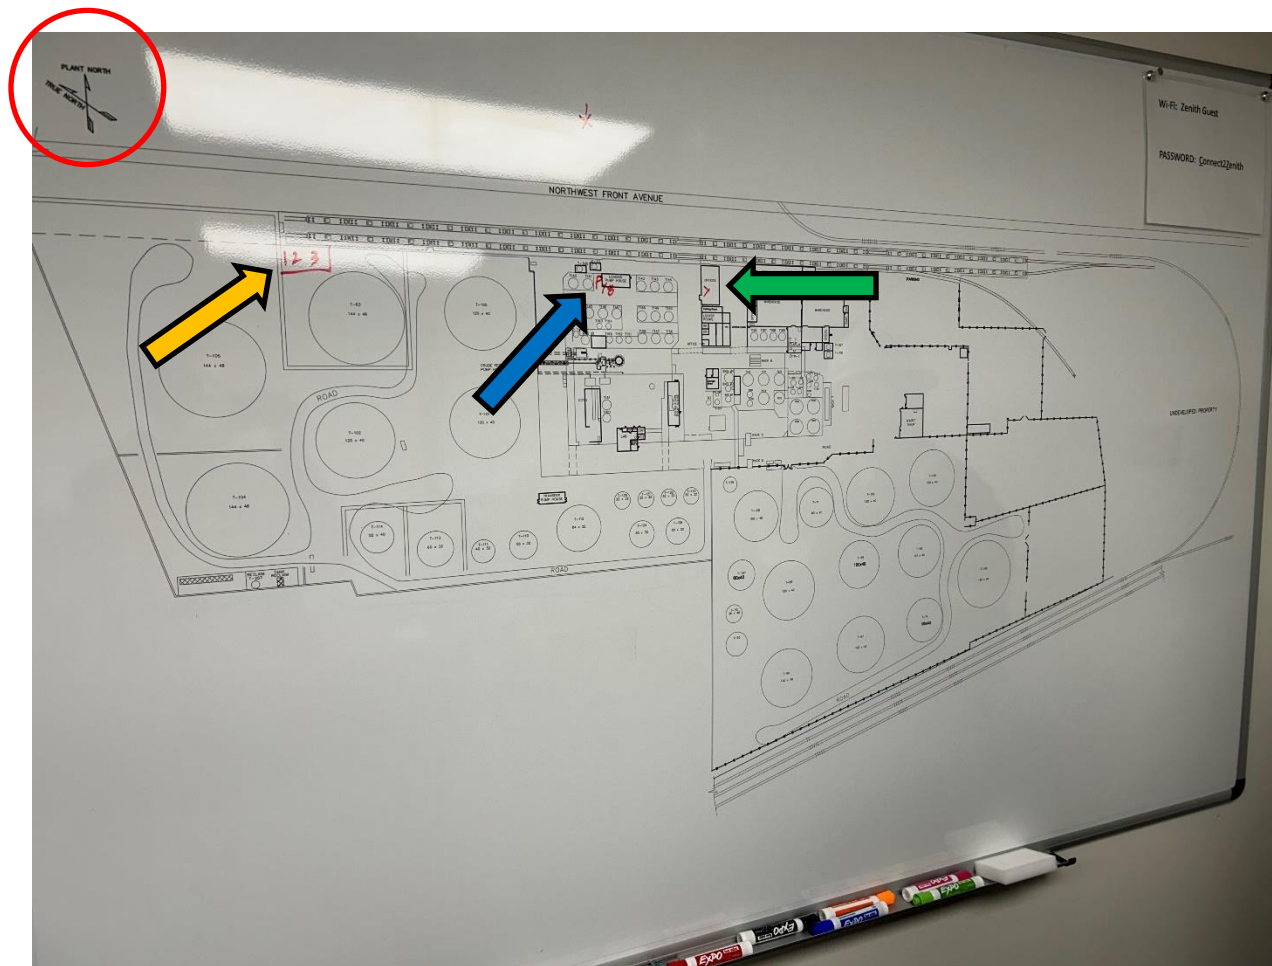
Photo #5 **2024-11-13, 10:38 PST**

This picture was taken at the Zenith conference room. This is a map of Zenith's facility. Notation showing true north and "plant north" is indicated by the red circle. JT included notations showing:

- the three pipes connected to the Chevron dock (orange arrow),
- the P-18 connection, where the Zenith-McCall pipeline resurfaces above ground (blue arrow), and
- the Zenith conference room (green arrow)

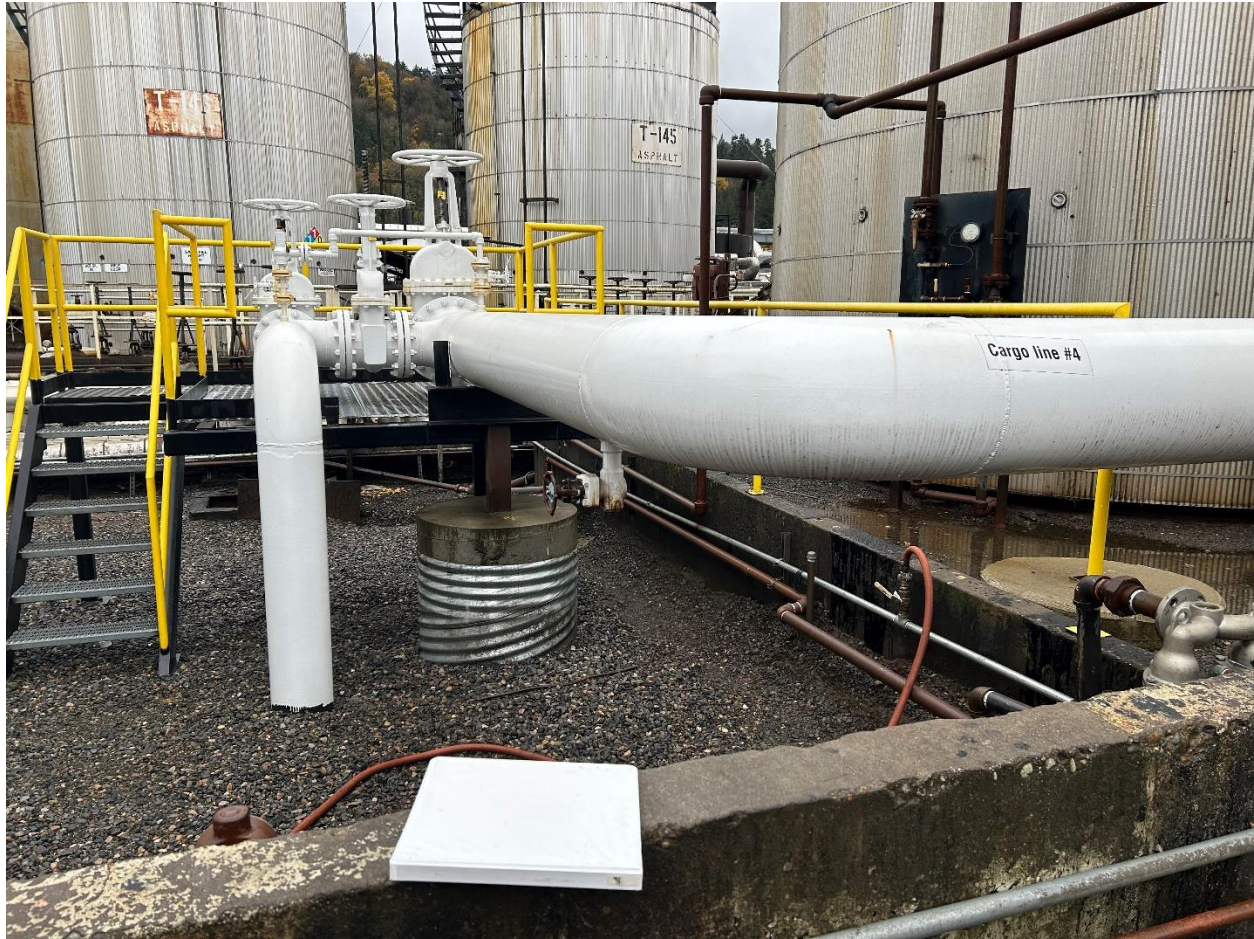
Photo #6 2024-11-13, 10:42 PST

This picture was taken on Zenith's property facing "plant south". The piping shown in this picture is all new construction from NoA #35397.

- i) Where is existing piping and how does it connect McCall & Zenith? **The existing piping carried asphalt between McCall Oil and Zenith. The pipeline connected the asphalt tanks to the “plant south” of the new connection in photo #6 and connected to McCall’s asphalt tanks through the silver pipe identified with an orange arrow in photo #8.**

At 10:42 PST, while facing “plant south” I took a picture of the new McCall connection (the P-18 line) on Zenith’s property, photo #6. This is the pipeline that connects the McCall and Zenith properties. The P-18 line used to connect to the asphalt tanks (e.g., T-143, T-145, etc., which are located farther “plant south” from the connection) but now connects to Cargo Line #4. I took a picture at 10:48 PST of the connection which shows “45” and “46” yellow tags, photo #7. The pipe components associated with these tags are the new segments installed on Zenith’s property for the McCall dock connection.

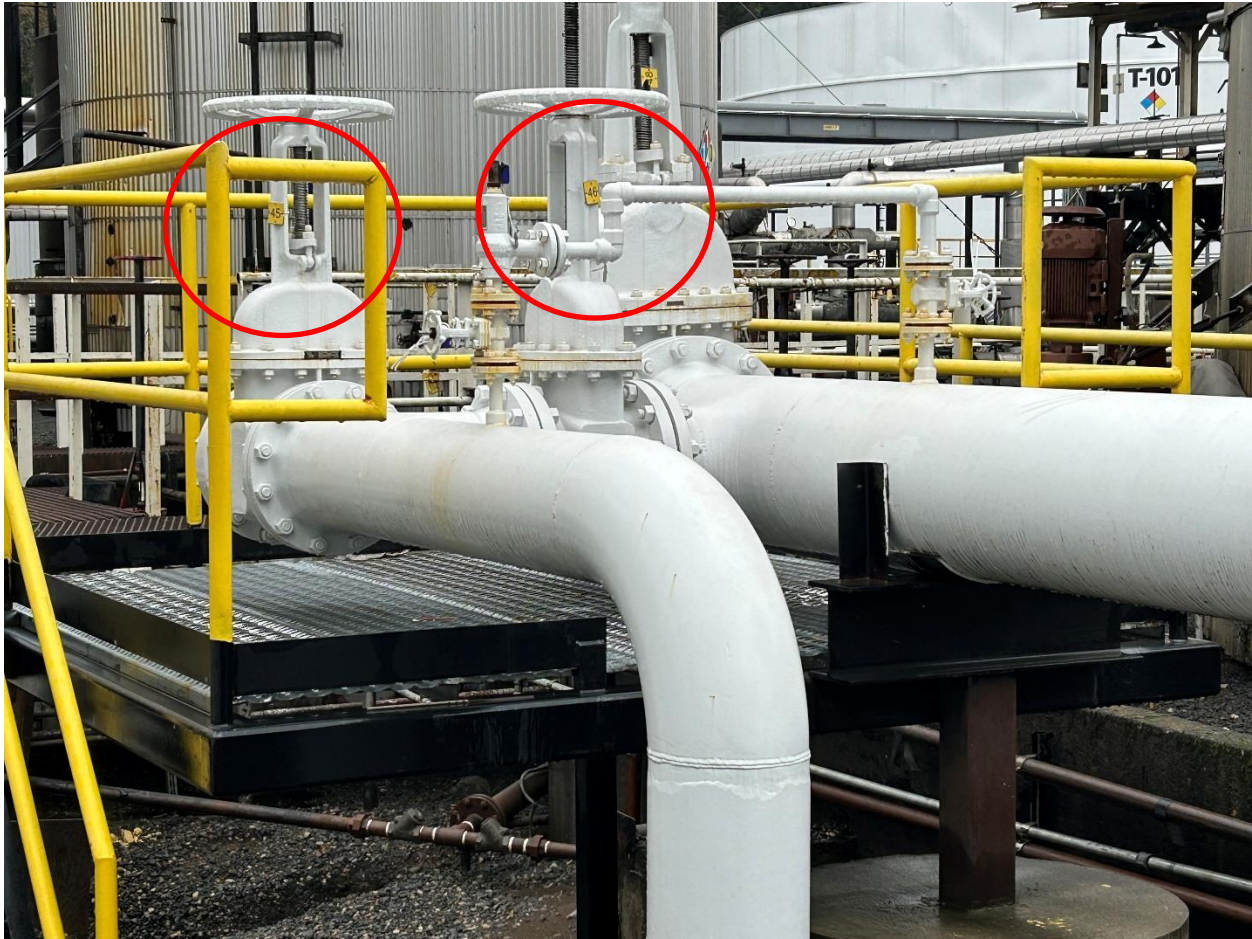
Photo #7 **2024-11-13, 10:48 PST**

This picture was taken on Zenith's property facing "plant SSW". The two circles highlight tags 45 and 46, the valve identifiers, which are new components installed as part of NoA #35397.

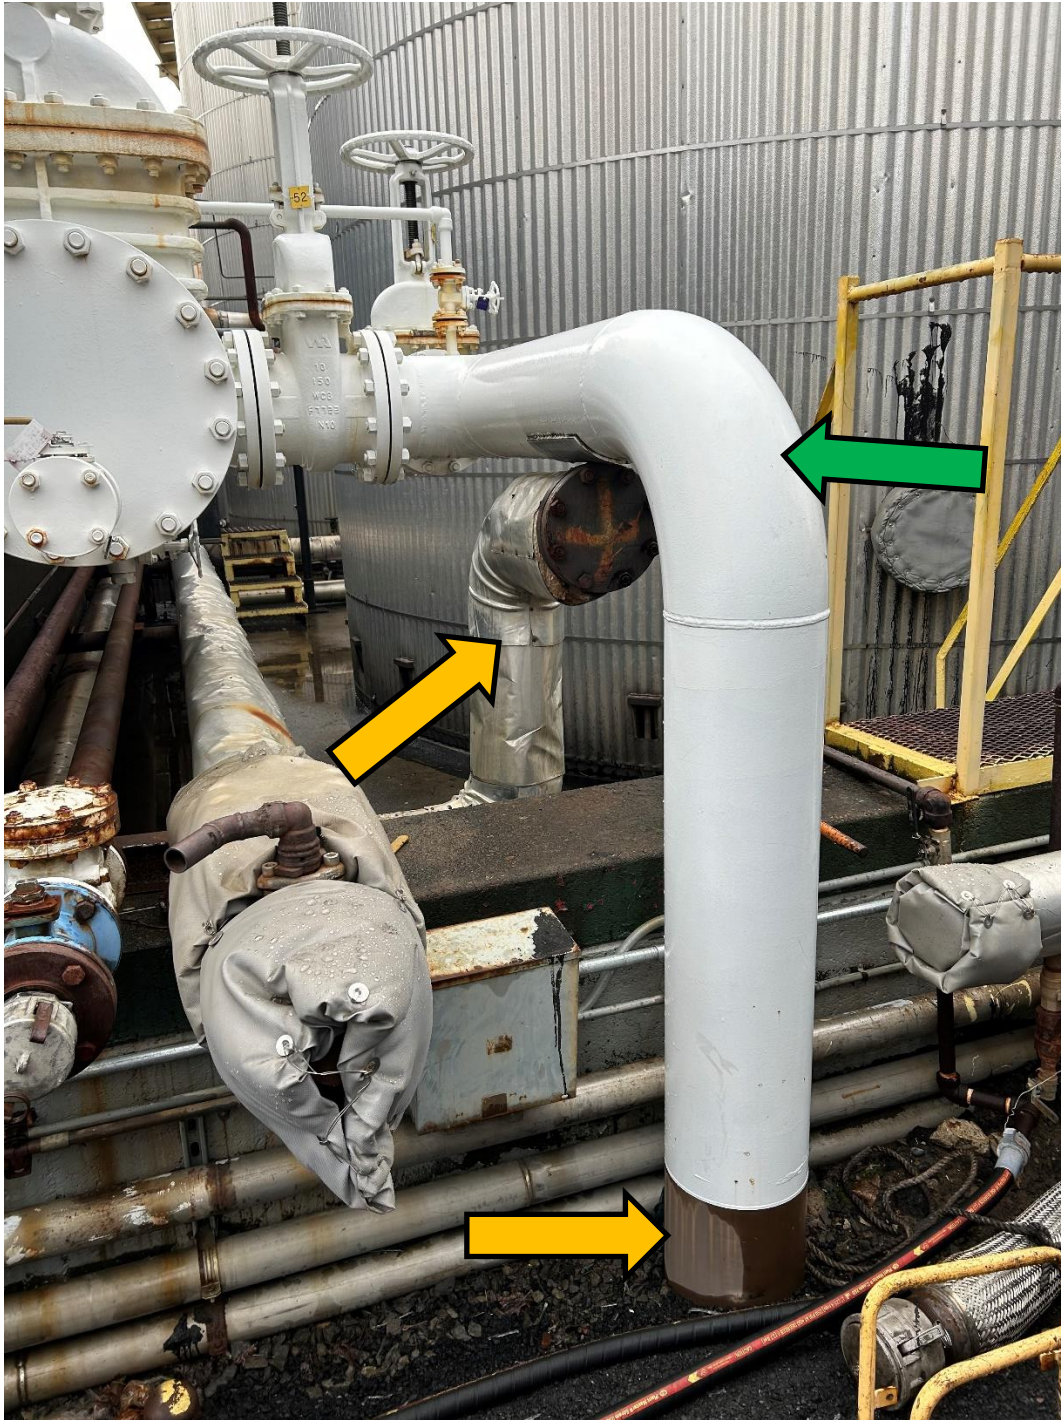
Photo #8 **2024-11-13, 10:56 PST**

This picture was taken on McCall's property, facing approximately ENE. The orange arrows indicate the existing pipe connections between Zenith and McCall and the green arrow indicates the new pipe segments constructed as part of NoA #35397.

At 10:56 PST I took a picture of the Zenith-McCall connection on McCall’s property prior to the pipeline going underground, photo 8. We then began walking the length of the new piping to where it hooked into the McCall diesel pipeline. McCall’s diesel pipe then connects to the McCall dock. I asked when the last time asphalt was transferred between Zenith and McCall through the existing pipeline. JT and DW were unsure but believed that the last asphalt transfer occurred in the 1980s or 1990s.

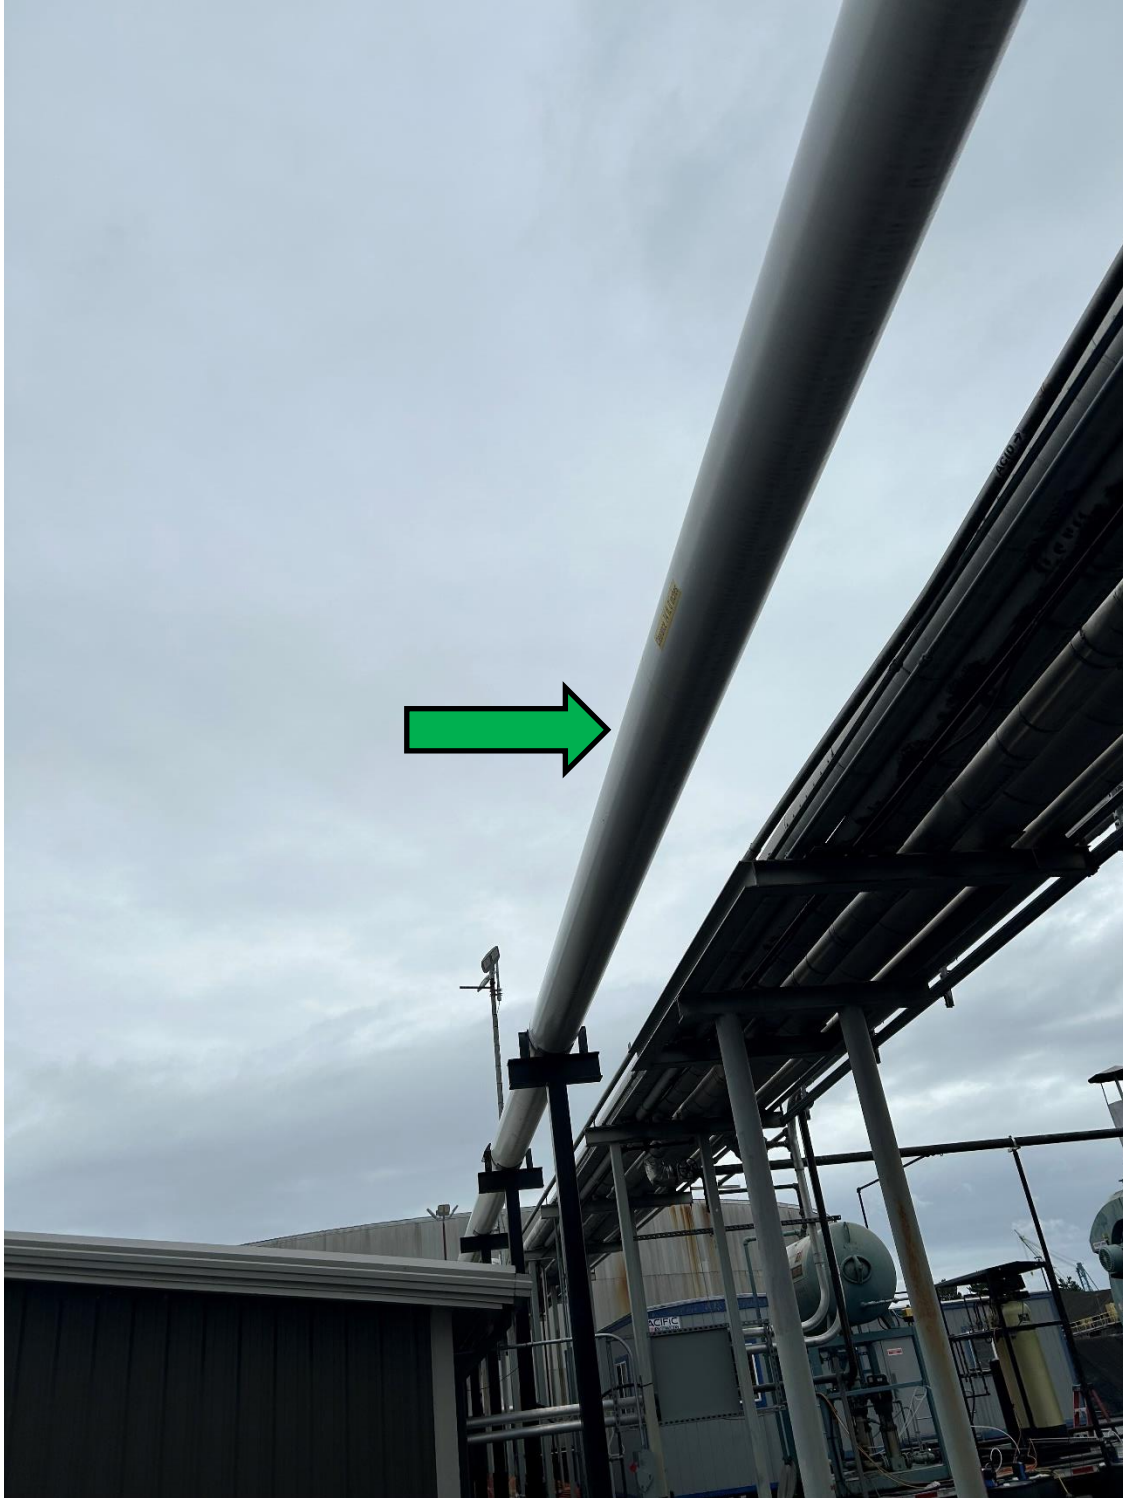
Photo #9 **2024-11-13, 10:16 PST**

This picture was taken on McCall's property, facing approximately NE. The green arrow indicates the new pipe segments constructed as part of NoA #35397.

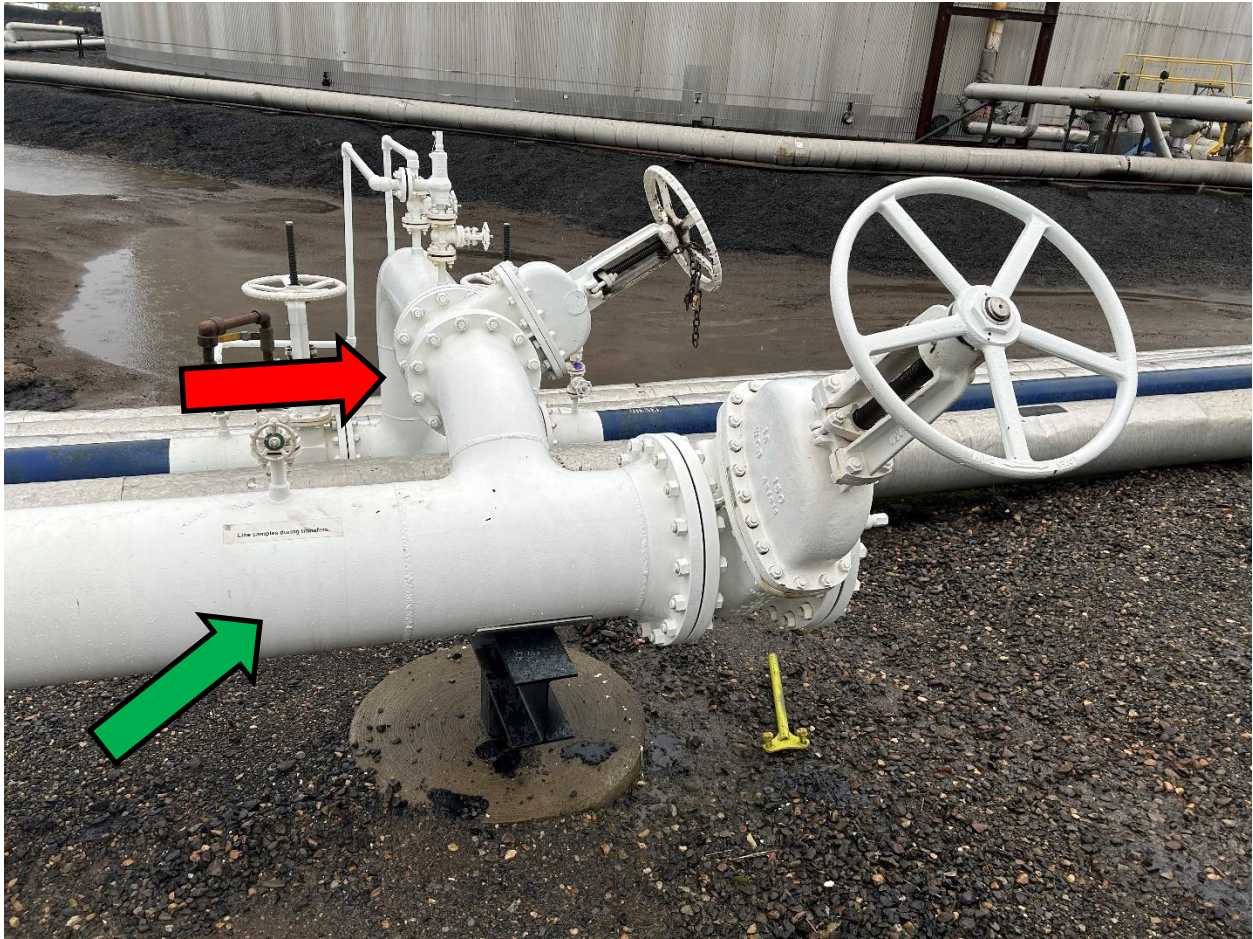
Photo #10 2024-11-13, 11:05 PST

This picture was taken on McCall's property approximately 80 m SW of the ramp to the McCall dock. The red arrow indicates where Zenith's new pipe segments connect to McCall's existing diesel pipeline (blue and white pipe). The Zenith pipe (indicated by the green arrow) and connection were constructed as part of NoA #35397.
