Beach Monitoring Investigative Sampling at Cannon and Tolovana Beaches

Oregon Beach Monitoring Program – DEQ Laboratory

May 2013

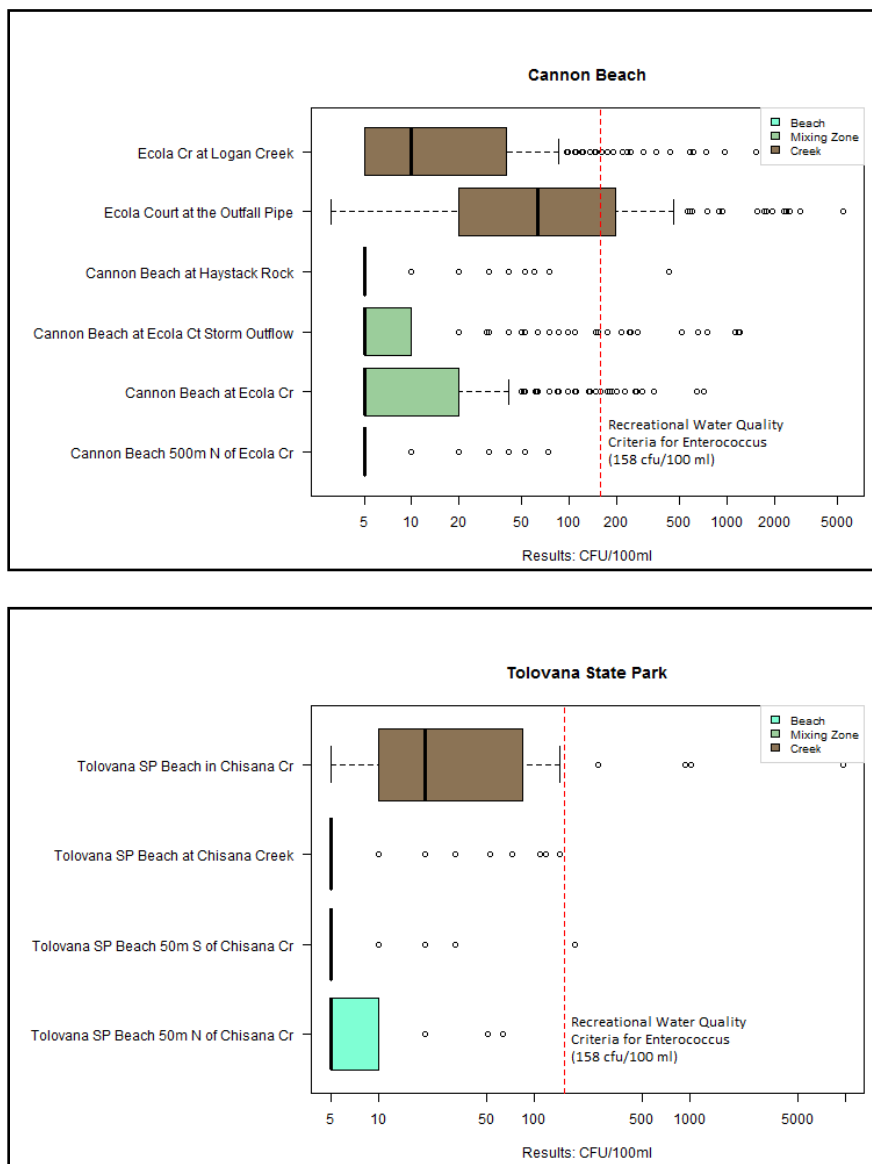
Figure 2. Summary plots of OBMP Cannon Beach fresh and marine water routine monitoring sampling locations.

Sample locations were selected to capture potential bacterial pollution sources identified through historic data collected as part of the OBMP. Creek outflows on to the beach, wastewater discharges, storm water outfalls, wildlife, domestic animals, agriculture, and beach visitors are potential pollution sources that were considered when selecting locations (ODHS, 2010). The OBMP monitors selected fresh water locations such as creeks and storm water outfalls associated with marine sample locations. The data showed these conveyances were sources of contamination at marine sample locations (Figure 2).

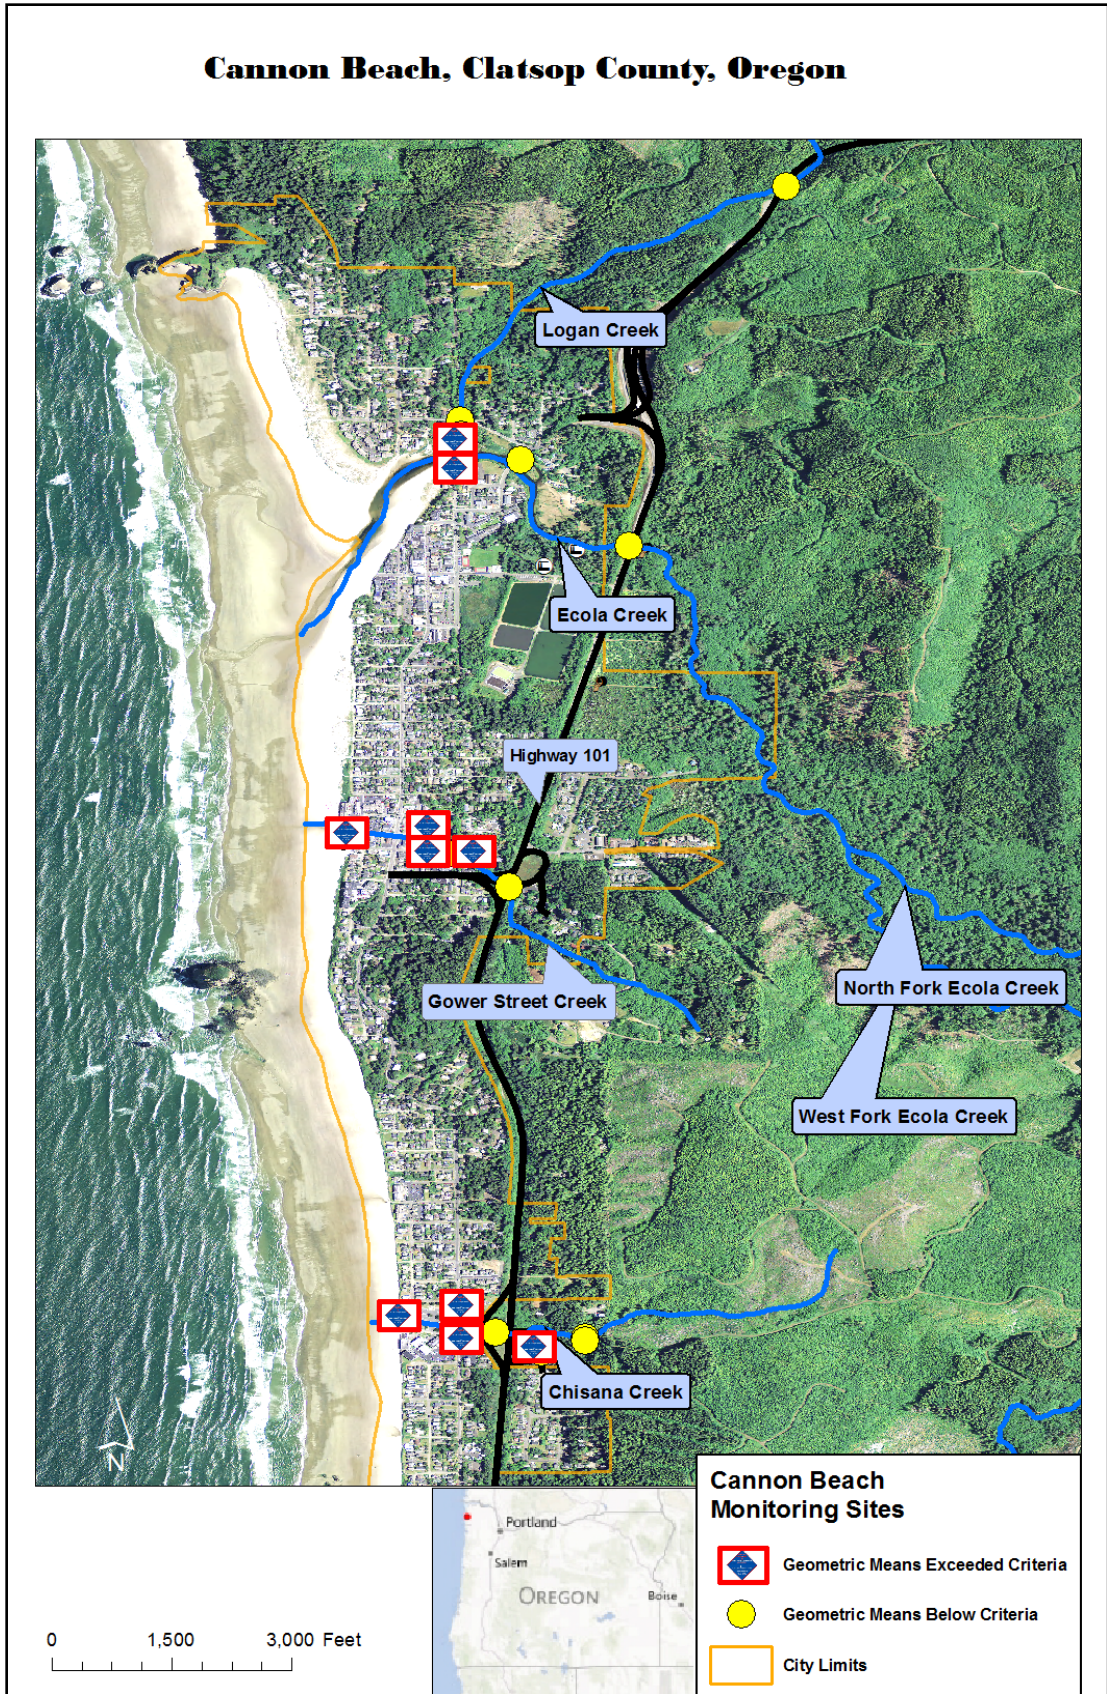
Figure 4. The long term averages of the sampling results exceeded the RWQC at downstream sites in residential areas.

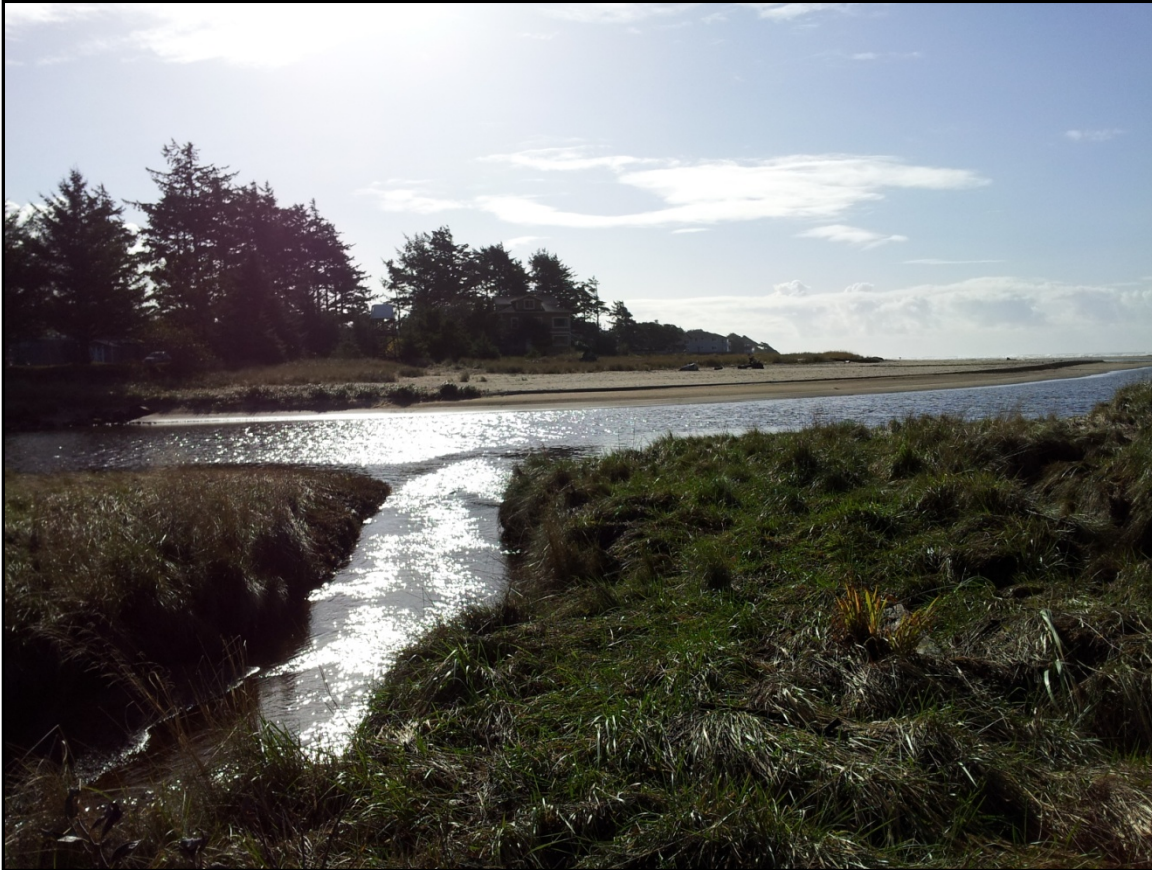
Figure 5. Logan Creek at Les Shirley Park flowing to Ecola Creek.

Logan Creek flows SW between mile posts 27 and 28 on Highway 101 to the confluence with Ecola Creek at Les Shirley Park in Cannon Beach. The watershed is forestland at the Logan Creek headwaters and low density residential near the park. There is public access to the beach from Les Shirley Park. Logan Creek discharges east of the park to the north bank of Ecola Creek about 0.4 miles from the Pacific Ocean (Figure 5). Logan Creek is tidally influenced at least as far upstream as the 5th Street sampling location during storms.

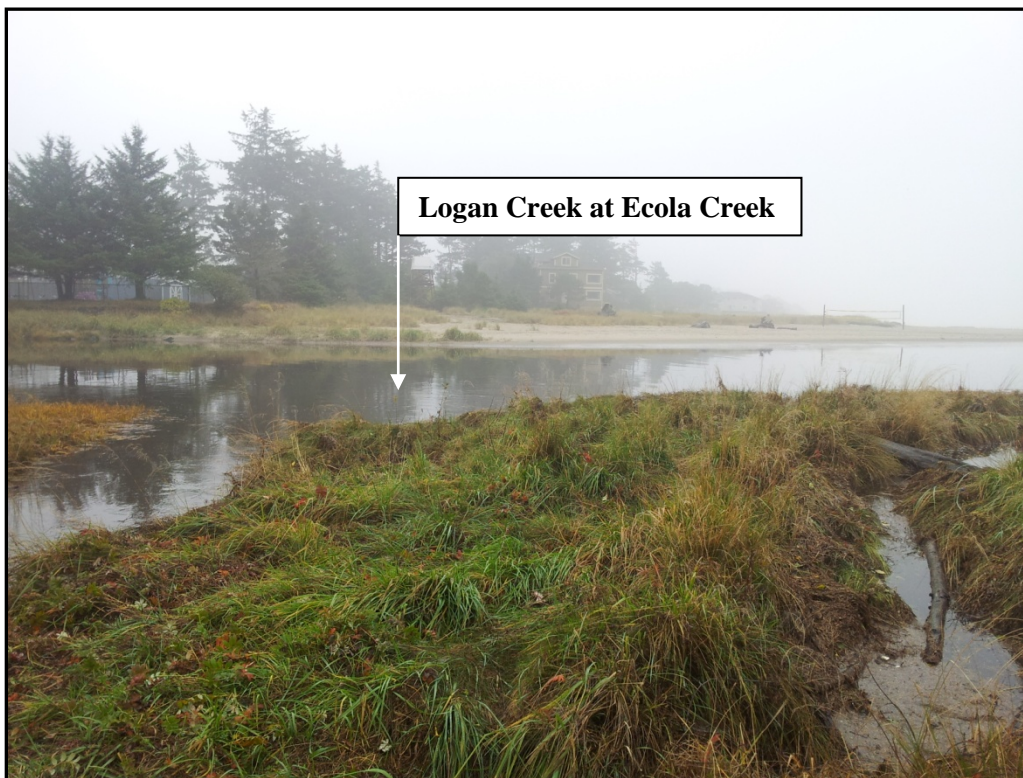
Figure 7. Logan Creek at the confluence with Ecola Creek.

Logan Creek water samples were collected at the confluence with Ecola Creek about 0.4 miles upstream from the Pacific Ocean. This location is sampled weekly during the summer OBMP sampling season. The OBMP has collected more than 275 samples from this location since 2004. Eighteen (6.5%) of those results exceeded the RWQC. The salinity at this site can be fresh or marine. Tides and storms push marine water up Ecola Creek and can affect the salinity/conductivity measurements there. For this project the OBMP collected six water samples at this location. Five of the samples were tested for *Enterococcus* sp. and one sample was tested for *E. coli*. One *enterococcus* sp. result exceeded the recreational water quality criteria. None of the *E. coli* results exceeded the single sample maximum criteria for *E. coli* (406 cfu/100 ml).

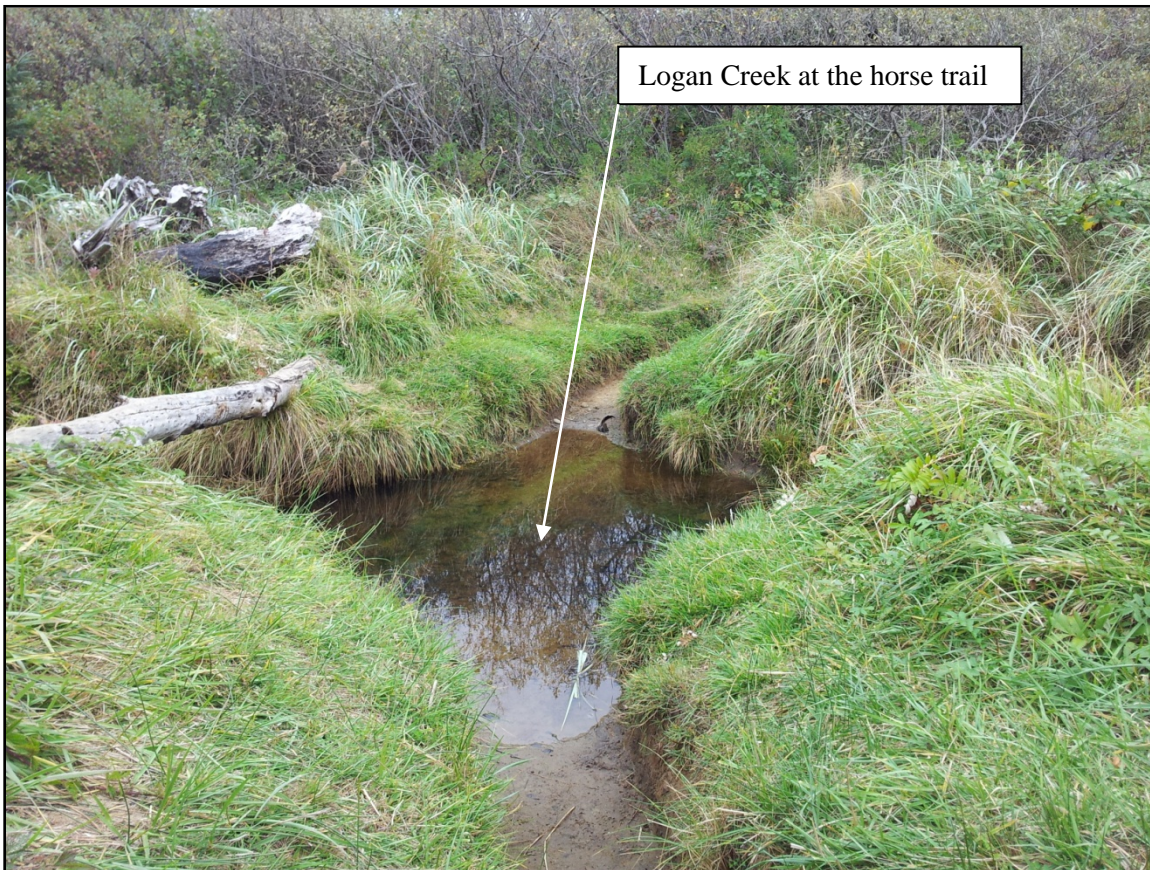
Figure 8. Logan Creek at the horse trail.

Logan Creek was sampled where a trail crosses the creek on the east side of Les Shirley Park. The trail is used by horseback riding tours as access to the beach. The horseback riding tours are provided east of the Fir Street Bridge. The site is 0.4 miles upstream from the confluence with Ecola Creek. Five of the samples were tested for *Enterococcus* sp. and one sample was tested for *E. coli*. One *Enterococcus* sp. result exceeded the recreational water quality criteria. None of the *E. coli* results exceeded the criteria for *E. coli*.

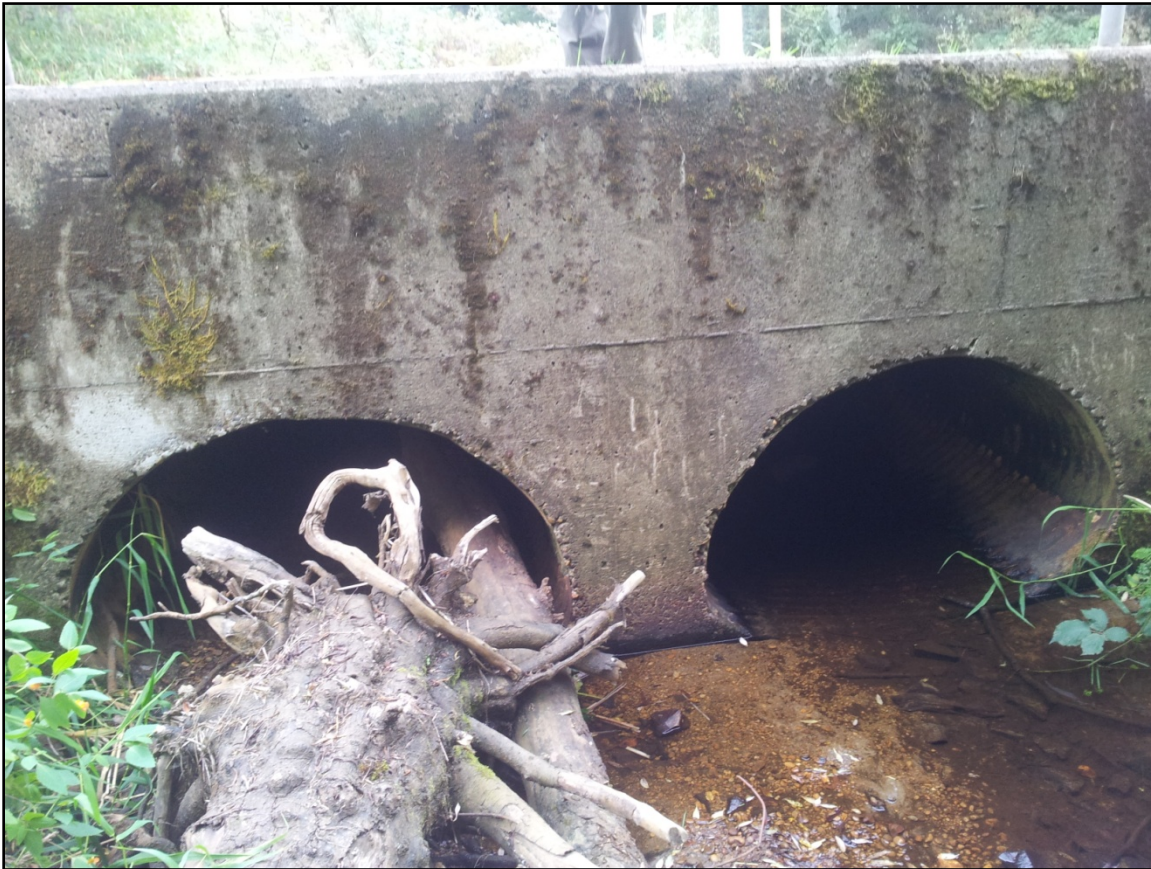
Figure 9. Logan Creek at 5th Street.

Logan Creek was also sampled on the downstream side of the culverts at 5th Street. The sample location is about 0.8 miles upstream from the confluence with Ecola Creek. There are residences upstream on the north side of this site. Ecola Park Road travels north of the site to Indian Beach in north Ecola State Park. One *Enterococcus* sp. result exceeded the recreational water quality criteria. None of the *E. coli* results at this site exceeded the criteria.

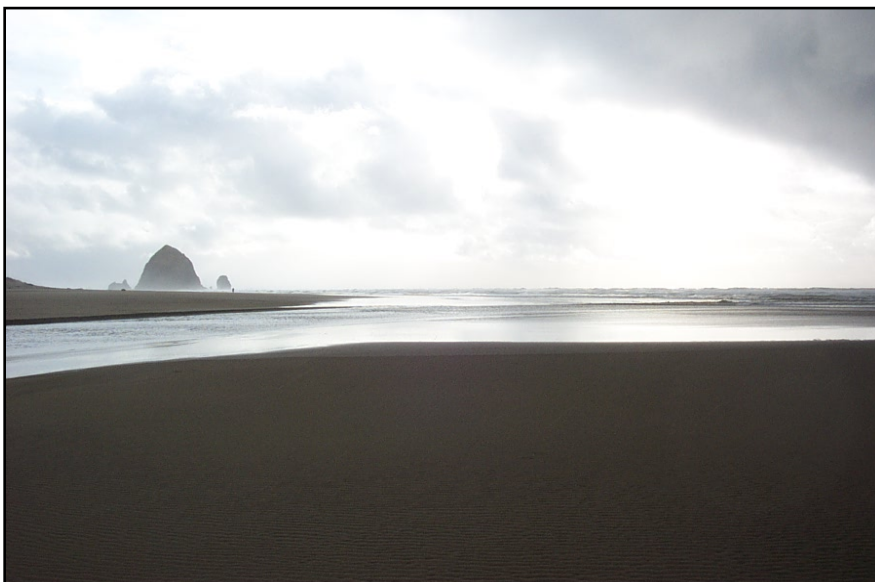
Figure 14. Ecola Creek at Cannon Beach.

Ecola Creek is part of a 22 square mile watershed that includes the Ecola Creek Forest Reserve, private timberlands, and the primary water supply for Cannon Beach. The North Fork and West Fork of Ecola Creek converge and flow to the Pacific Ocean at Ecola State Park. The Ecola Creek watershed contains old growth forest and quality salmonid habitat (McComb, 2012).

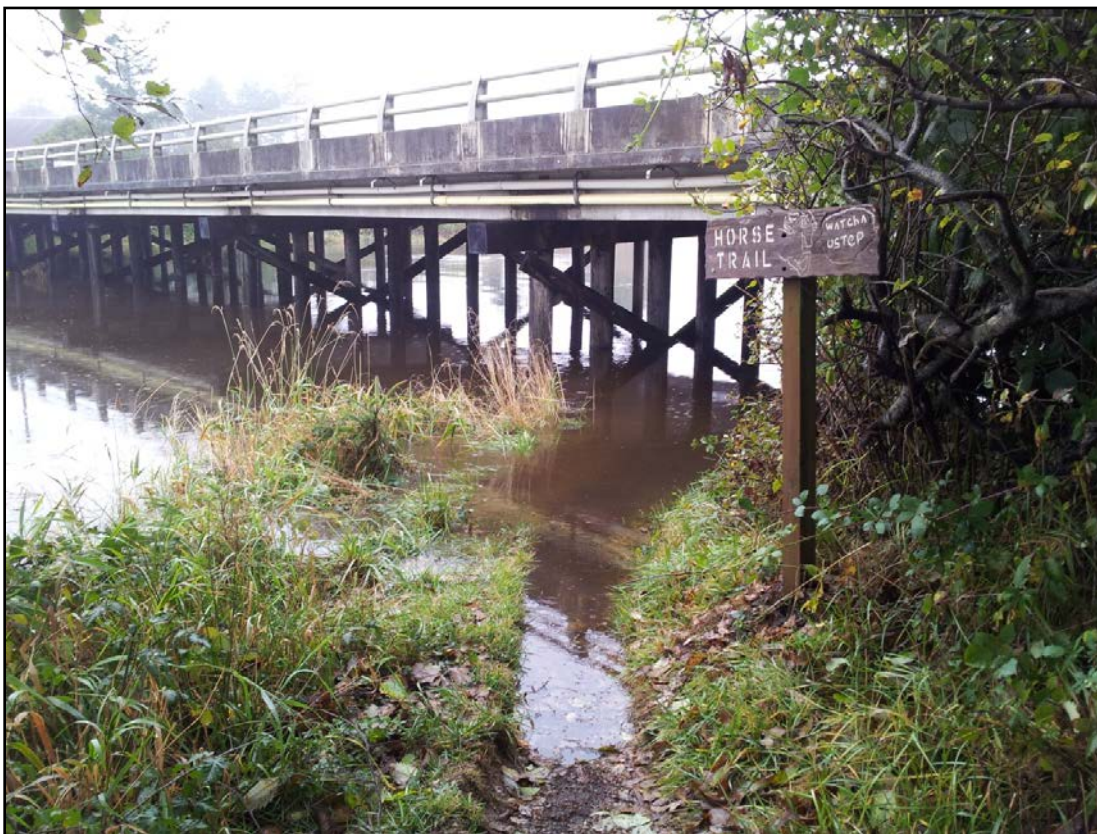
Figure 16. Ecola Creek at the Fir Street Bridge.

The bridge at Fir Street is upstream from the confluence with Logan Creek. This sample location is a popular access to Les Shirley Park and is adjacent to a section of the horseback riding trail that runs from the Sea Ranch RV Park to Ecola State Park. Cannon Beach Elementary School is SW of the site on the south side of Ecola Creek. The surrounding area is estuarine wetland, residential, urban, and parks. Five samples collected from this location were tested for *Enterococcus* sp. and one for *E. coli*. One of the *Enterococcus* sp. results exceeded the recreational water quality criteria. None of the *E. coli* results exceeded the criteria.

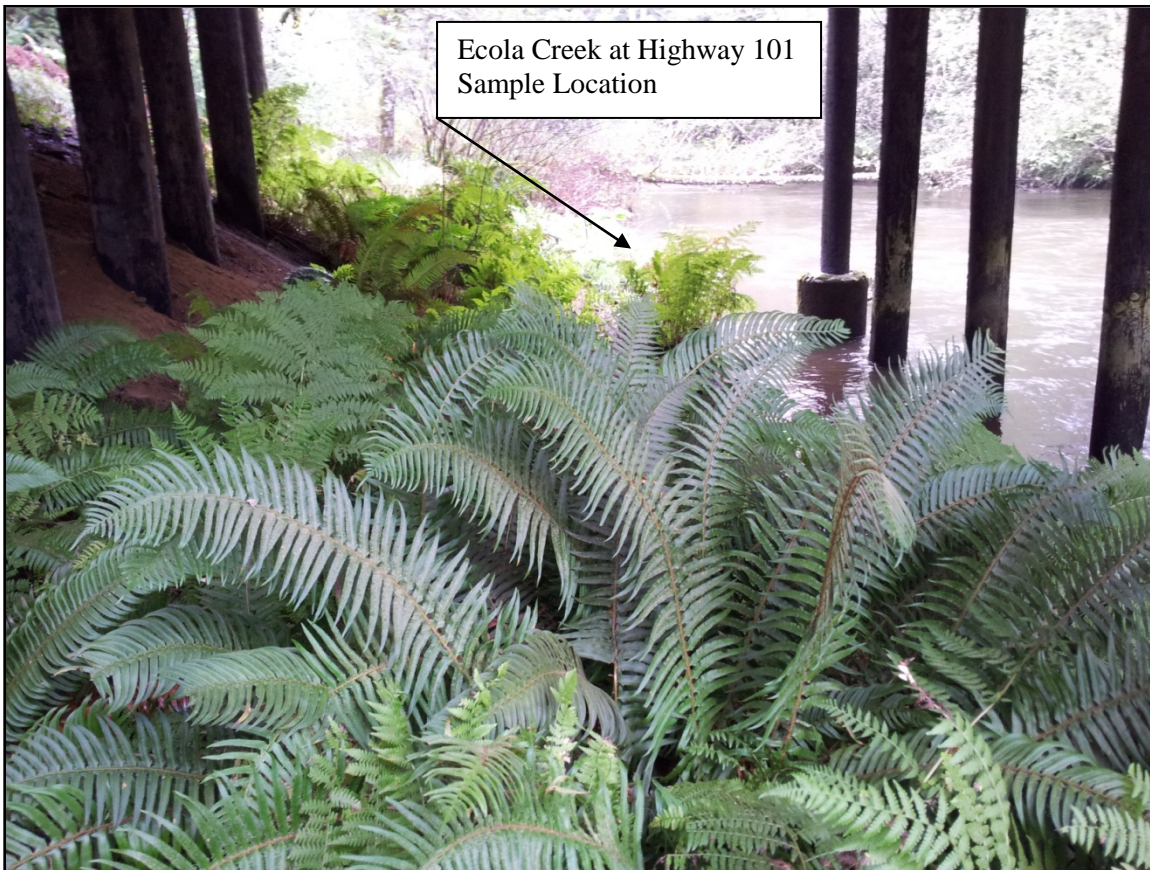
Figure 17. Ecola Creek at the Highway 101 bridge.

The most upstream Ecola Creek samples were collected at the Highway 101 bridge. There are forestlands, the Cannon Beach Municipal Watershed, and water treatment facilities upstream. There are also water treatment effluent sample locations upstream of this site. There are wetlands and residential areas downstream. Four samples were tested for *Enterococcus* sp. and one for *E. coli*. One of the *Enterococcus* sp. results exceeded the recreational water quality criteria. The *E. coli* sample result did not exceed the criteria.

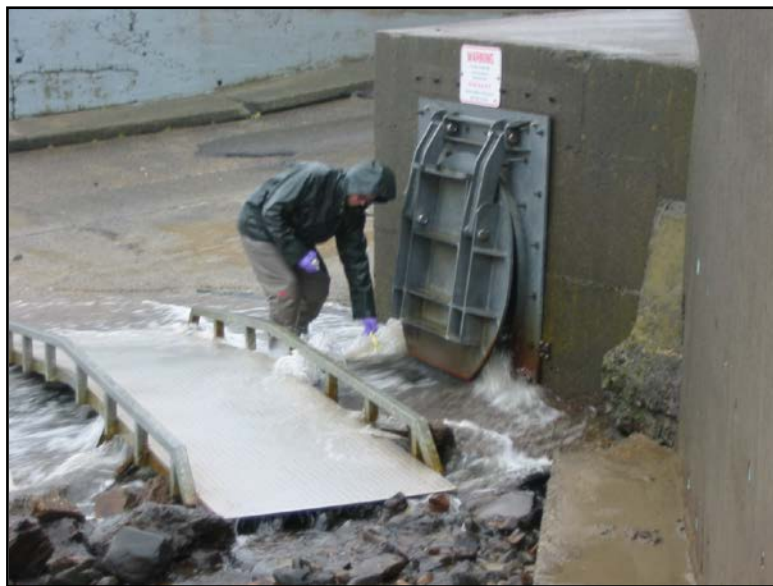
Figure 23. Gower Street Creek at the Ecola Court outfall.

Surf rider’s volunteer monitoring group, the Blue Water Task Force, has monitored this outfall and has communicated with the city of Cannon Beach about their sample results. The task force has been involved with possible solutions to reducing bacterial contamination such as mycofiltration, using mycelium fungus filters to remove bacterial contamination from the runoff (Dias, 2011). The City of Cannon Beach has also sampled this location and has noted high bacteria counts. The city continues to monitor the Ecola Court outfall and recent results can be viewed on the web at [City of Cannon Beach Ecola Outfall](#).

Twelve samples were collected at this location for this project. Five samples and five duplicate samples were tested for *Enterococcus* sp. and one sample and one duplicate was tested for *E. coli*. Four of the *Enterococcus* sp. results (40%) exceeded the recreational water quality criteria. One sample result from this location taken on the driest sampling day for this project (October 11th, 2012) exceeded the recreational water quality criteria. Sample results from this location were also high on the two sampling days with the most rainfall (October 15th and November 20th). The *E. coli* sample results taken November 20th were close to but did not exceed recreational water quality criteria.

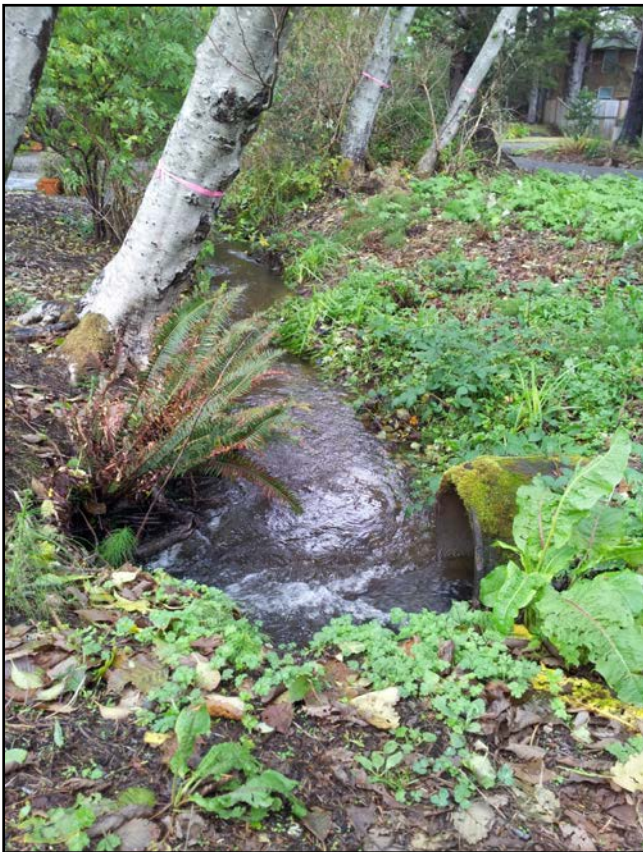
Figure 25. Gower Street Creek at Spruce Street.

Samples were taken from the Gower Street creek at the NW corner of East Dawes Avenue and South Spruce Street; about 0.2 miles from the ocean. The site is in the neighborhood just upstream from the Coolidge Avenue site. Here the Gower Street Creek passes through culverts and roadside drainage ditches cutting through the residences. Storm runoff spills in from the west from a roadside drainage and from the south from a drainage pipe. Most of the water spilling into the site surfaces from a midsize concrete culvert pipe where Gower Street Creek runs from the east under Spruce Street. Four samples collected from this site were tested for *Enterococcus* sp. and one was tested for *E. coli*. One *Enterococcus* sp. result exceeded the recreational water quality criteria. This high result was from a sample taken on one of the two sampling days with heavy rainfall. This location was not sampled on the driest day of sampling.

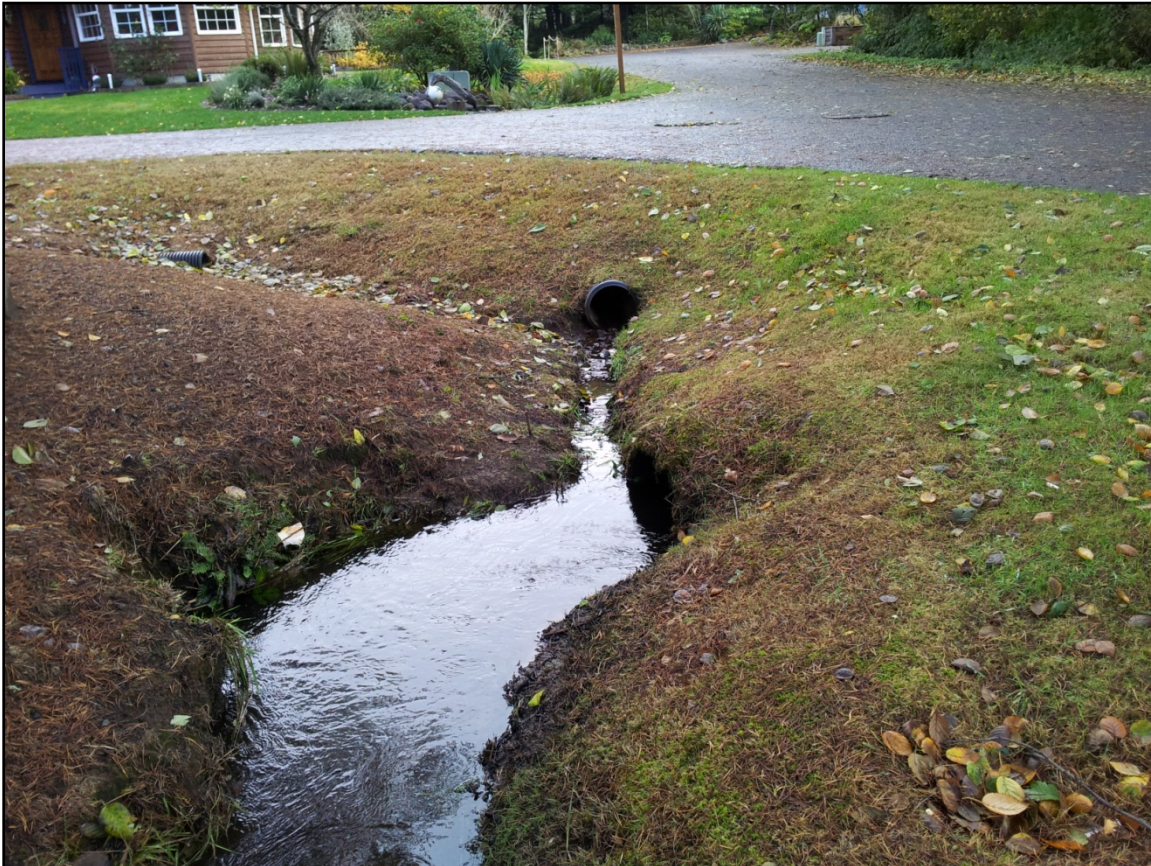
Figure 26. Gower Street Creek at Cypress Court.

Samples were collected one block SE of the trash rack at the NW corner of East Dawes Avenue and Cypress Court. This site is one block east of the Spruce Street site. The creek runs from a small wetland to the south through a culvert and spills in to a roadside ditch at Cypress Court. The creek then runs east two blocks to the Spruce Street sample site. There are residences in all other directions from the site. Four samples were taken from the site and tested for *Enterococcus* sp. and one sample was tested for *E. coli*. One sample tested for *Enterococcus* sp. exceeded the recreational water quality criteria. That sample was also collected during one of the heavy rainfall sampling days. The other results from this location were relatively low.

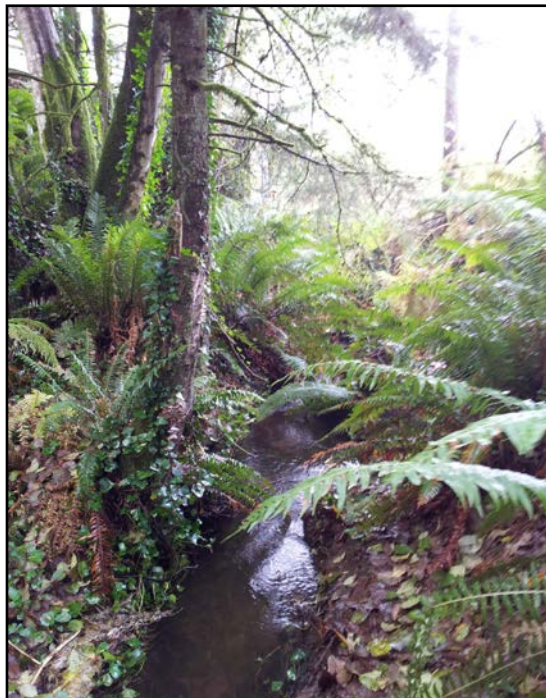
Figure 27. Gower Street Creek at Highway 101 and Sunset Boulevard.

The City of Cannon Beach has also monitored sample locations in this drainage at Sunset Boulevard and noted occasional high results. As with this project, the City of Cannon Beach results are high less often at this location than at the downstream locations on this creek.

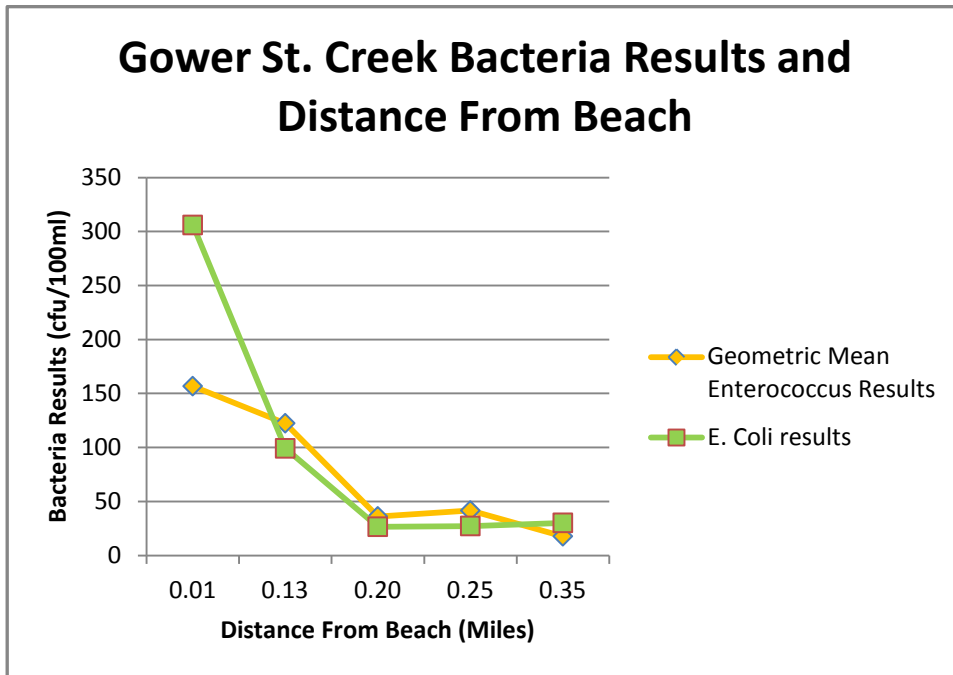
Figure 28. Gower Street Creek and distance from the beach.

The Logan Creek results from downstream sample locations near the beach outfall and the Coolidge Avenue trash rack were higher (Figure 28). Results generally correlated with rainfall amounts. But the high results from the Gower Street beach outfall and the Coolidge Avenue trash rack on October 11th, the dry sampling day, were an exception (Figure 29).

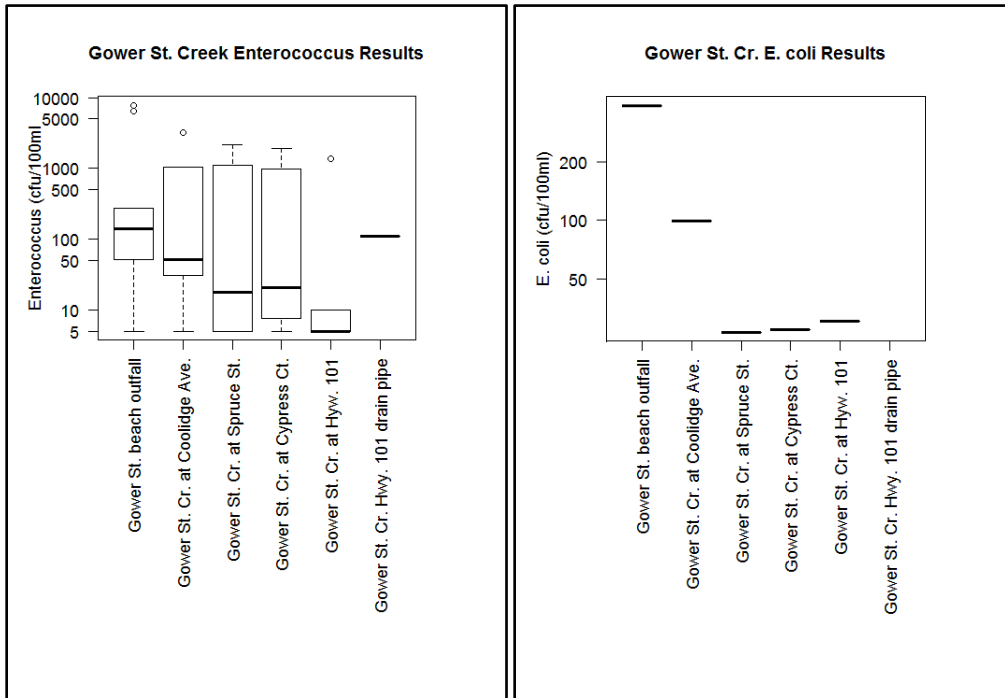
Figure 30. Gower St. Creek *Enterococcus* sp. and *E. coli* summary results.

The summary plots display the same pattern of results decreasing depending on the sample site distance from the beach (Figure 30).

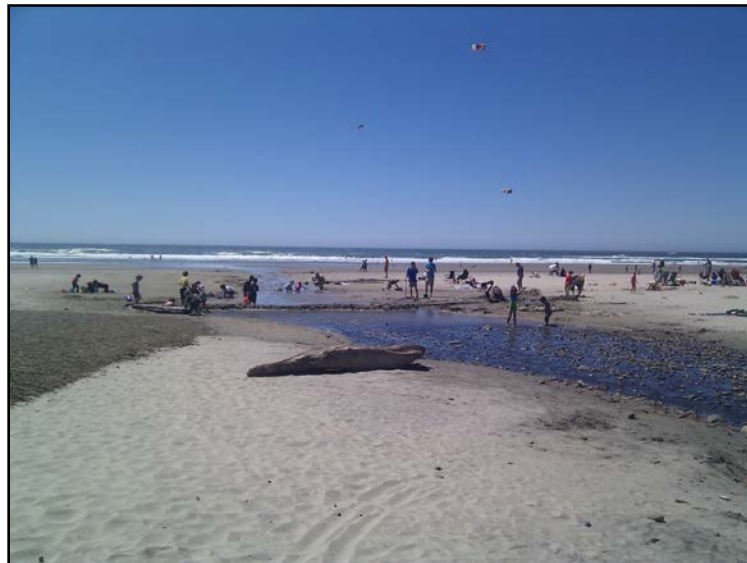
Figure 32. Beach visitors wading in Chisana Creek at Tolovana State Park.

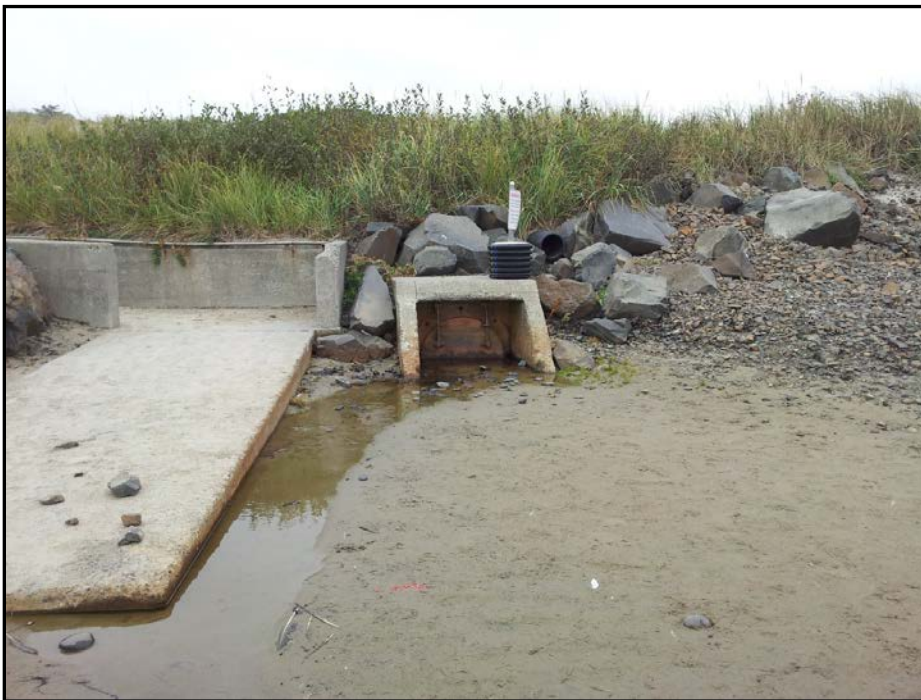
Figure 34. Chisana Creek outfall at Tolovana Beach State Park.

Samples were collected at the Chisana Creek outfall at Tolovana Beach State Park. This location is sampled routinely by the OBMP during the summer sampling season. The creek discharges across the beach and to the ocean from the outfall. The surface outflow to the beach may not reach the ocean during the dryer summer season. Chisana Creek can move several meters north or south depending on the weather and surf conditions. Beach visitors, pets, and birds wade in the creek wherever it ends up crossing the beach. The OBMP collected 42 samples at this location from May 2010 to September 2012. Four of those sample results (9.5%) exceeded the recreational water quality criteria. Six samples were collected at this location for this project. Five of those samples were tested for *Enterococcus* sp. and one for *E. coli*. Only one of the sample results exceeded the recreational water quality criteria. That sample was taken during heavy rainfall on October 15th. *Enterococcus* sp. test results from the next heavy rainfall event on November 20th were closer to but less than the RWQC. The only *E. coli* test result was relatively low.

This site has also been monitored by the City of Cannon Beach. The city reports several results exceeding the recreational water quality criteria in the fall of 2011.

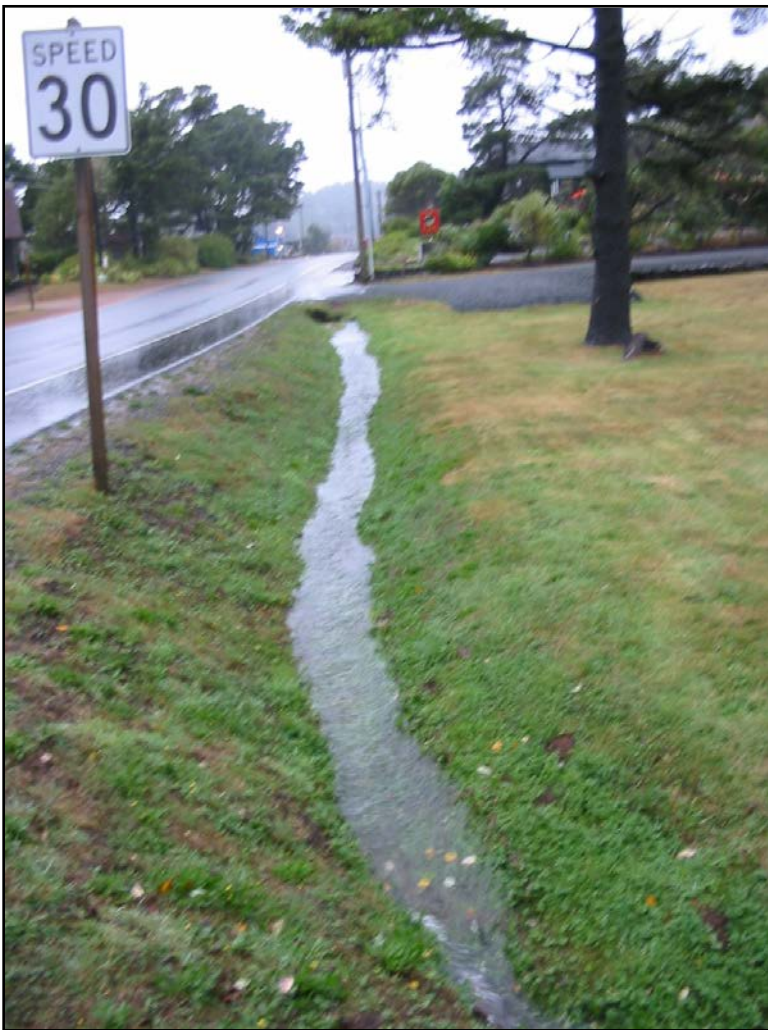
Figure 35. Chisana Creek Tributary at South Hemlock Street.

Samples were collected at a tributary to Chisana Creek from a drainage ditch on the east side of South Hemlock Street between East Warren Way and Fernwood Street. The sample location is 0.1 miles from the ocean just west of the Tolovana Beach parking area. The ditch may be dry during the summer season. Four samples were taken from this drainage and tested for *Enterococcus* sp. and one of those results was more than 30 times the recreational water quality criteria. The only sample tested for *E. coli* was about half the standard.

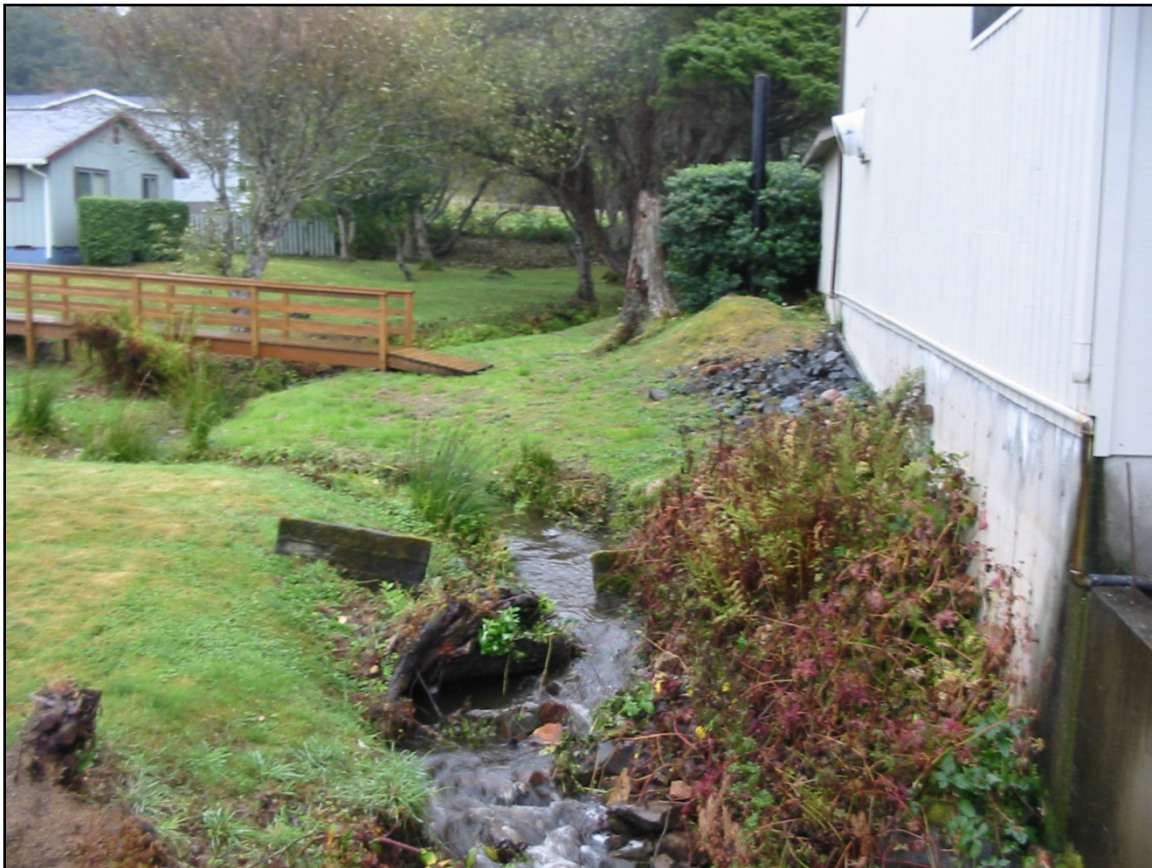
Figure 36. Chisana Creek at South Hemlock Street.

Samples were collected at confluence of the roadside ditch and the culvert on the north side of the Wayside Inn. This site is on the upstream side of the confluence with the drainage ditch site. The creek drains to this location from Highway 101 and alongside a parking lot and the Wayside Inn to the culvert then to the beach at Tolovana State Park. There is blackberry and thick vegetation near the highway but the creek is more open closer to Hemlock Street. Four samples were taken and tested for *Enterococcus* sp. at this site and one was tested for *E. coli*. One *Enterococcus* sp. sample exceeded the recreational water quality standard. That sample was taken during heavy rainfall on October 15th.

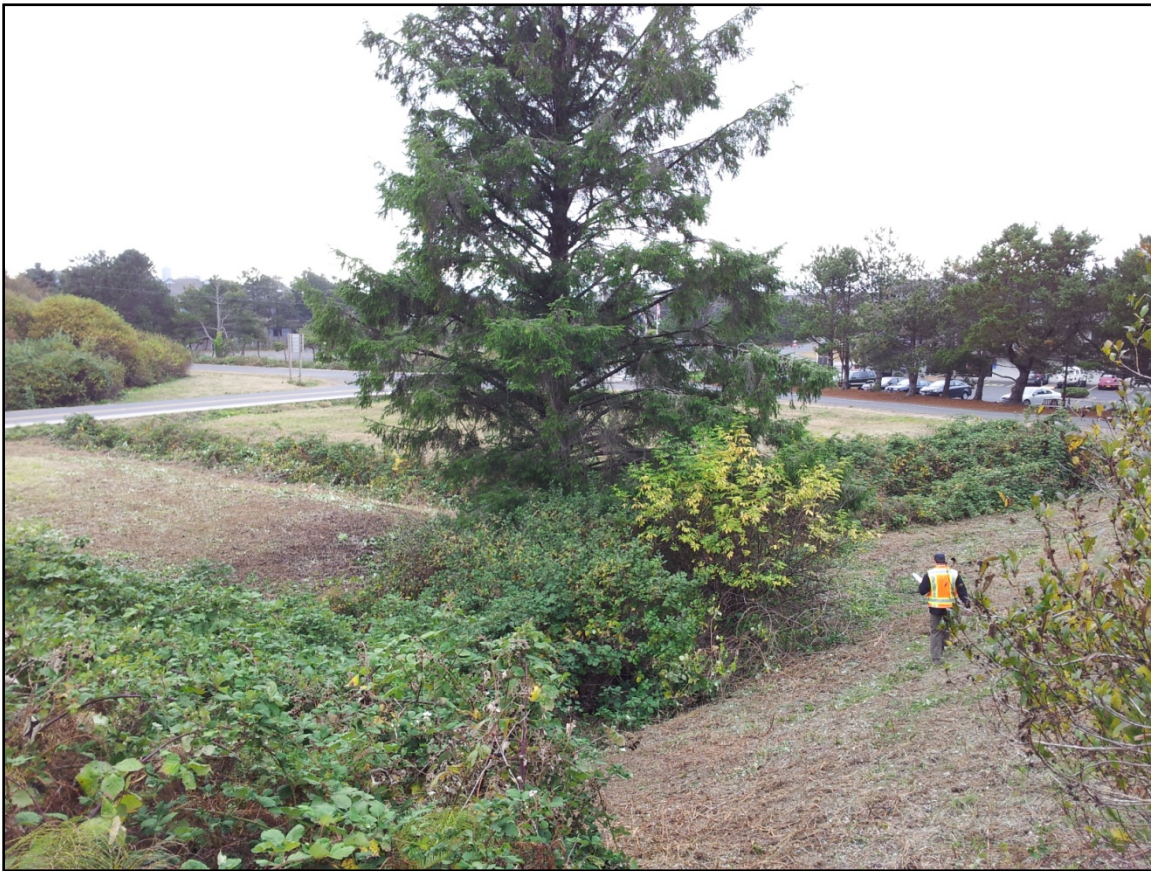
Figure 37. Chisana Creek at Highway 101.

More Chisana Creek samples were collected about 50 meters west of Highway 101 on public property between the highway and the exit ramp; about 0.17 miles from the beach. There are residences and a business on the east side of highway 101. There is thick vegetation including blackberry on the creek banks. The shrubs extend a few meters out from the banks and the vegetation is maintained to the highway and ramps. Five samples were taken at this site and tested for *Enterococcus* sp. One sample was collected and tested for *E. coli*. One of the *Enterococcus* sp. results was more than five times the recreational water quality criteria. The sample with the high result was taken during heavy rainfall on October 15th.

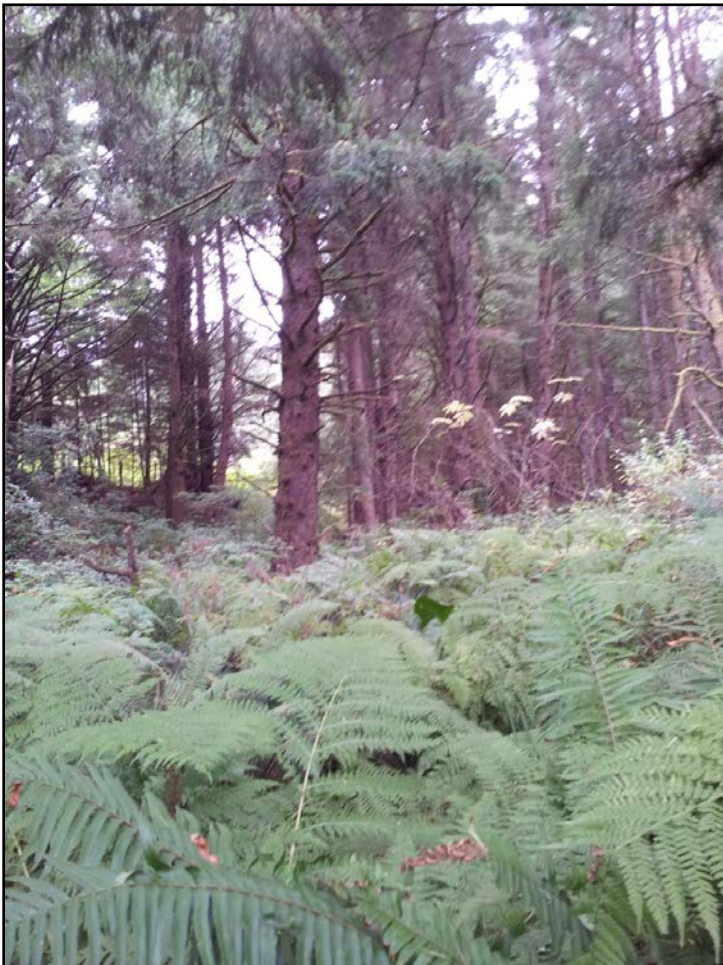
Figure 38. Chisana Creek Tributary at E. Warren Way and Chinook Avenue.

Samples were taken at a tributary to Chisana Creek at a culvert under the East Warren Way highway ramp at West Chinook Avenue about 0.28 miles from the beach. The tributary runs through the culvert east of Highway 101 north of the intersection with West Chinook Avenue. The banks are steep and the creek is about a meter wide and shallow. The banks are covered with ferns and shrubs. There is a community of residences south of West Chinook Avenue. The creek runs from forestland SE of West Chinook Avenue and then towards Highway 101. Five samples were taken at the site and tested for *Enterococcus* sp. and one was tested for *E. coli*. One of the *Enterococcus* sp. results was six times the recreational water quality criteria. That sample was taken during heavy rain on October 15th.

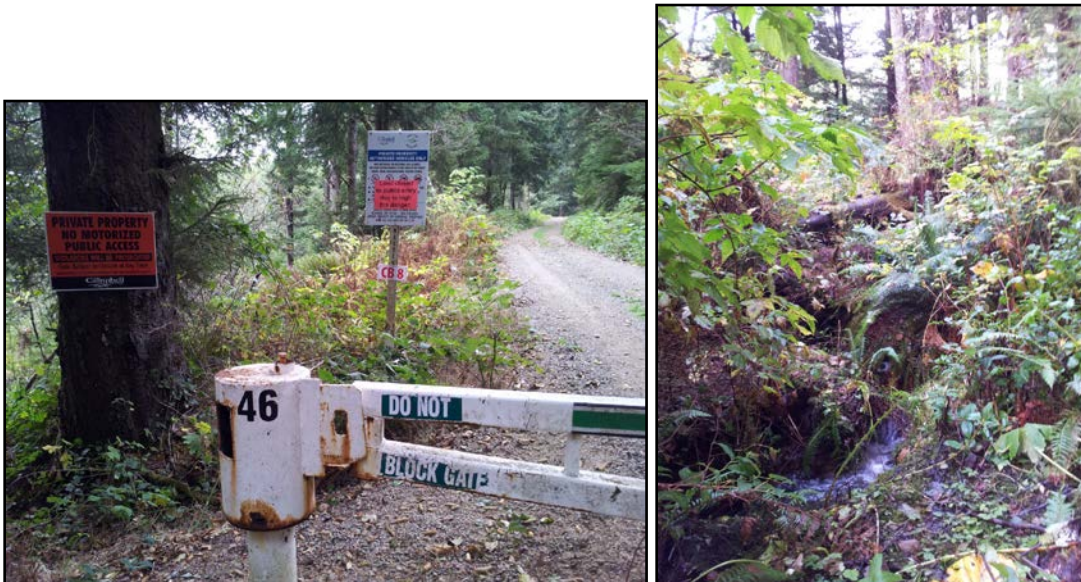
Figure 39. Chisana Creek at the Ecola Forest gate next to East Warren Way.

The farthest upstream Chisana Creek samples were collected at an Ecola Forest access gate on East Warren Way. Chisana Creek flows in to this location from about a half mile NE through forestland, rural residential land, and past a landscape business. This sample location is about 0.35 miles upstream from the beach and Chisana Creek is less than a meter wide at this location. A similar sized tributary flowing from the east along East Warren Way converges with Chisana Creek here. Upstream from this location the Chisana Creek main stem courses through small pools and riffles. The tributary along East Warren Way runs along the roadside in a drainage ditch.
