ODA Nursery 2017 Final Report
Insect Damage to Nursery Irrigation

Problem: A large nursery was concerned about damaged drip tube irrigation in Aug 2016. The manufacturer that they first contacted proposed it might be insect damage. We met with the grower in Spring 2017 to discuss what they have seen, and some basic observational studies.

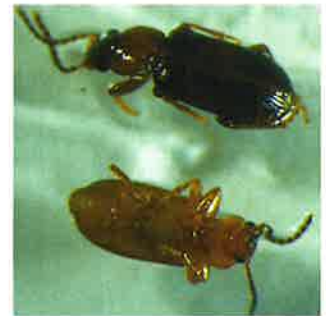
Carabid beetle *Bradycellus congener* near damaged tubes Aug. 1, 2017

This is a common small native species, identified by J. LaBonte.

Culprit? We think not, its preference for moisture may explain why it has been found by the grower, and in our pitfall traps.

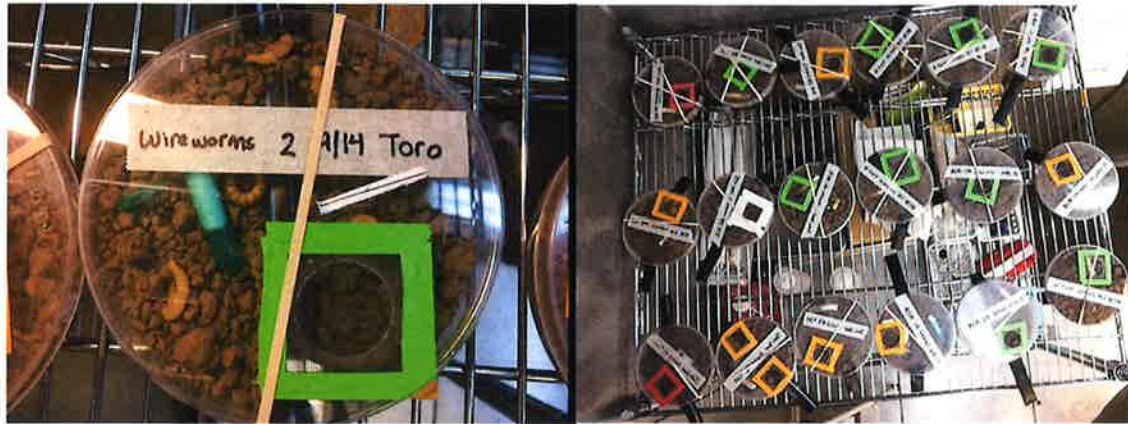
Extra-large petri dishes (14 cm diameter), with ventilating mesh lids were used to create a small observable chamber to hold soil and insects. Tubing was placed through the chamber and pinched closed on both ends by closing the lid tightly with rubber band. The tubing was filled with the diet relevant to each insect to stimulate chewing. The design was based on work with irrigation damage by white-fringed weevils (Nicholas, 2010). Insects would only be able to access the food by chewing through the plastic; the tubing placed in the dish were prepared so as not to have an emitter hole.

10-20 insects were placed in each chamber and 12 replications for each insect type. 4 different brands of drip tape were tested, with 3 replications of each drip tape for each insect. The drip tape brands used were PL-Ultra, Jain, John Deer, and Toro.

Schedule: Tubing was taken out and checked for each replication after no more living insects were found in the dish. Arthropods were kept alive by spraying the soil with water and adding a new water wick with a 5% sugar solution each week. However, arthropods were kept without a full diet to stimulate them to chew on the tubing.
