Assessment of the aquatic plant community and water quality status in Willamette River alcoves and sloughs infested with *Ludwigia* spp.

Rich Miller¹, Kurt Carpenter², David Weathers², Marci Krass³, Andrea Berkeley⁴,
Melissa Newman⁵, and Mark Sytsma¹

Oregon Department of Agriculture Noxious Plant Forum

March 7, 2018

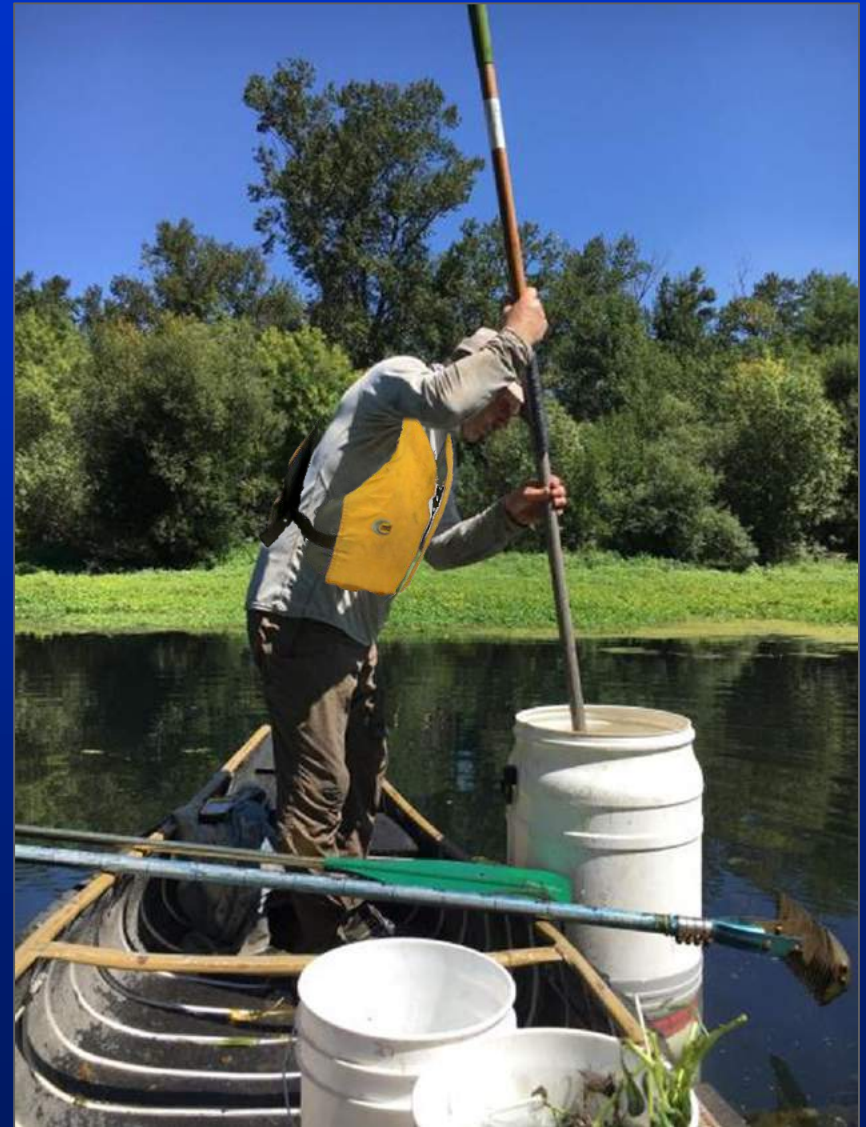
Mission Lake

- August 1 and 3, 2017
- 59 acre survey area
- 0 - 2.8 m sample depths

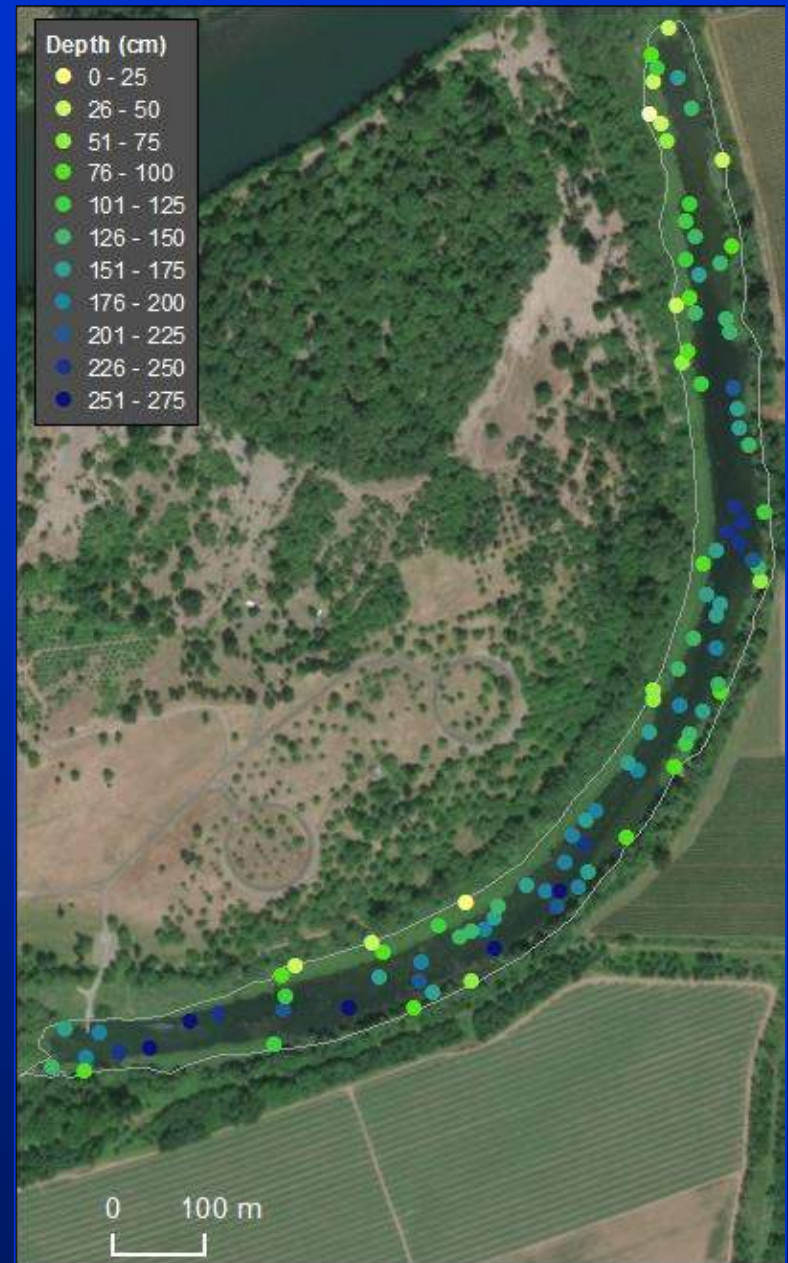
Windsor Slough

- August 15 and 17, 2017
- 45 acre survey area
- 0 – 2.4 m sample depths

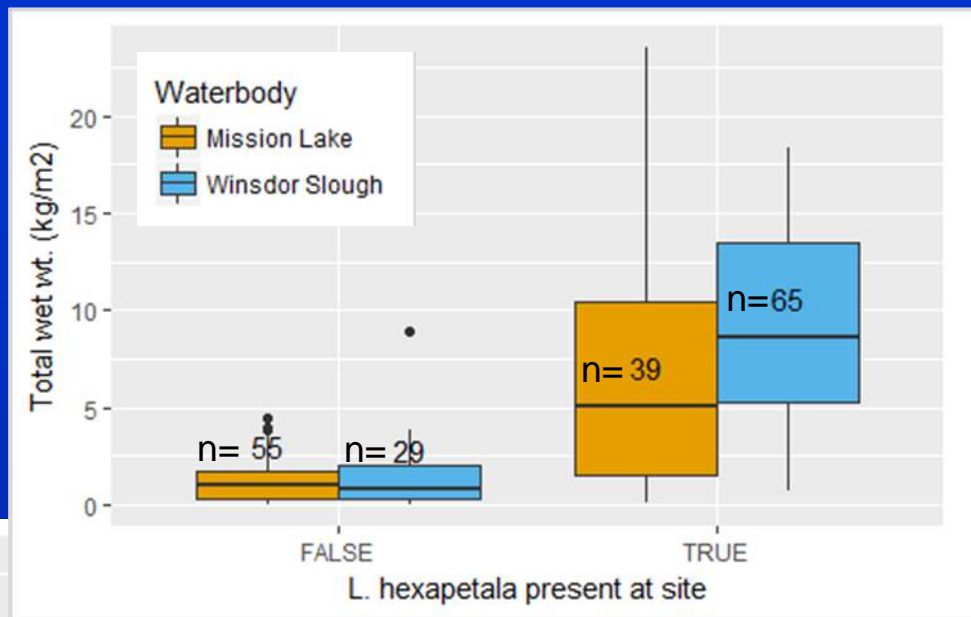
All species

- Plants present at 94% of sites
- *LUDHEX* dominated biomass
- *Egeria densa* (AIS) and *Ceratophyllum demersum* (native) important in deeper samples, but lower biomass

Windsor Island
Slough (left)

Mission Lake
(right)

Total plant
fresh wt.
(kg/m²)

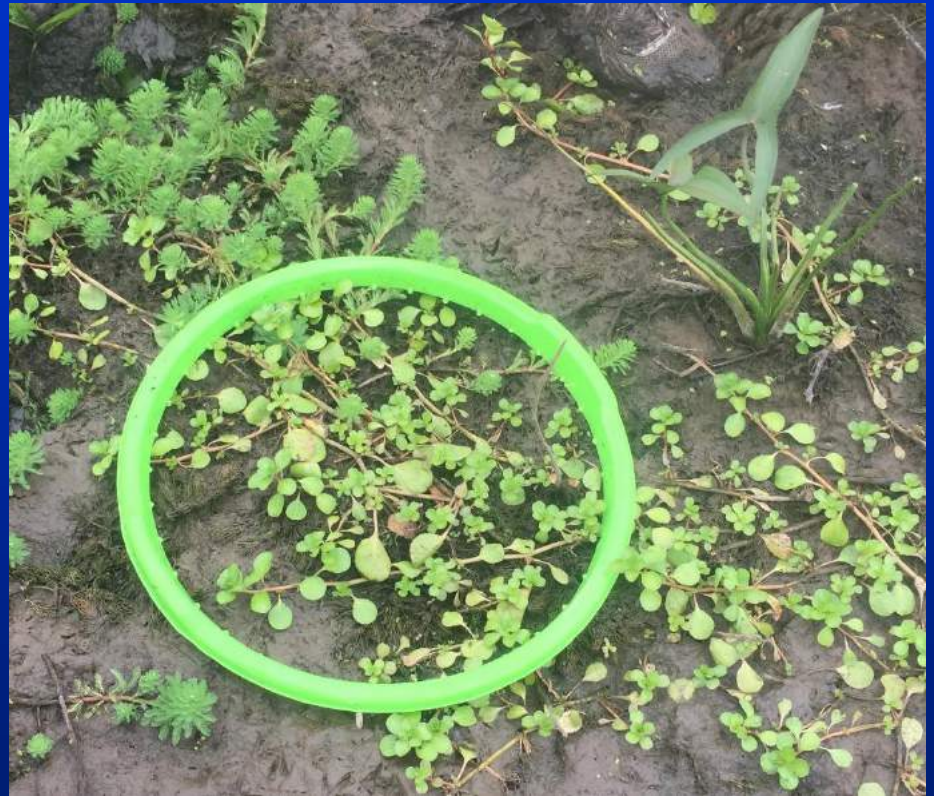
Collins Bay / Scatter Bar Aquatic Plant Survey Methods

- Survey areas defined using LiDAR elevation and aerial images
- Sampled 60 pre-selected random points per survey area during three events
- Recorded sample depth and semi-quantitative species abundance

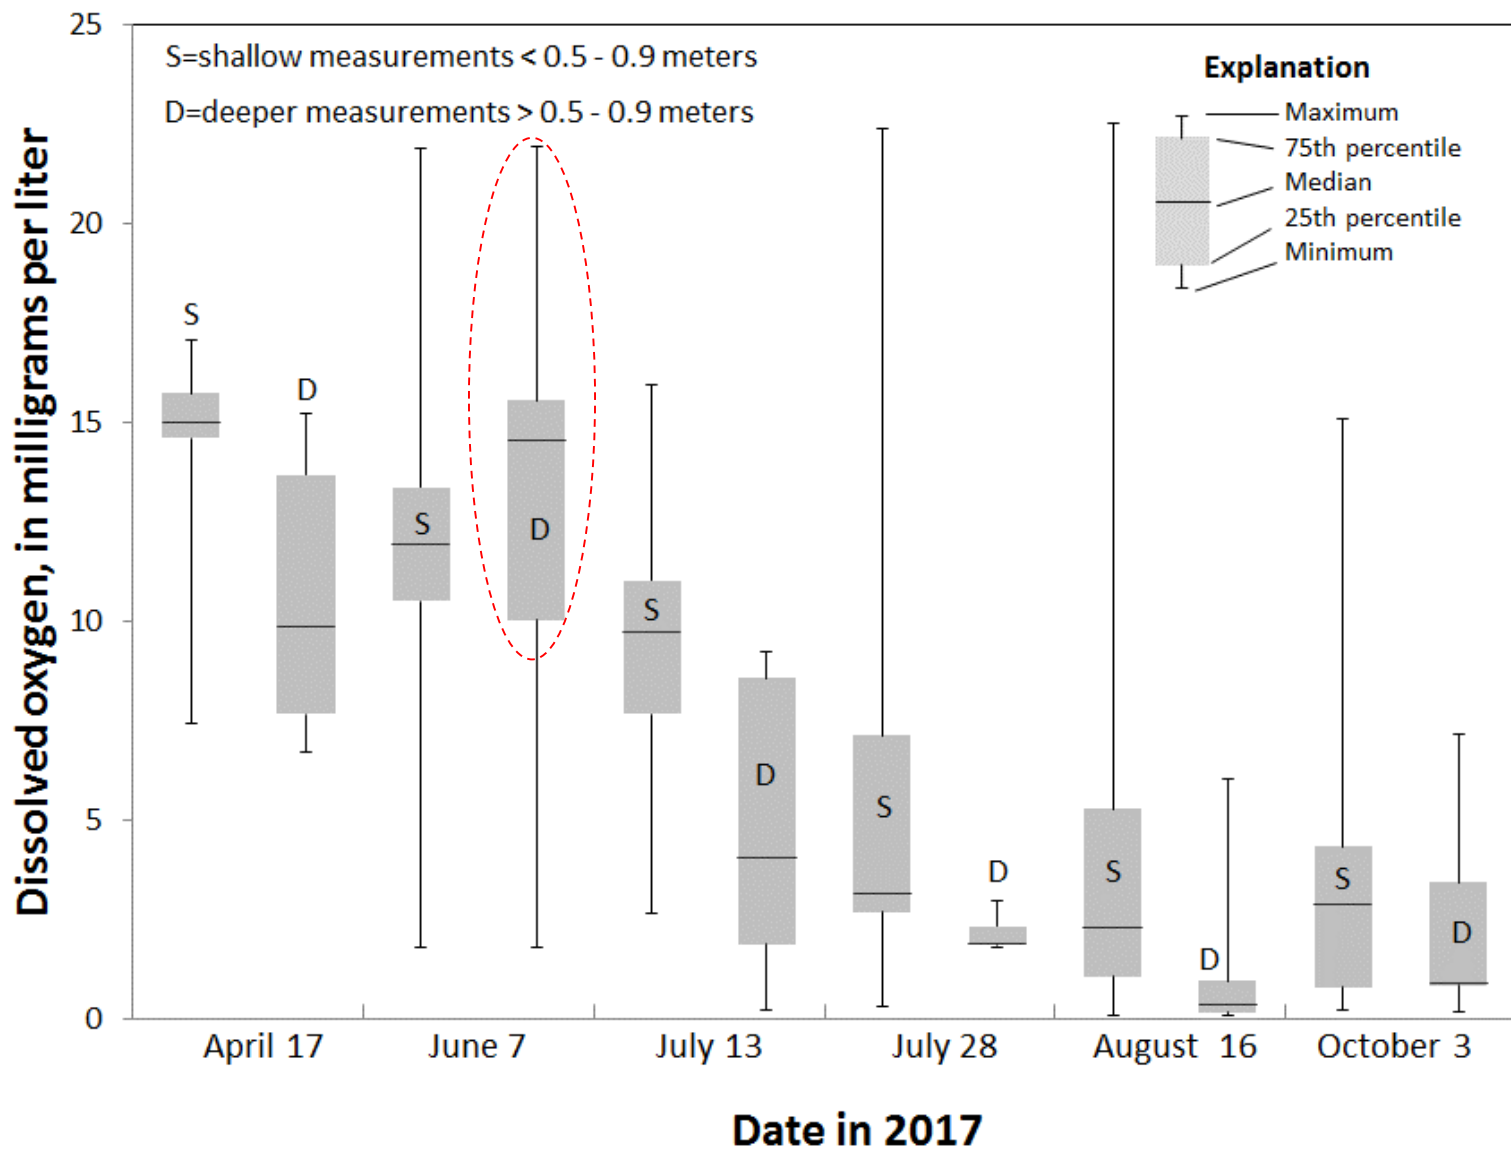
Mission Lake: Dissolved Oxygen

Higher DO at depth was observed where *Egeria densa* and *Melosira* proliferated to the bottom

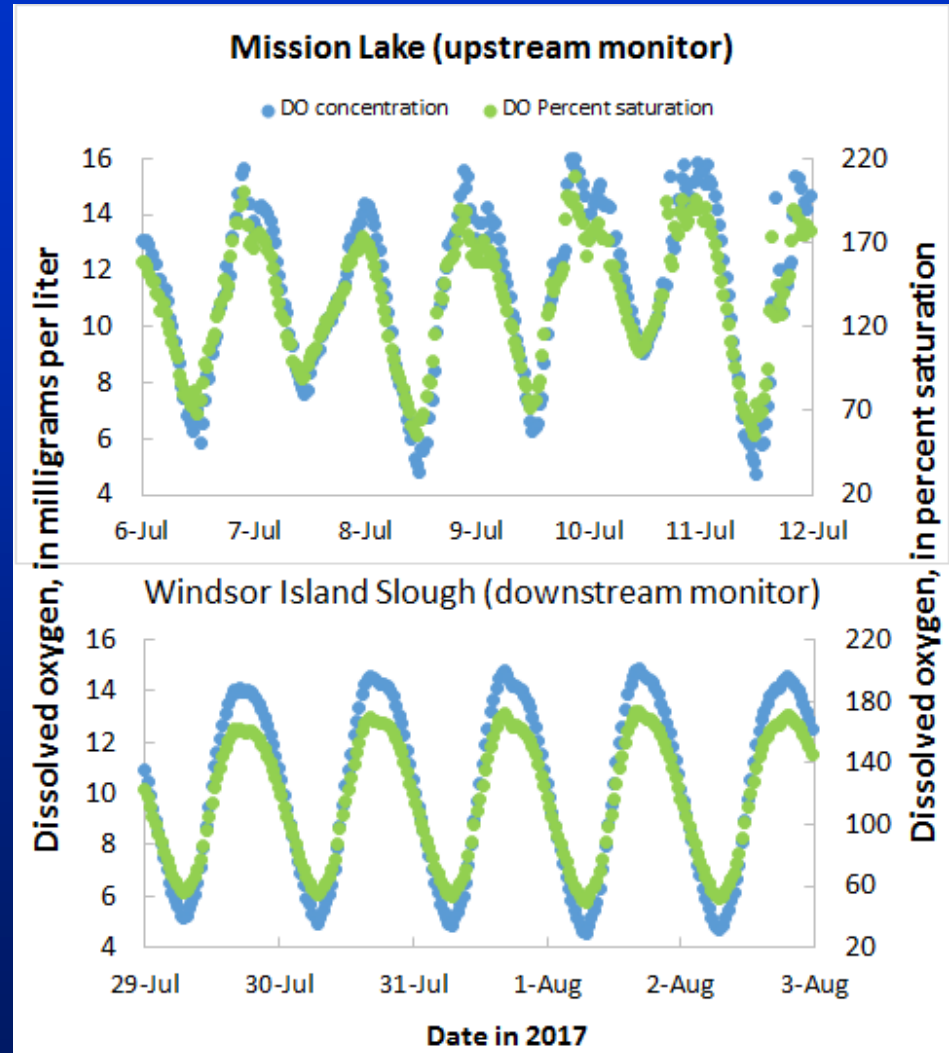
Plant photosynthesis causes large diel fluctuations in DO

- Daily swings of 9–10 mg/L in both waterbodies
- Percent saturation swings of 120%–130%
- Minimum DO was less than 5 mg/L

- DO increases during the day along with water temperature,
- SO.. aquatic plant photosynthesis controls DO (not water temperature)

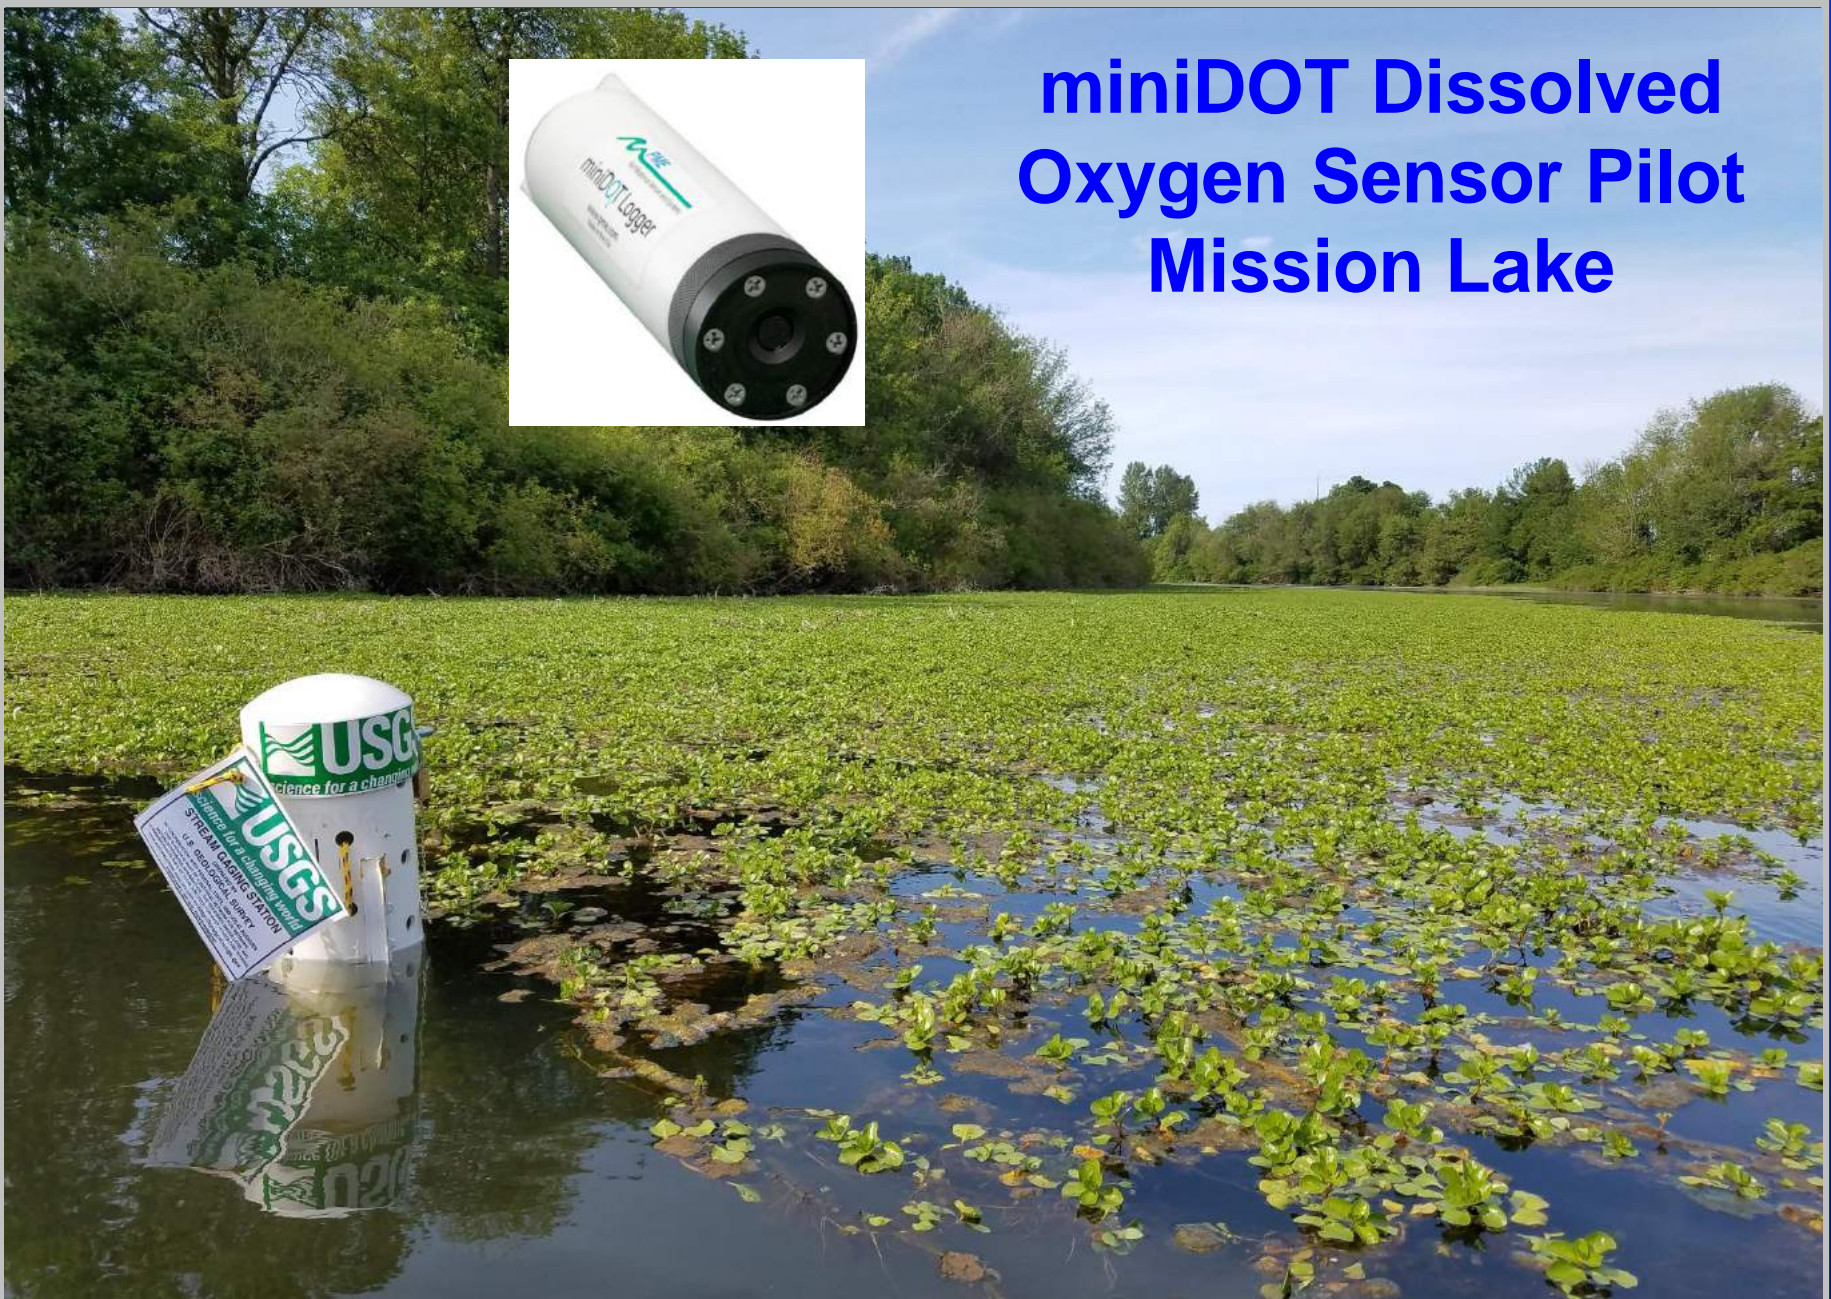
miniDOT Dissolved Oxygen Sensor Pilot Mission Lake

- Large diel fluctuations in DO (0–18 mg/L, or 0–250% saturation)
- Stable, low DO (near anoxia) off bottom

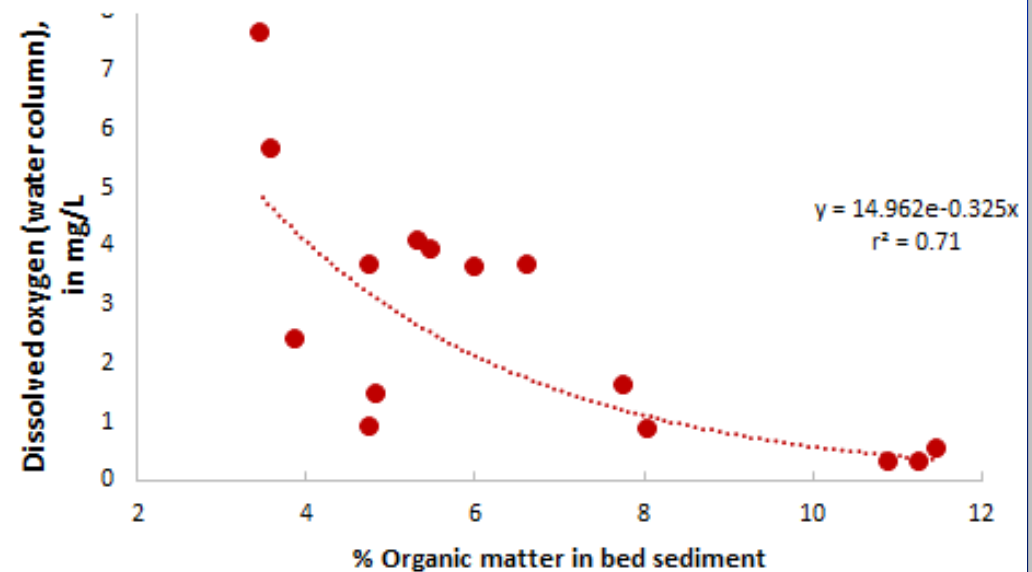
Mission Lake Bed Sediment - August 2017

- Percent organic matter in bed sediments high - increased downstream
- DO in water column lowest where % OM in sediments was highest
- Respiration/ sediment oxygen demand

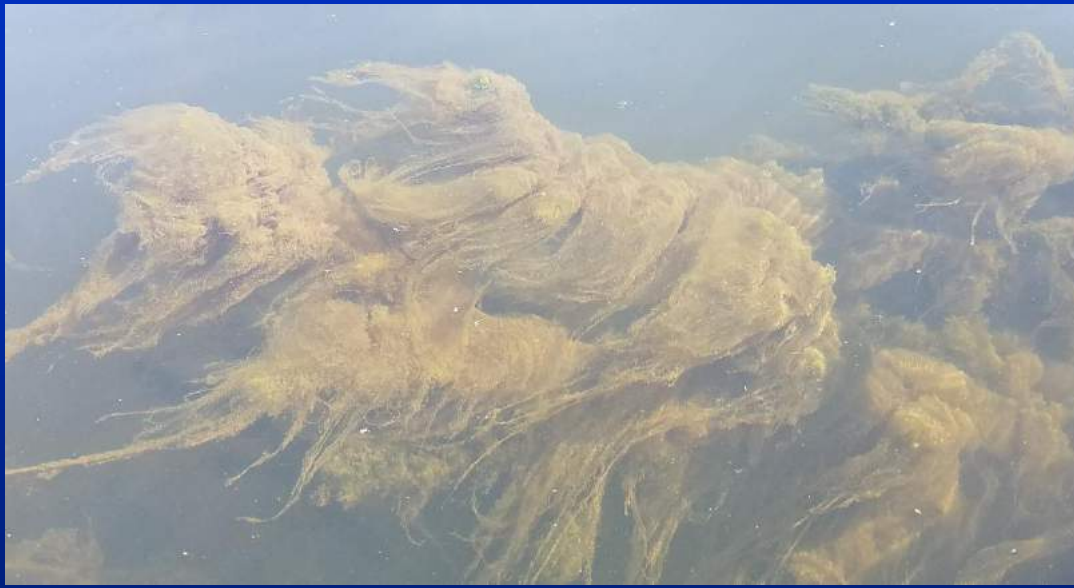
Windsor Island Slough: Algae and Cyanobacteria

- Elevated concentrations of nitrogen and phosphorus fueled growth of filamentous algae - both greens (*Oedogonium*) and diatoms (*Melosira*) - and cyanobacteria (*Oscillatoria*)

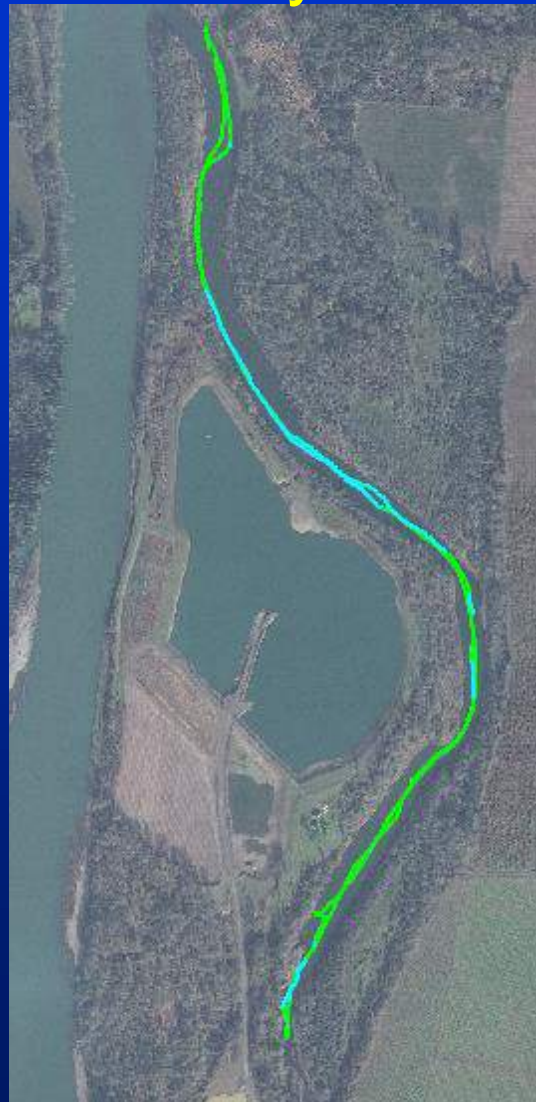
July

Windsor Island Slough: Dissolved Oxygen

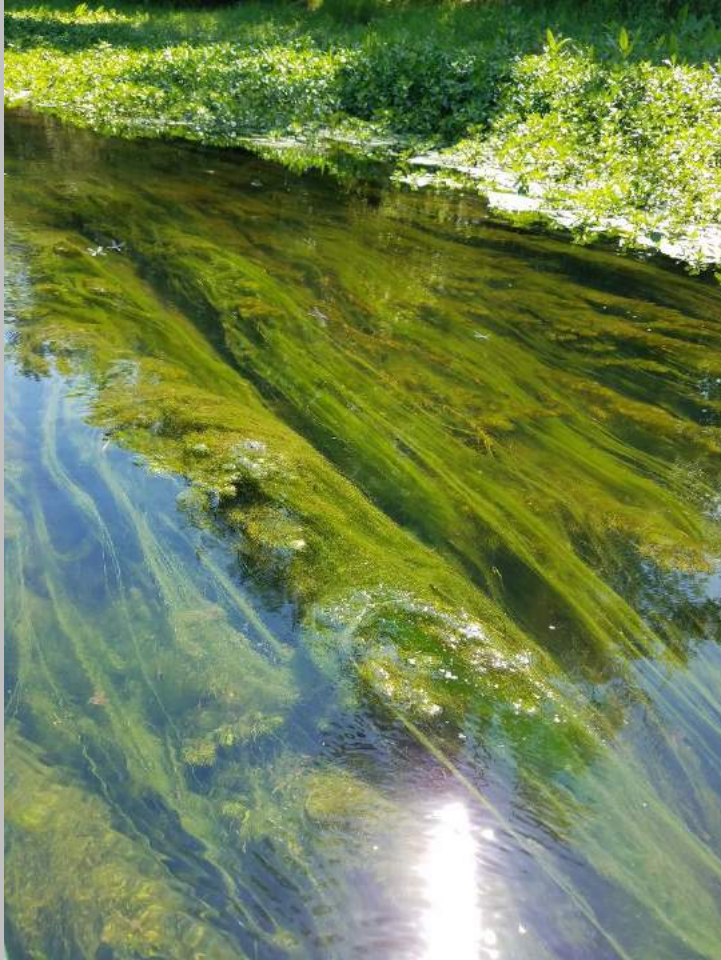
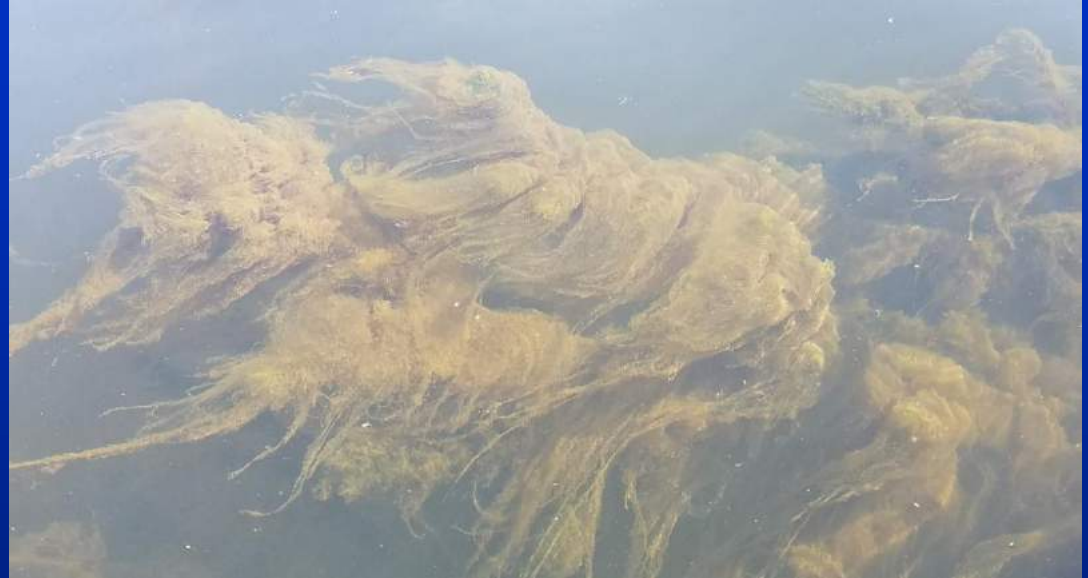
Bioavailable Nutrients: Windsor Island Slough

- Nitrogen and phosphorus fueled filamentous periphyton – green algae (*Oedogonium*) and diatoms (*Melosira*), and rooted, submerged, and emergent macrophytes
