OR 211: Meridian Road Intersection

Completed Safety Improvements

Safety Improvements

Current, Planned and Potential Future

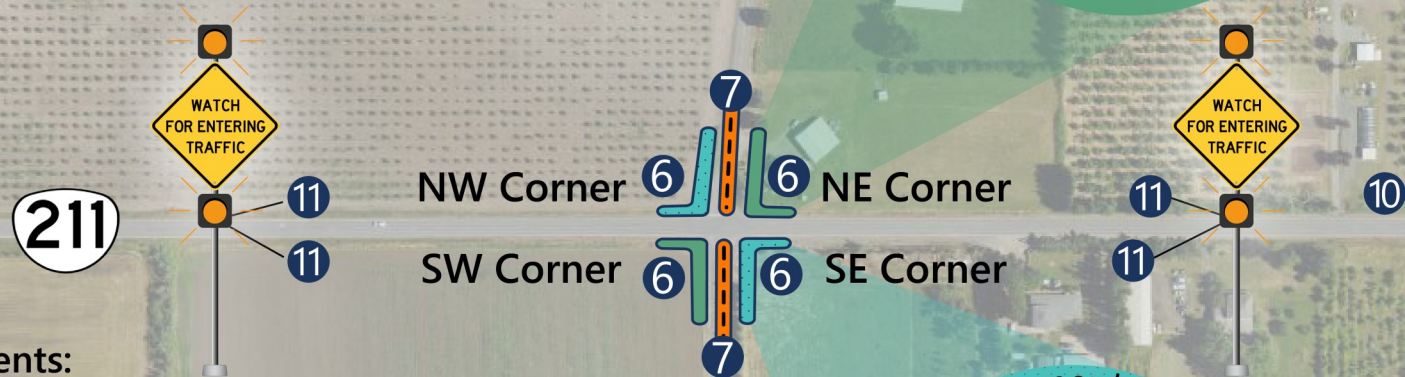
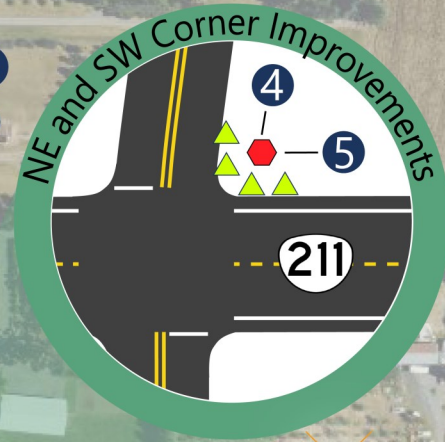
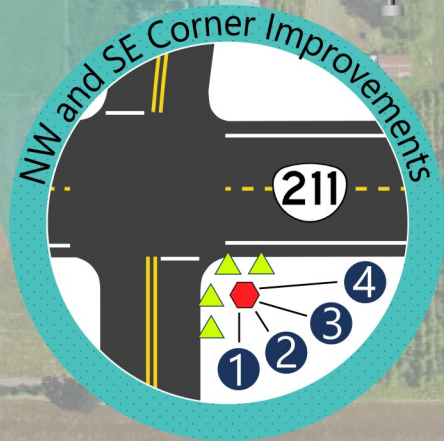
Safety Improvements:

- 1 Larger stop sign
- 2 Flashing red beacons
- 3 "Cross traffic does not stop" plate
- 4 Reflective red tape on sign post
- 5 Left-hand stop sign
- 6 Clear branches, yard signs & mow
- 7 Refresh striping
- 8 Larger stop ahead sign
- 9 Flashing amber beacon
- 10 Intersection ahead sign & flashing beacon
- 11 Warning lights – 2025
- ▲ Delineator

This is a rendering, exact locations and features may change.

- Installed larger stop signs to make it easier for drivers to see as they approach the intersection.
- Installed and tested red flashing beacons on top of the stop sign posts to alert the driver that they need to stop.
- Added "cross traffic does not stop" plates below the stop sign.
- Added reflective red tape onto the stop sign poles to help make the signs more visible.
- Added reflective markers, called delineators, at the corners to help make the intersection easier for drivers to see when it is dark.
- Removed advertisements and signs that could be distracting or blocking drivers view.
- Mowed, pruned branches and cleared plants to improve driver visibility of signs and other cars.

- Installed stop signs on the left side of the road to alert drivers on Meridian Road to stop.
- Added reflective red tape onto the stop sign poles to help make the signs more visible.
- Added reflective markers, called delineators, at the corners to help make the intersection easier for drivers to see when it is dark.
- Removed advertisements and signs that could be distracting or blocking drivers view.
- Mowed, pruned branches and cleared plants to improve driver visibility of signs and other cars.

- Refreshed the stop bar paint and striping to make lanes and where to stop more visible.
- Installed intersection ahead warning signs with amber flashing beacons on OR 211.
