# LITHIUM-ION BATTERY FIRES AND EMISSIONS CHARACTERIZATION

REPORT

*November 2024*

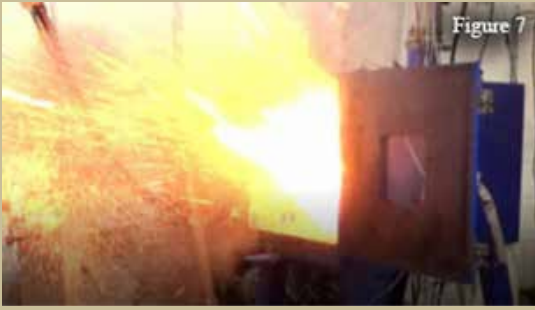
**Figure 7 (Left):** Battery Test #3, where internal pressure from Li battery thermal runaway forced the blast chamber door to open.

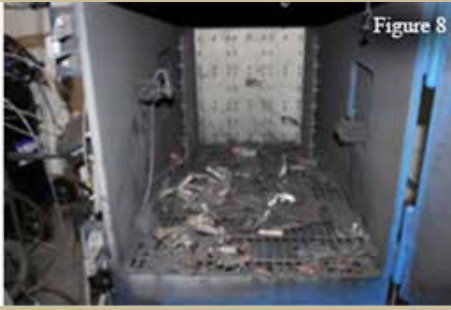
**Figure 8 (Right):** Remains of Li-ion battery in blast chamber post-thermal runaway.

- In each test, significant battery weight loss, ranging from 44% to 63%, was observed post-thermal runaway.
