Technical Memorandum

January 22, 2022

To: Lisa Cornutt
Oregon Department of Transportation
3500 NW Stewart Parkway
Roseburg, OR 97470

RE: South Coast Site Reconnaissance Report

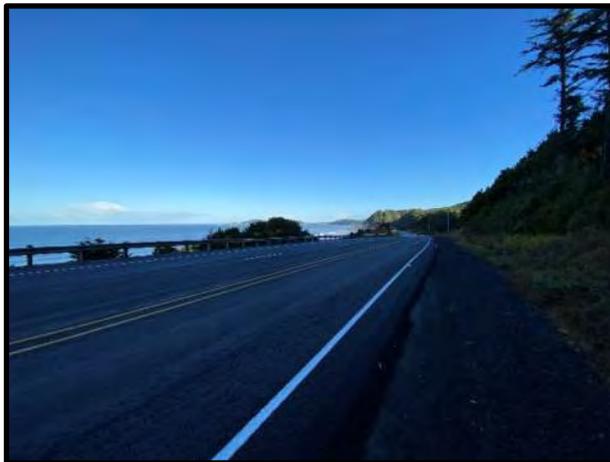
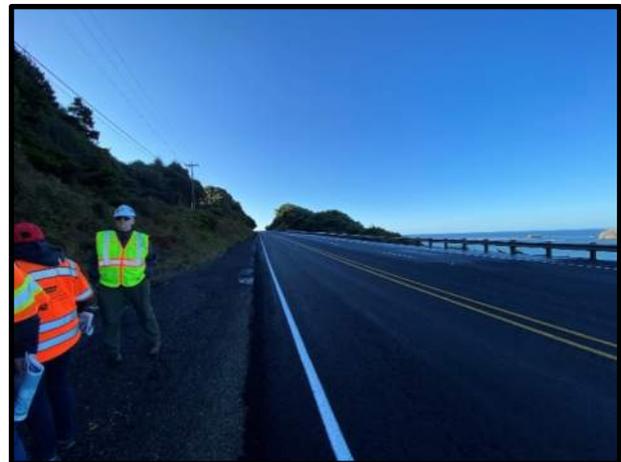
Retz Creek South Slide (MP 304.72)

Exhibits 27 and 28 - Looking North* (Left) & Looking South* (Right) at Retz Creek South Slide

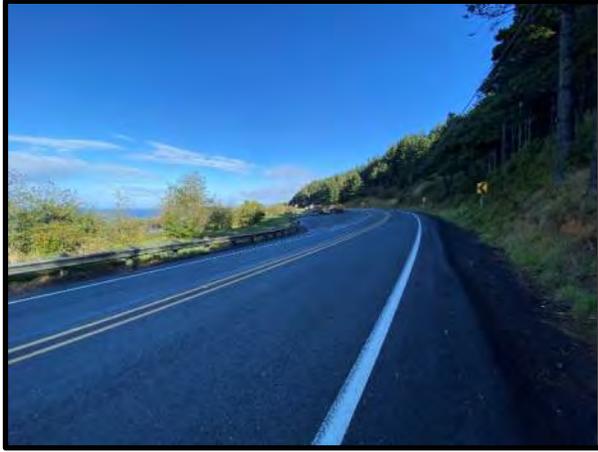
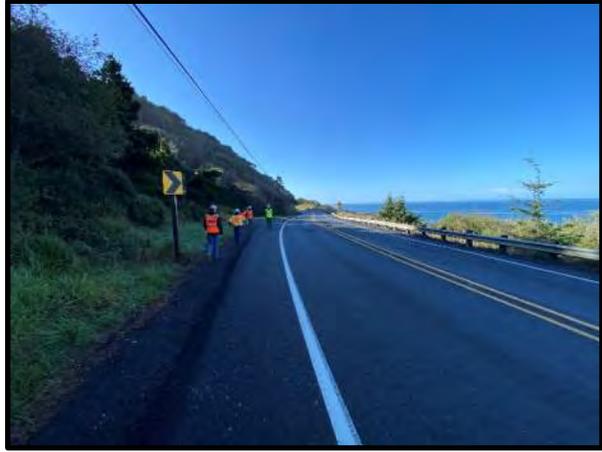
Coal Point Slide (MP 305.53)

Exhibits 29 and 30 - Looking North (Left) & Looking South (Right) at Coal Point Slide

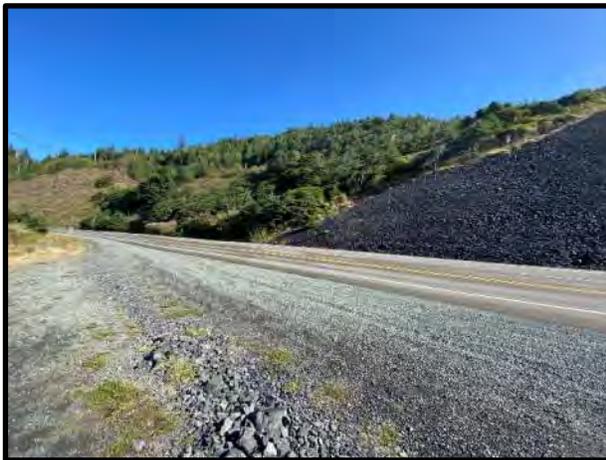
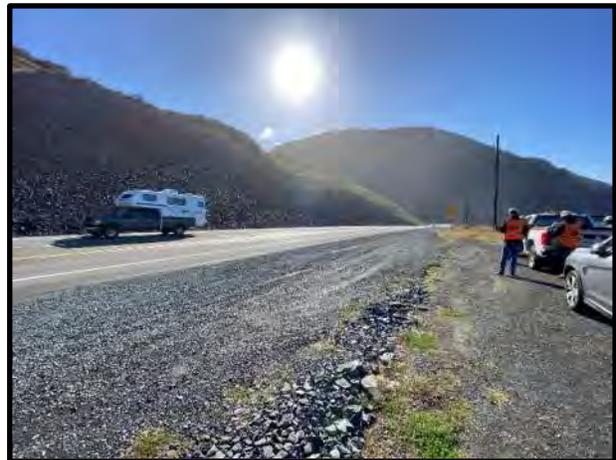
North Brush Creek Hump (MP 306.12)

Exhibits 31 and 32 - Looking North (Left) & Looking South (Right) at North Brush Creek Hump

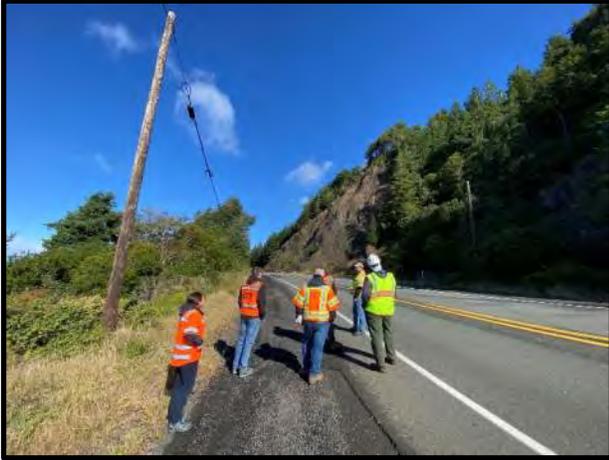
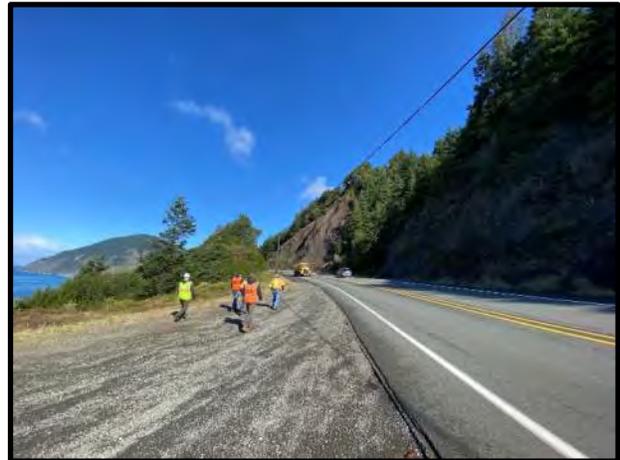
Brush Creek Slide (MP 310.24)

Exhibits 33 and 34 - Looking North Close In (Left) & Looking North Further Out (Right) at Brush Creek Slide

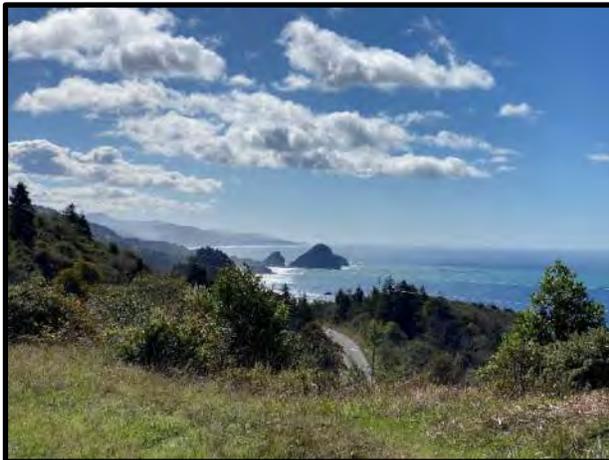
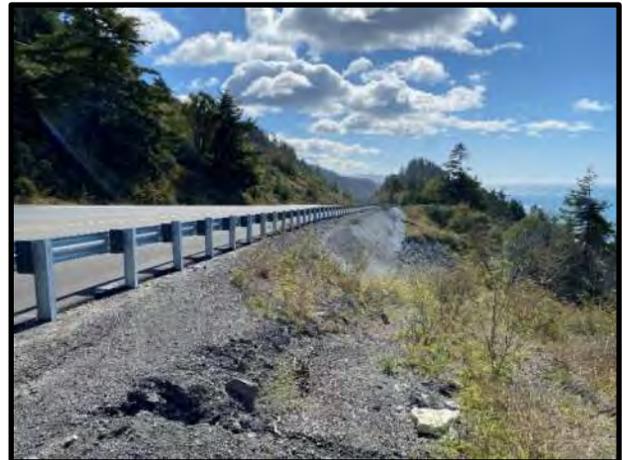
Arizona North Slide (MP 312.00)

Exhibits 35 and 36 – Above Slide Complex Looking South (Left) & Looking South (Right) at Arizona North Slide

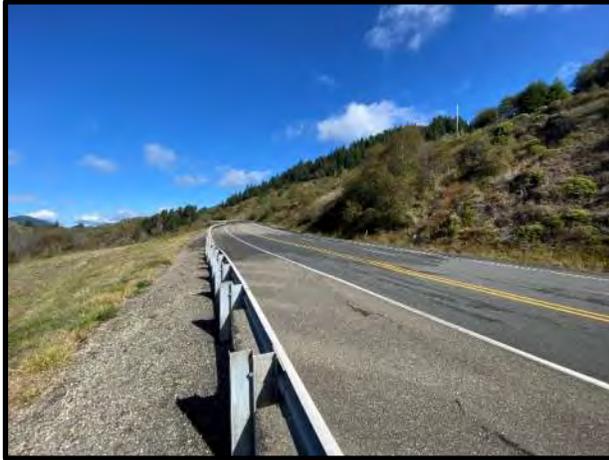
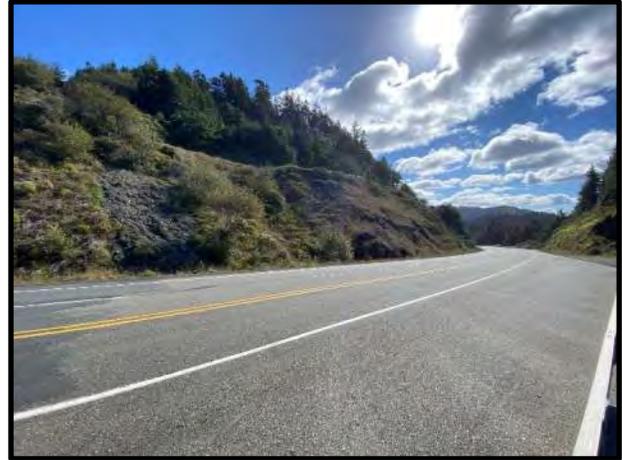
Arizona Inn Slide (MP 312.39)

Exhibits 37 and 38 - Looking North (Left) & Looking South (Right) at Arizona Inn Slide

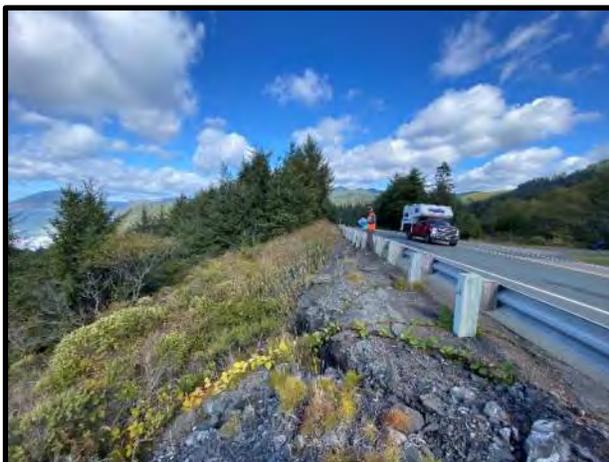
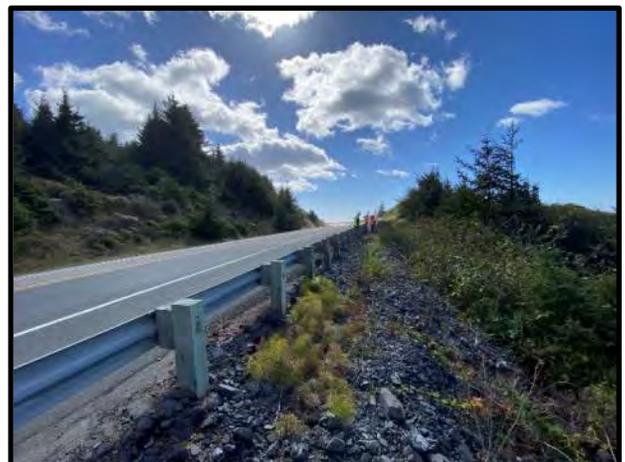
Christmas Tree (Frankport North) Slide (314.10)

Exhibits 39 and 40 - Looking North (Left) & Looking South (Right) at Christmas Tree Slide

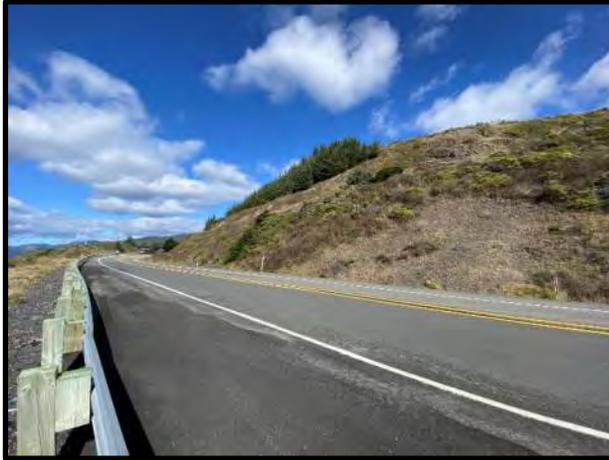
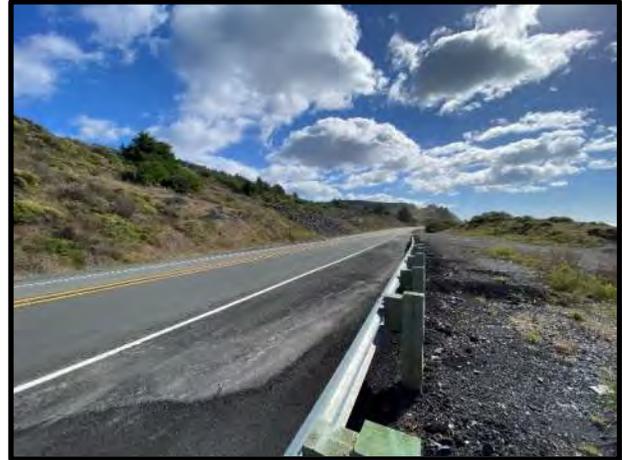
Sisters Rock Sink (314.32)

Exhibits 41 and 42 - Looking North (Left) & Looking South (Right) at Sisters Rock Sink

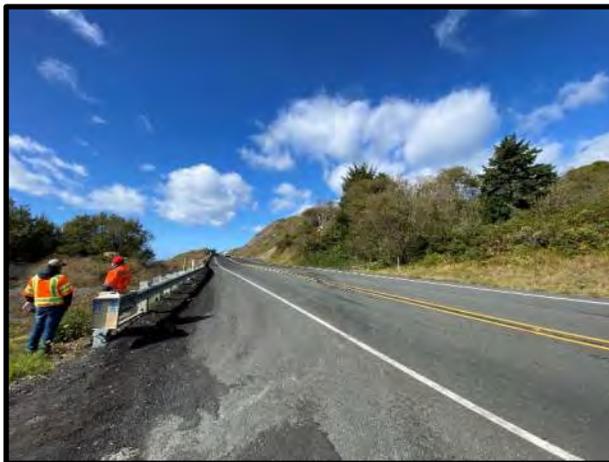
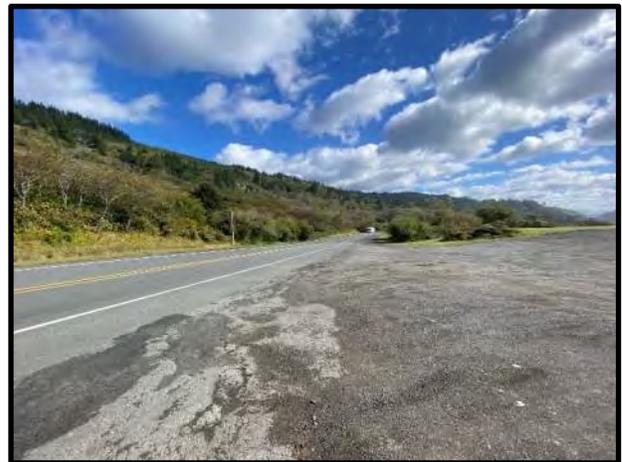
Frankport South Slide (MP 314.79)

Exhibits 43 and 44 - Looking North (Left) & Looking South (Right) at Frankport South Slide

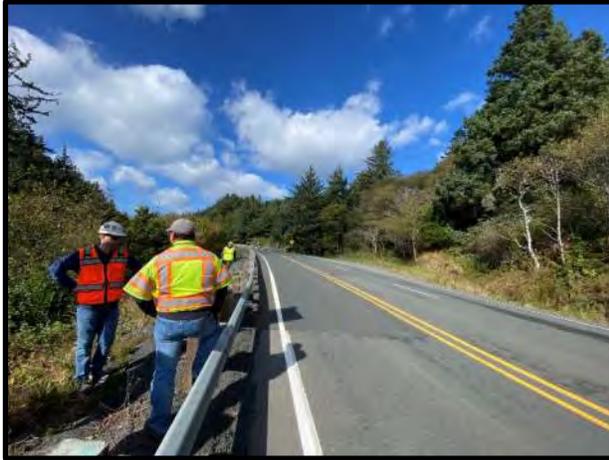
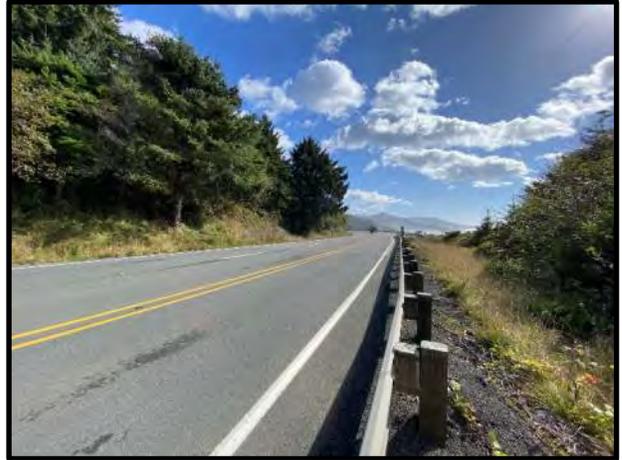
Woodroof Creek Slide (MP 315.93)

Exhibits 45 and 46- Looking North (Left) & Looking South (Right) at Woodroof Creek Slide

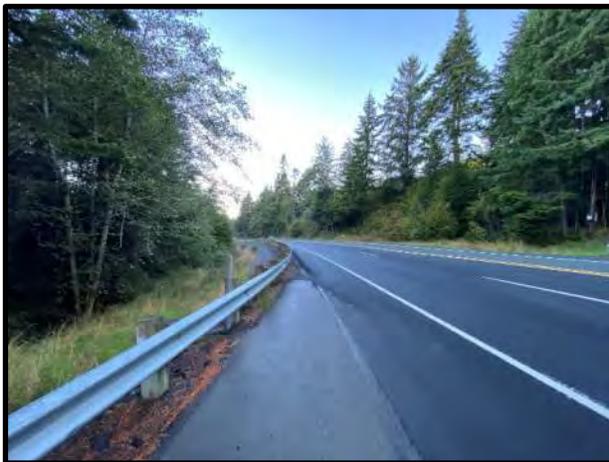
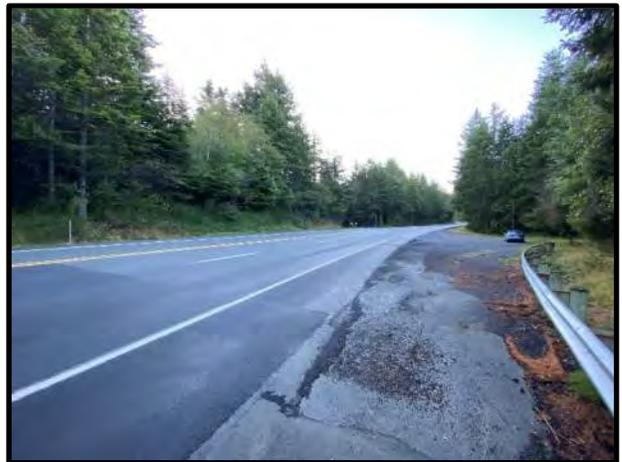
Eighty Acres Slide (MP 332.55)

Exhibits 47 and 48 - Looking North (Left) & Looking South (Right) at Eighty Acres Slide

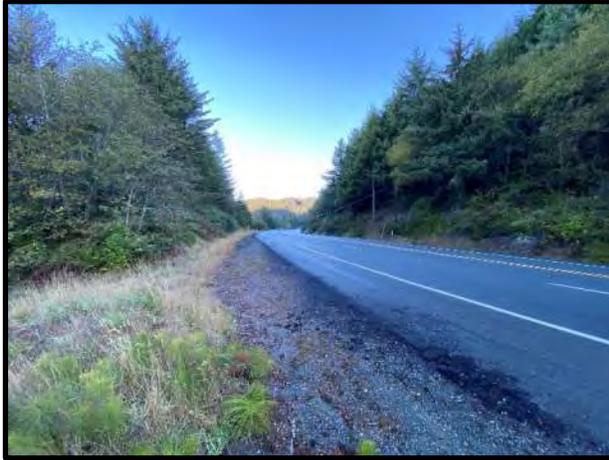
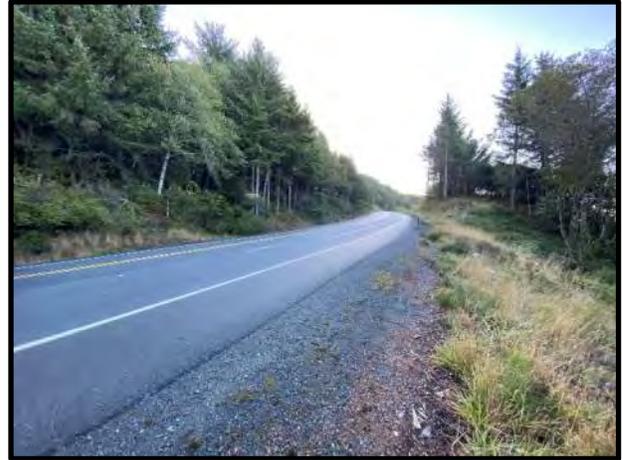
Burnt Hill Slide (MP 342.55)

Exhibits 49 and 50 - Looking North (Left) & Looking South (Right) at Burnt Hill Slide

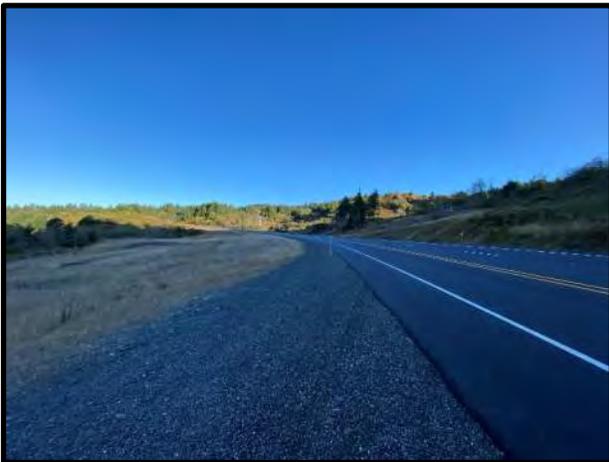
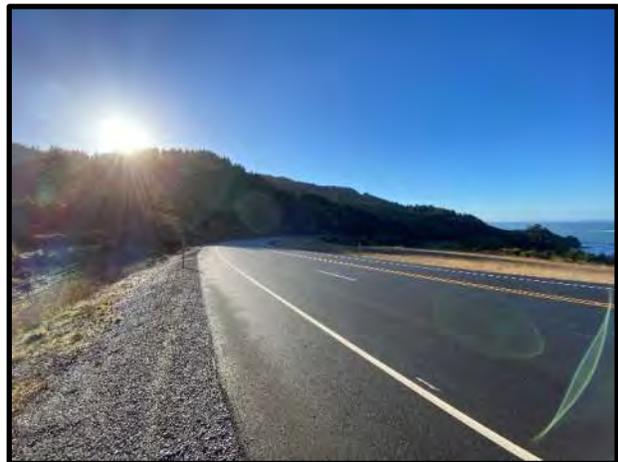
Hooskanaden Slide (MP 343.63)

Exhibits 51 and 52 - Looking North (Left) & Looking South (Right) at Hooskanaden Slide

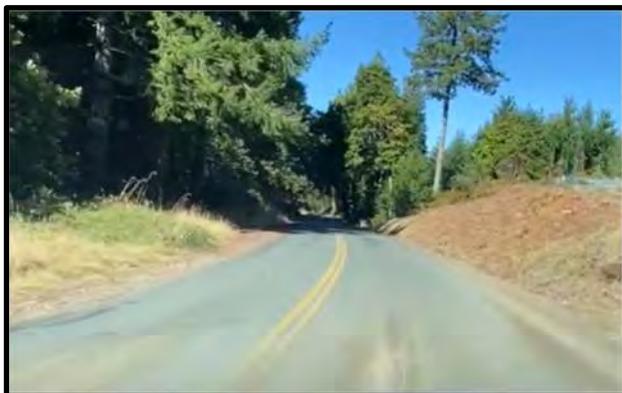
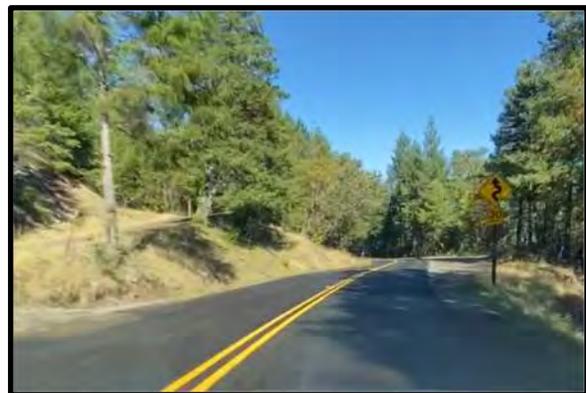
The images below show the current condition of Carpenterville Road including new curve warning signage that was recently installed (curve warning sign shown in right image).

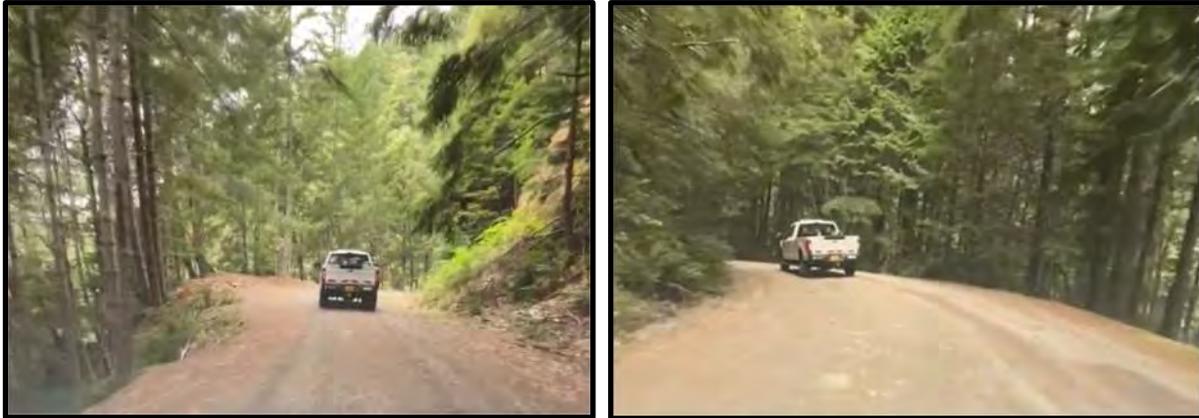
The route then heads along a gravel Forest Service owned/maintained road FS-5325/FS-5502 for approximately 19 miles. It traverses through a large amount of elevation change peaking at an elevation of 2,600, about five miles into this segment. The images

below show the steep topography and narrow corridor along the Forest Service segment.

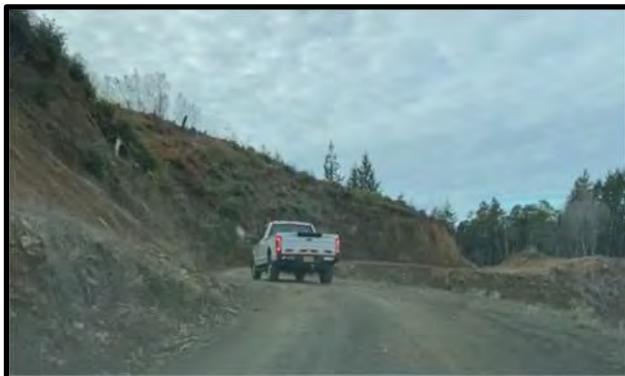
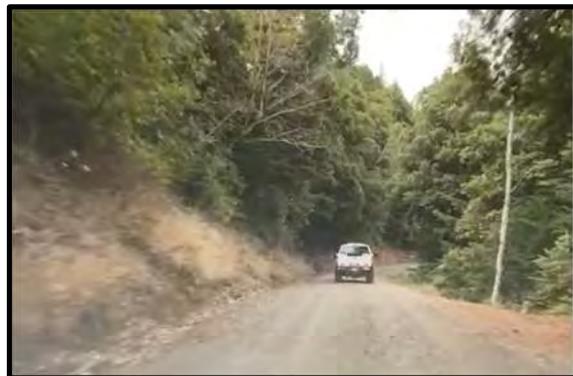
The images below highlight the steep terrain experienced along this route.

It is not recommended to use this route as a restricted access route in the event of a closure on US 101. It may be suitable for some passenger vehicles. Using the longer Elk River Rd/FS 5502/Euchre Creek Rd route would be a more suitable restricted access route.

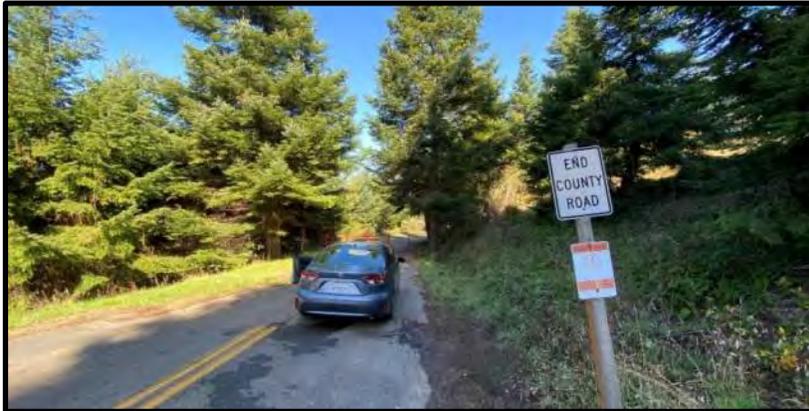
See image below showing the gated access point.

This is not a viable detour or restricted access route.

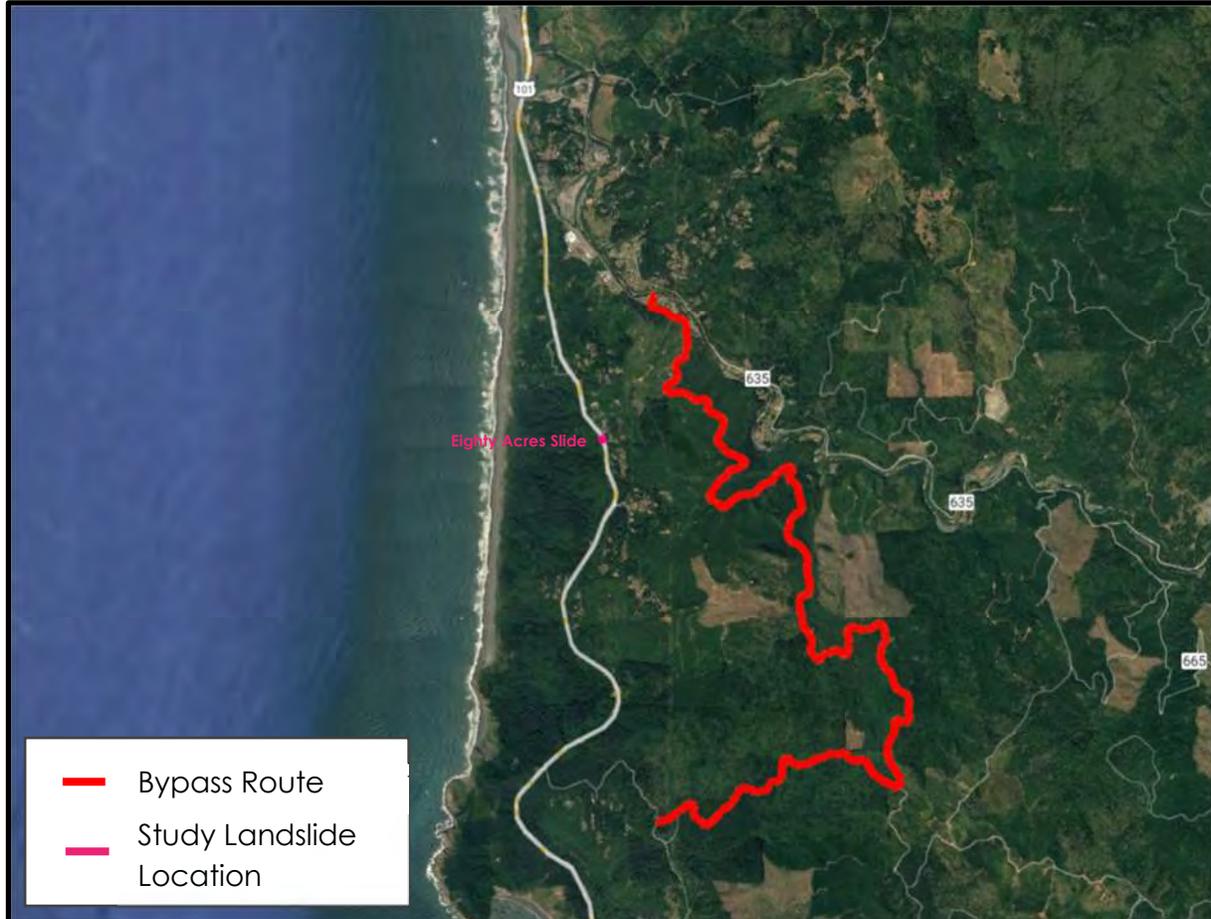
Figure 7 – Eighty Acres Bypass Route

As shown in **Figure 7**, this route is the only potential route to bypass the Eighty Acres slide complex, however, the route is not currently accessible on either end.

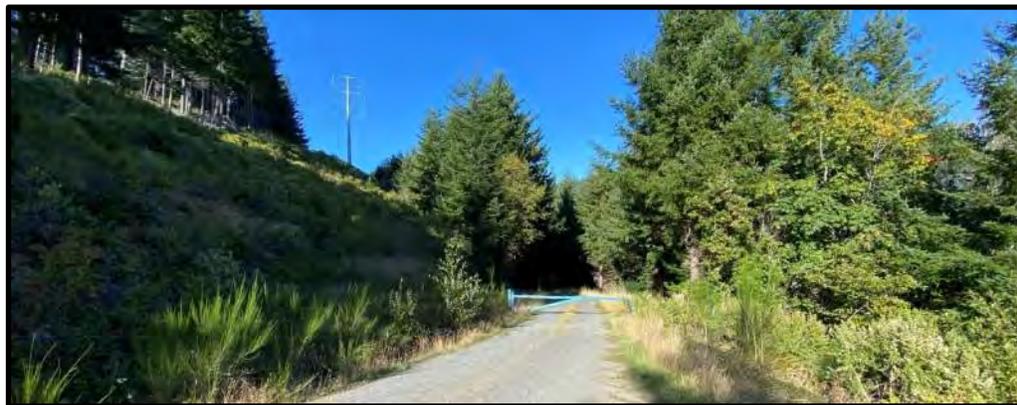
The northern access point near Hunter Creek Road is no longer accessible (blocked by vegetation and unable to be located) and the southern access point near Meyers Creek Road was gated off and likely not useable. See image below showing the southern gated access point.

This is not a viable detour or restricted access route.

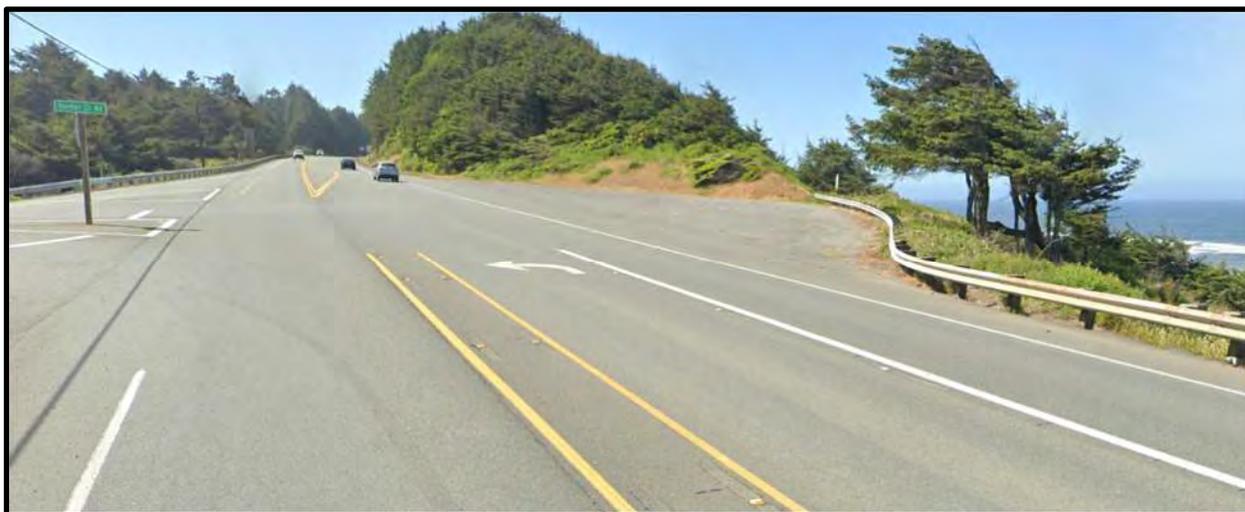
Potential Northern Stockpile Location: Intersection of US 101 and Hunter Creek Road (MP 331.07)

This location provides a widened shoulder that could provide enough room to stockpile a smaller amount of material and is 1.5 miles north of the Eighty Acres slide complex allowing easy access from Gold Beach in a significant event. The wide intersection would also allow for easy truck turning movements.

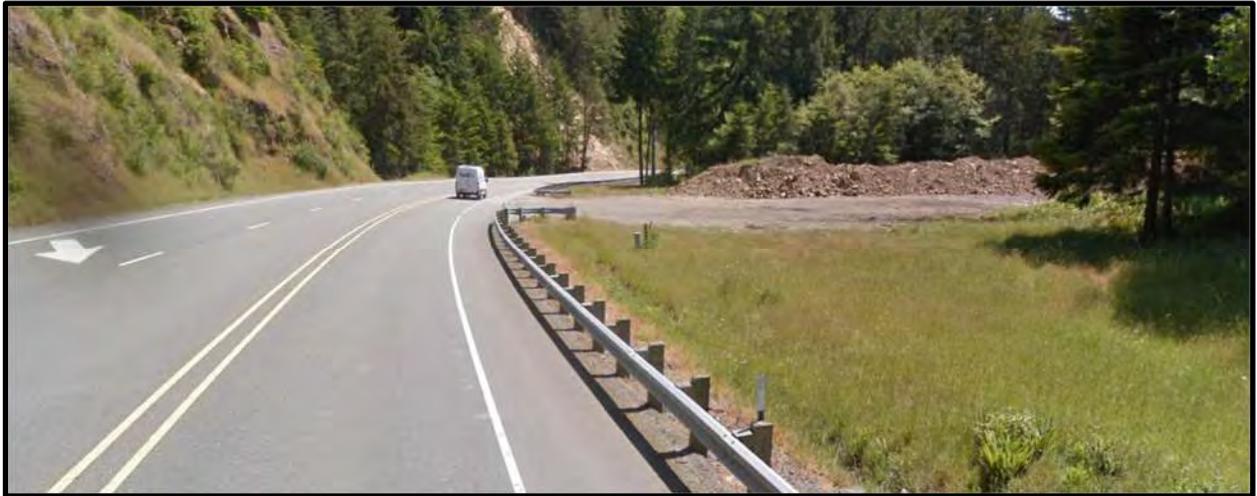
Potential Southern Stockpile Location: US 101 MP 334.25

This location provides a significant amount of area to stockpile material (it looks like it's currently being used for that in some capacity) and is less than 2 miles away from the center point of the Eighty Acres slide complex. There is enough room for trucks to fully pull off the road and turn around before re-entering.

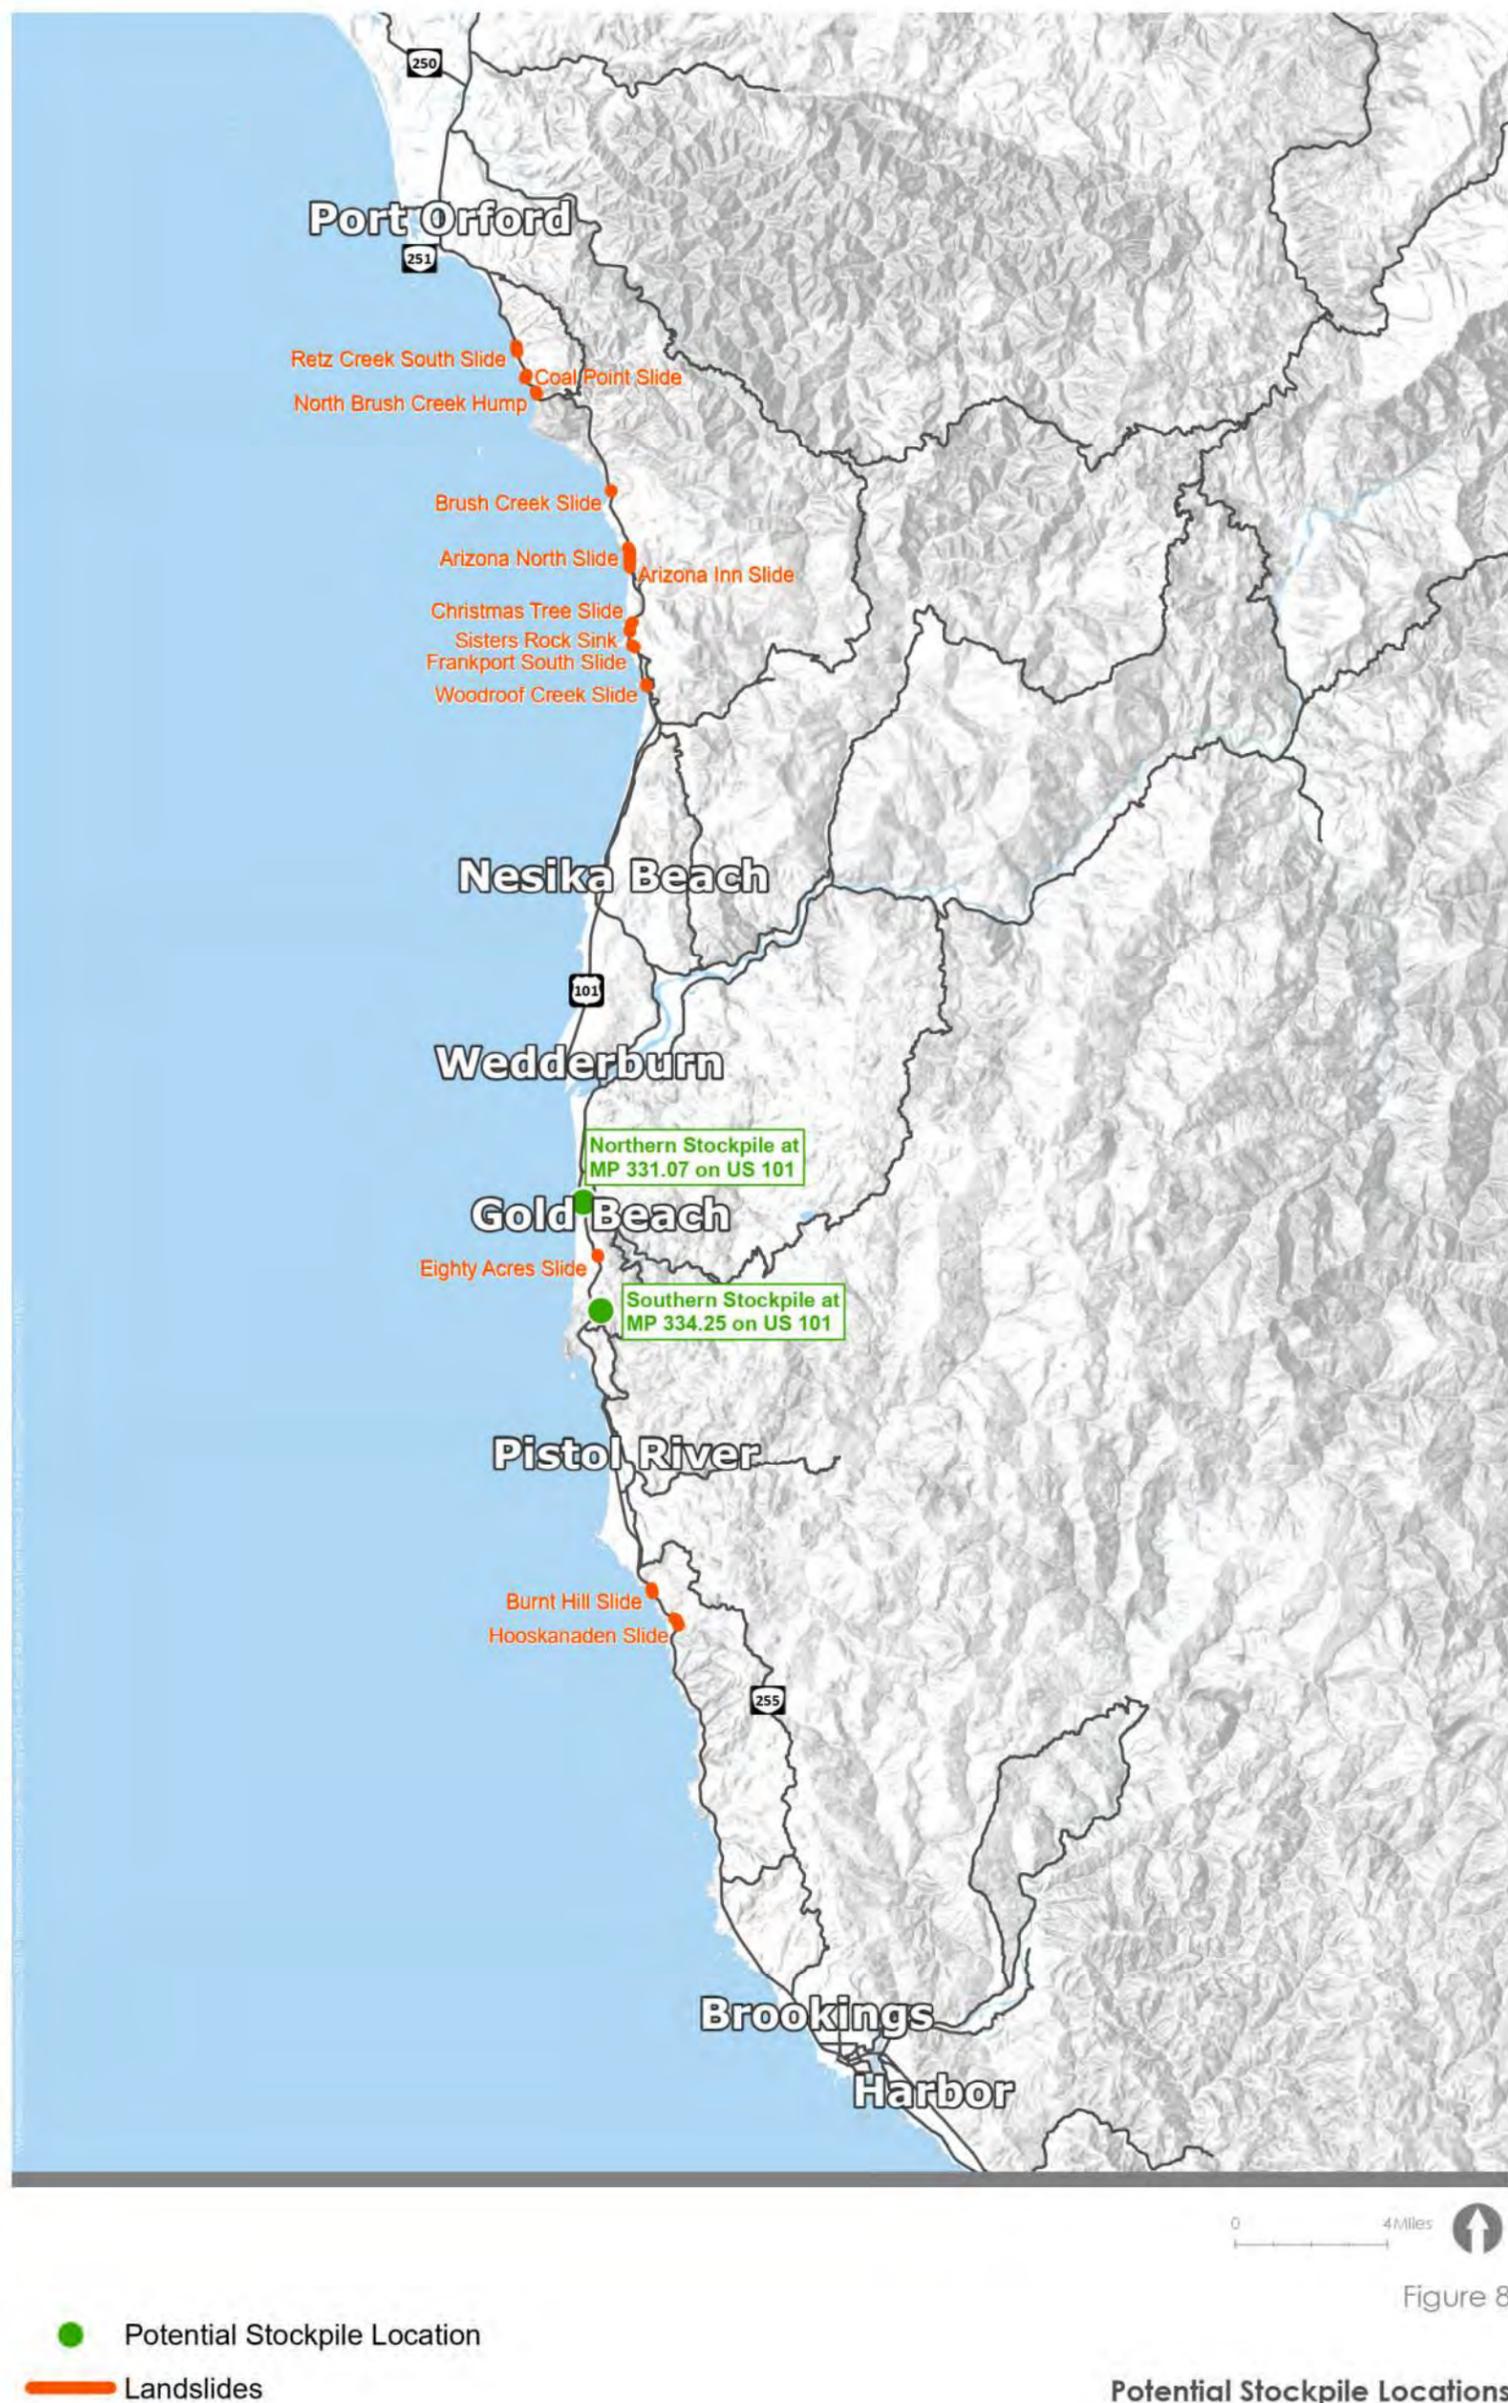
Figure – 8: Potential Stockpile Locations

While the route explored is not a viable route to bypass the Eighty Acres slide complex, providing gravel stockpile locations to the north and south of the slide to expedite re-opening US 101 after a slide would be beneficial. The identified potential stockpile locations are shown in **Figure 8**.
