Technical Memorandum

RE: Final Technical Memorandum #2 Inventory

The purpose of the South Coast Slide Study project is to develop a plan for transportation resiliency along US 101, between the City of Port Orford and the City of Brookings. Study landslides and road failures, shown in Table 1 and Figure 1 along this segment have been an ongoing problem for decades. These events result in full or partial closures of travel lanes and require days or even weeks of maintenance work to be able to fully reopen to passenger car and heavy vehicle travel. As a result, these landslide and road movement incidents have a significant cost to Oregon Department of Transportation (ODOT), disrupt the local and regional economies, strain emergency services, and reduce the mobility of communities to reach critical services.

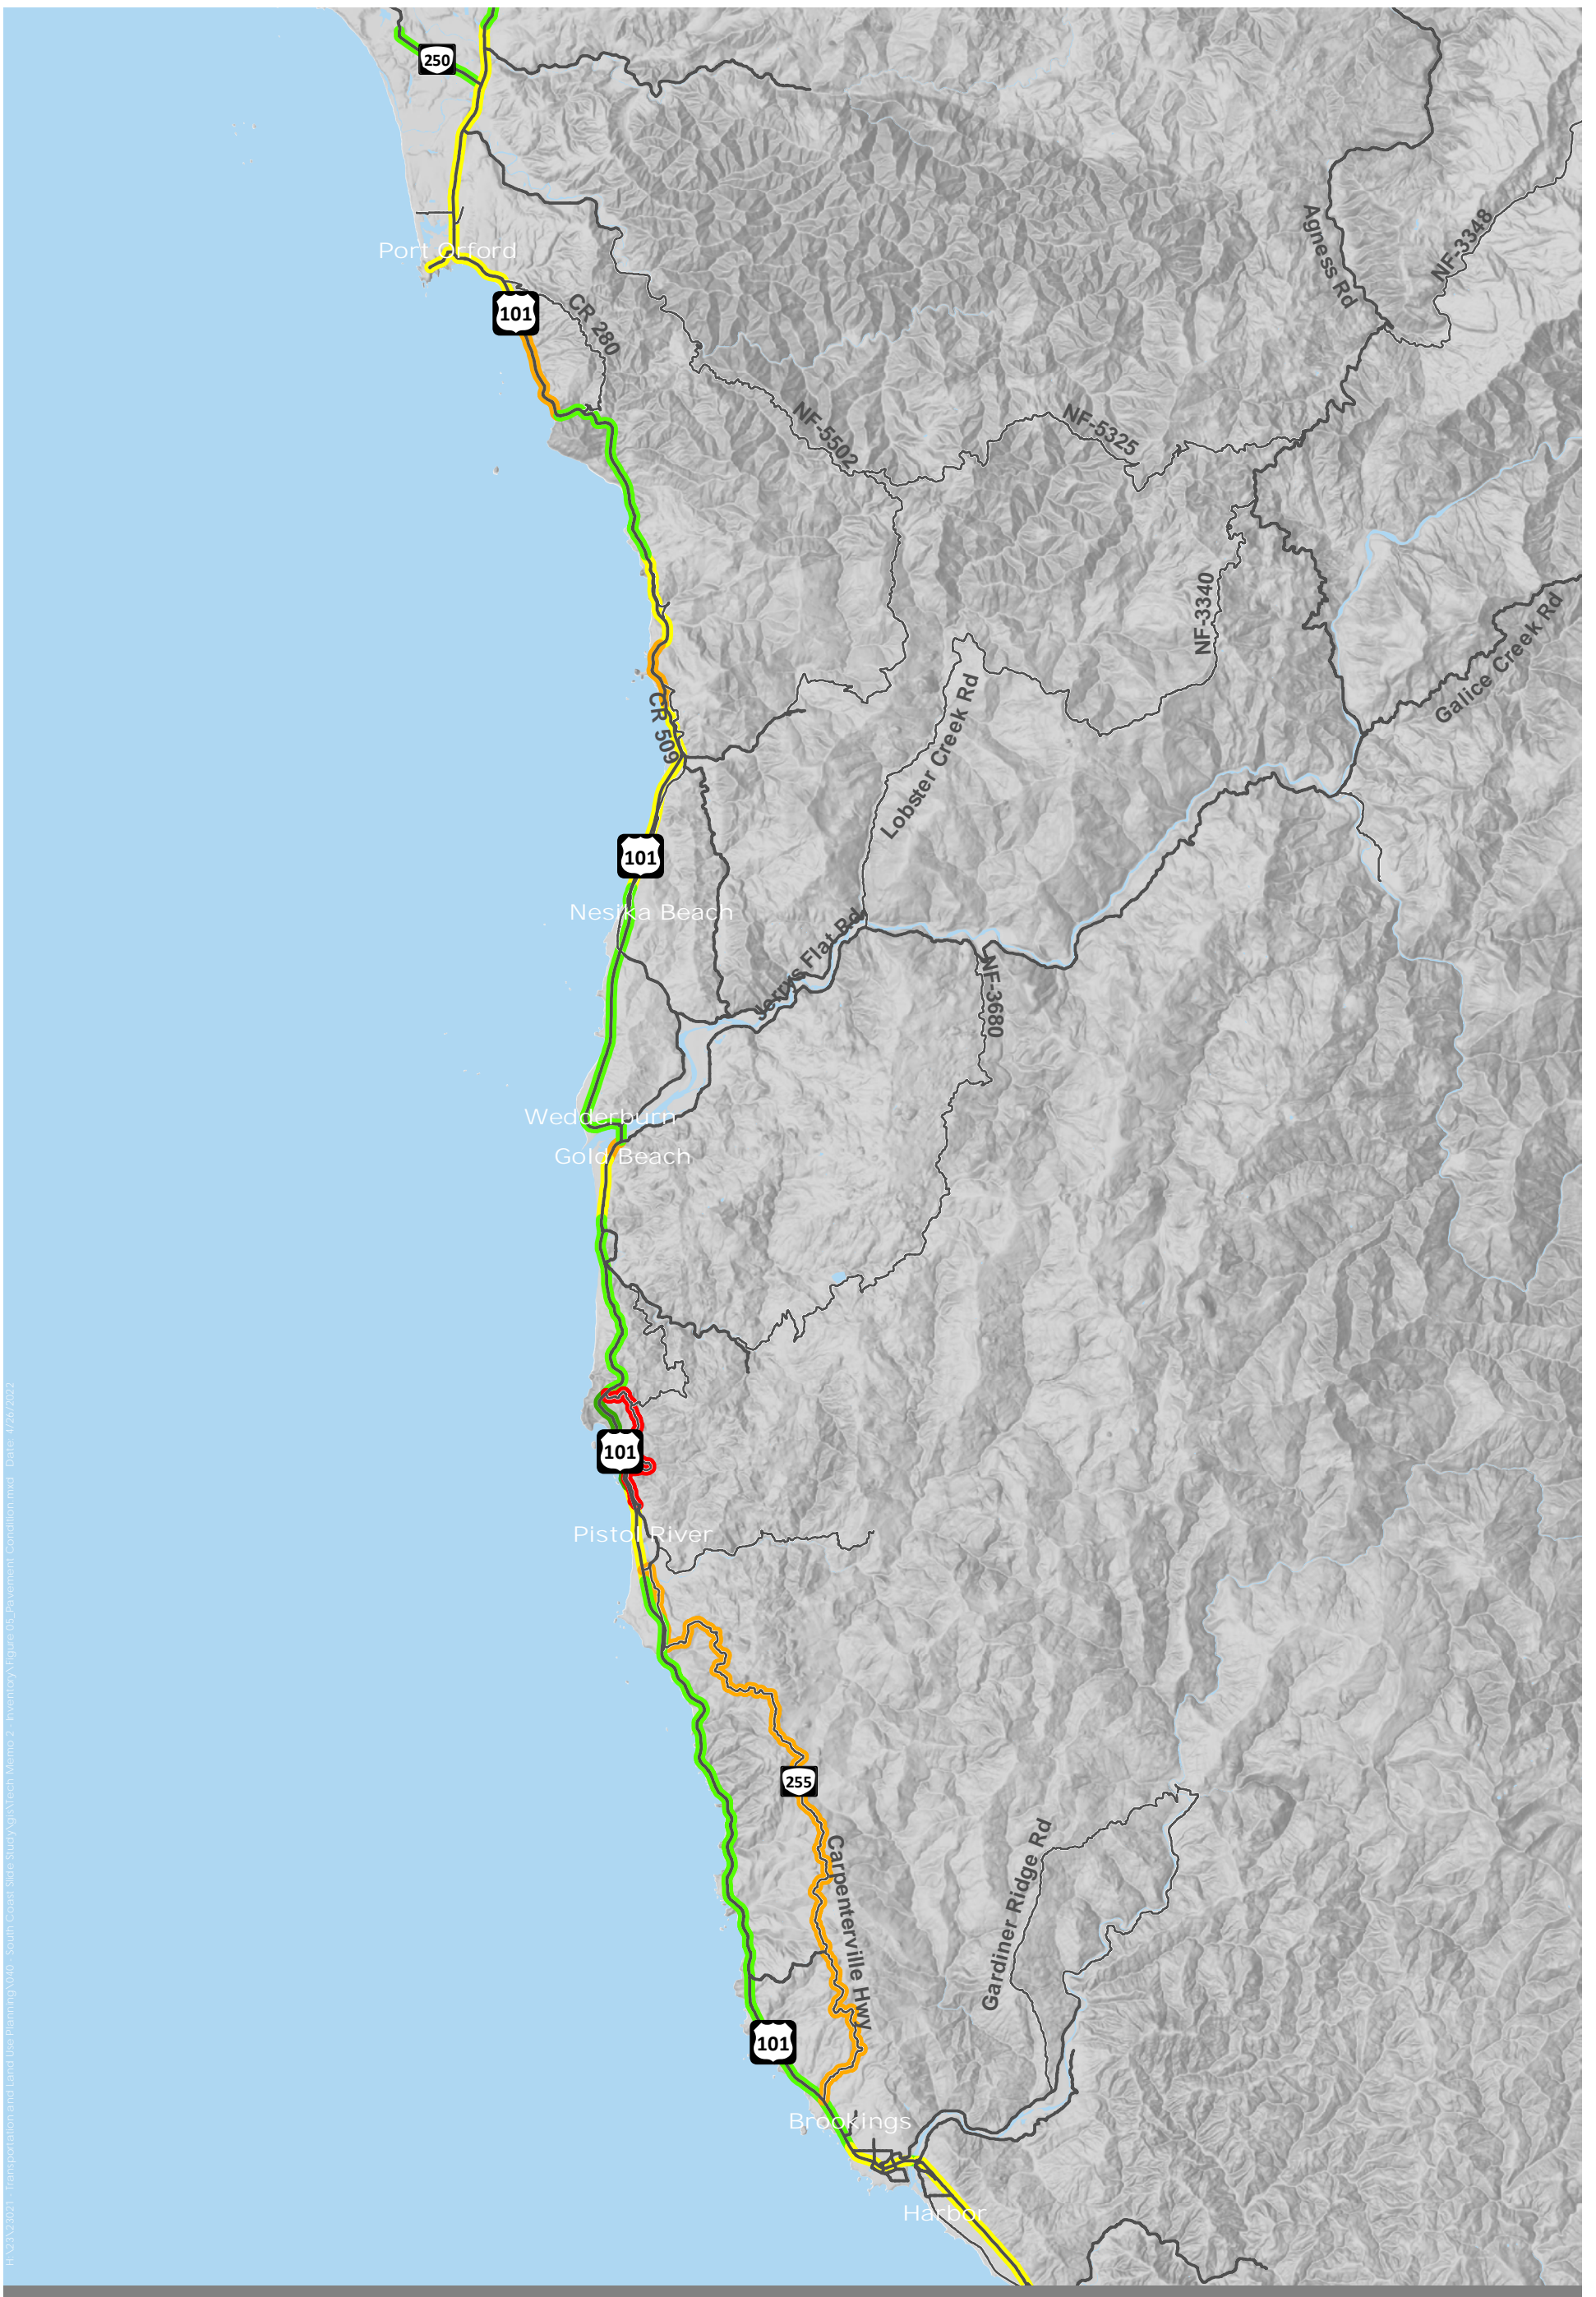
Figure 5

Pavement condition information along ODOT facilities was obtained from the ODOT TransGIS database and is shown in Figure 5. ODOT conducts surveys to determine the extent of pavement conditions in rut fatigue, patch, no load, raveling, and overall condition. Overall pavement condition rating categories include very good, good, fair, poor, and very poor. Both US 101 and Carpenterville Highway are reported with pavement conditions varying from good to poor.

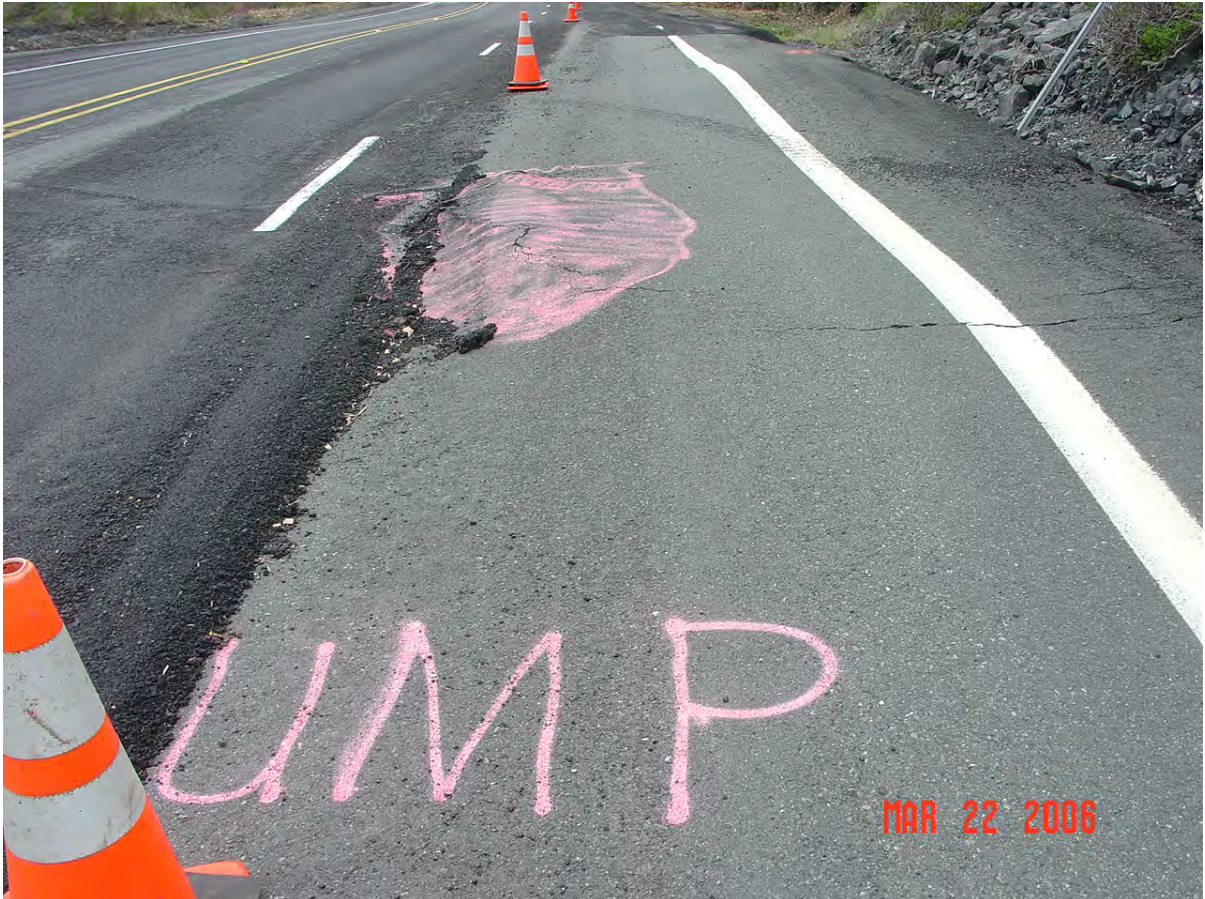
Exhibit 1: Photo looking north at pavement distress within the North Brush Creek Slide limits. Photo taken March 22, 2006.

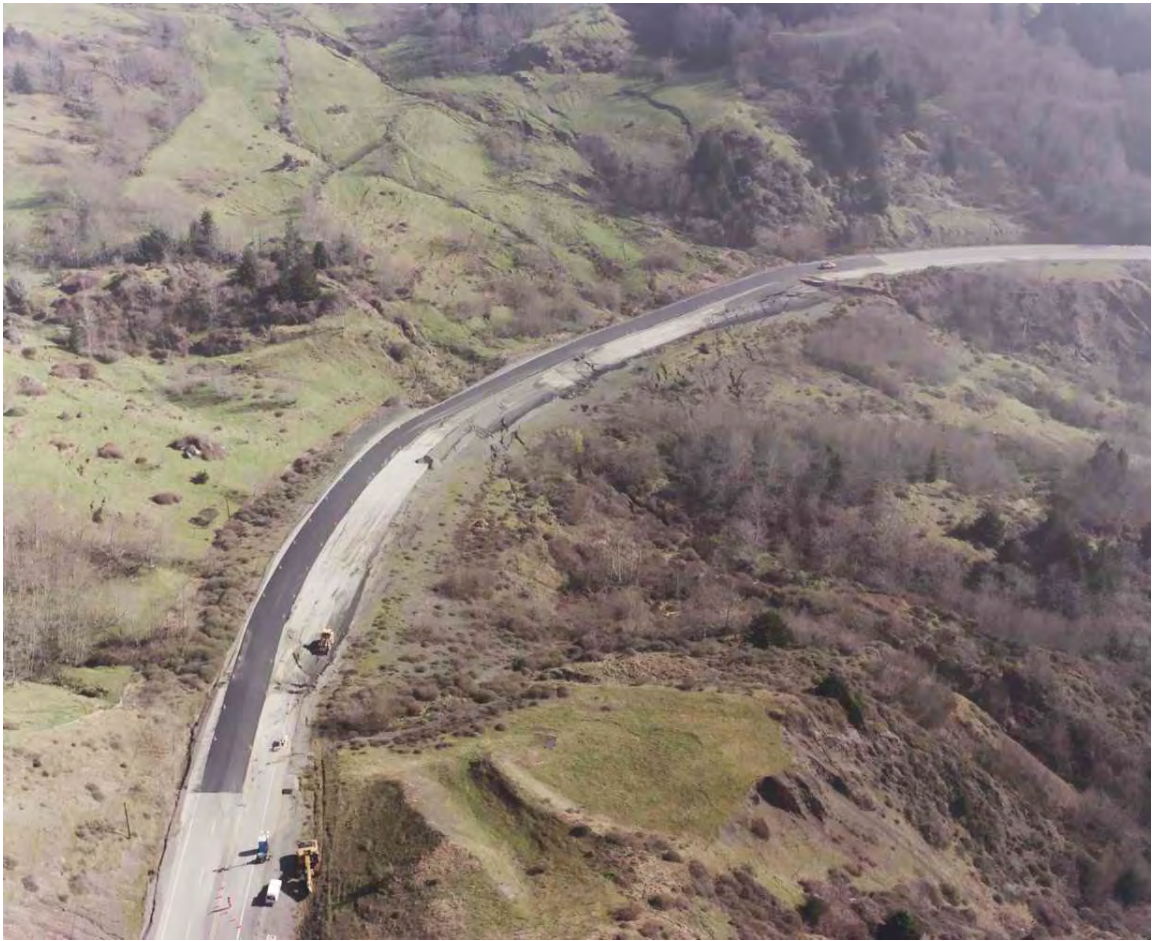
Exhibit 1: Aerial photo looking south at US101 within Hooskanaden Slide limits. Photo taken February 10, 2006
