Oregon Parks and Recreation Commission

Topic: **Otter Crest Gift Shop Construction Contract**

Title: The Look-Out at Otter Crest Restoration and Rehabilitation

8d Attachment A – Historic photos, current site conditions, and proposed work

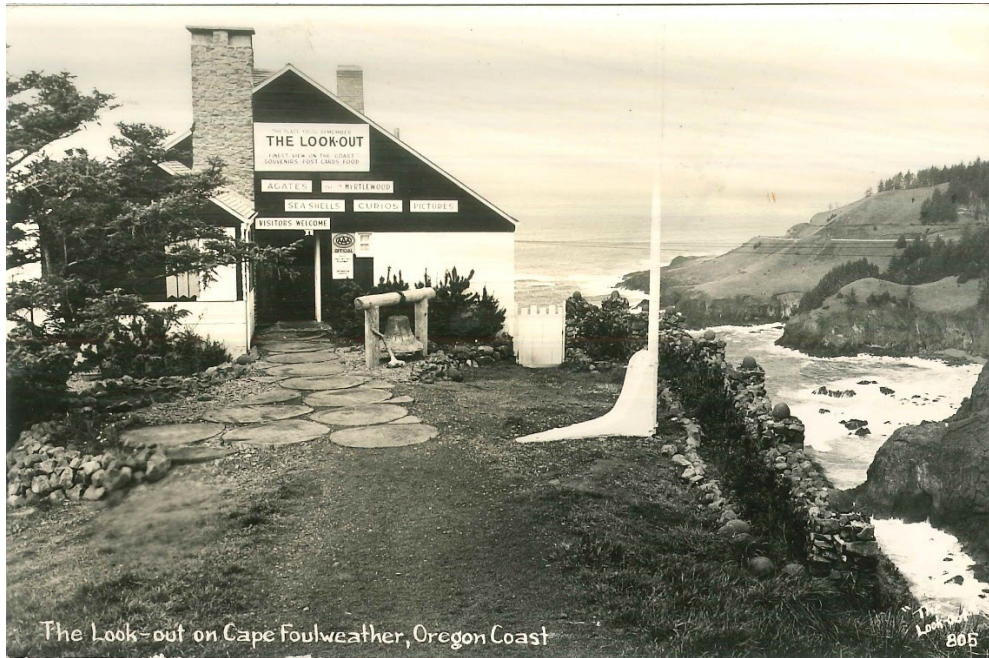
Historic photo taken shortly after the building’s construction in the 1937.

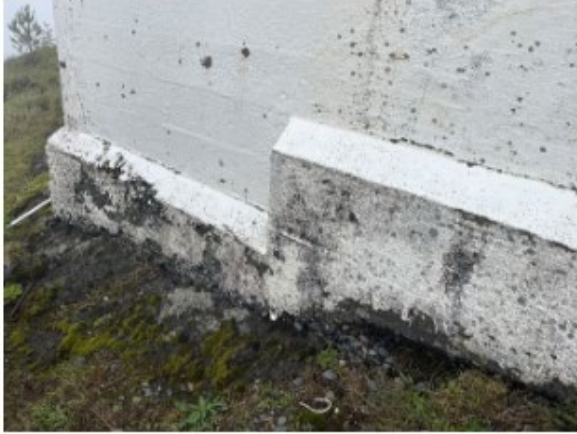
(a) Erosion of concrete at exterior of existing foundations at southwest corner

Foundation requires repairs to address deterioration, photos demonstrate exposed rebar and loose aggregate.

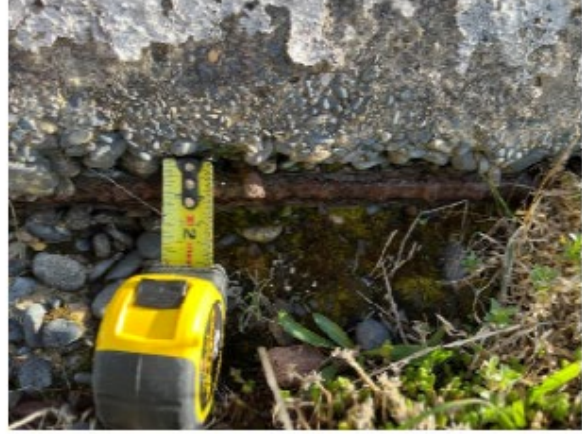
(b) Exposed, corroded foundation reinforcing at south facade

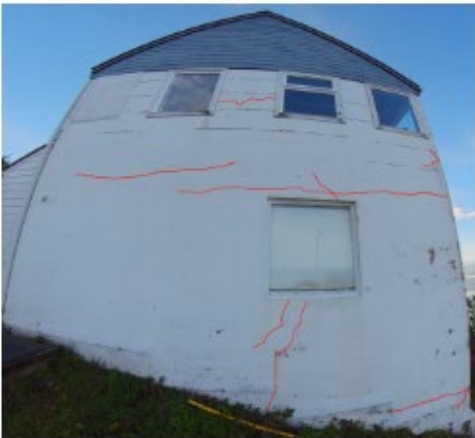
(a) West Elevation

Photos highlight significant cracking to the buildings concrete as assessed by structural engineer consultant. Repairs include addressing concrete stabilization as necessary.

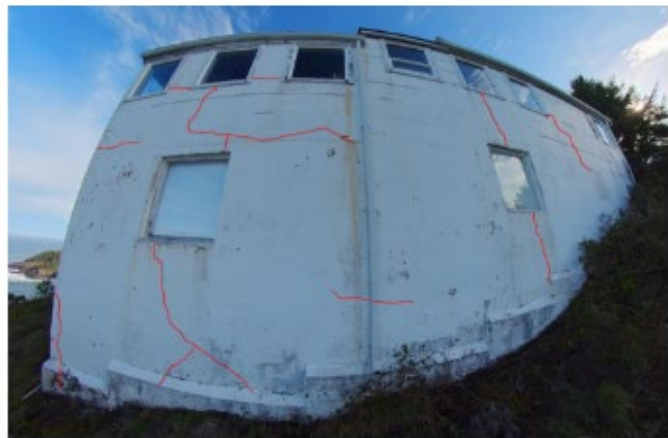
(b) South Elevation

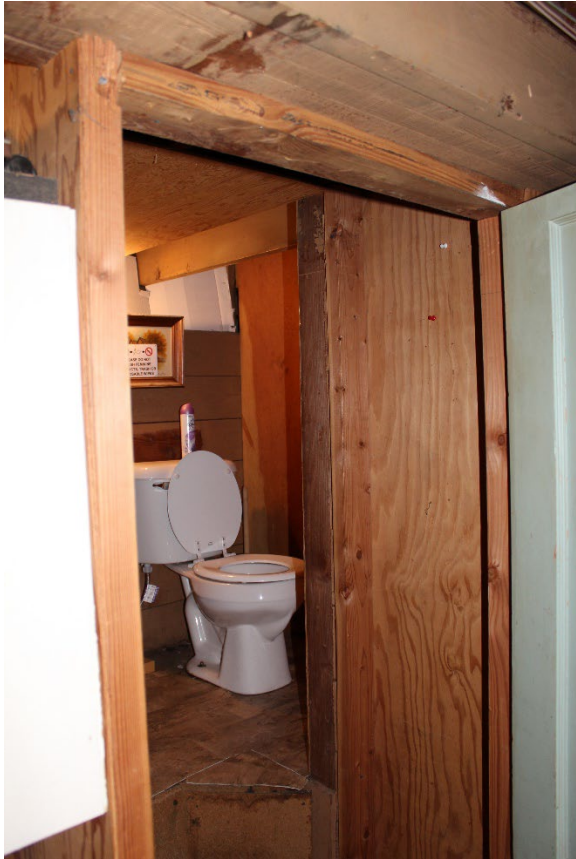
Current restroom conditions.

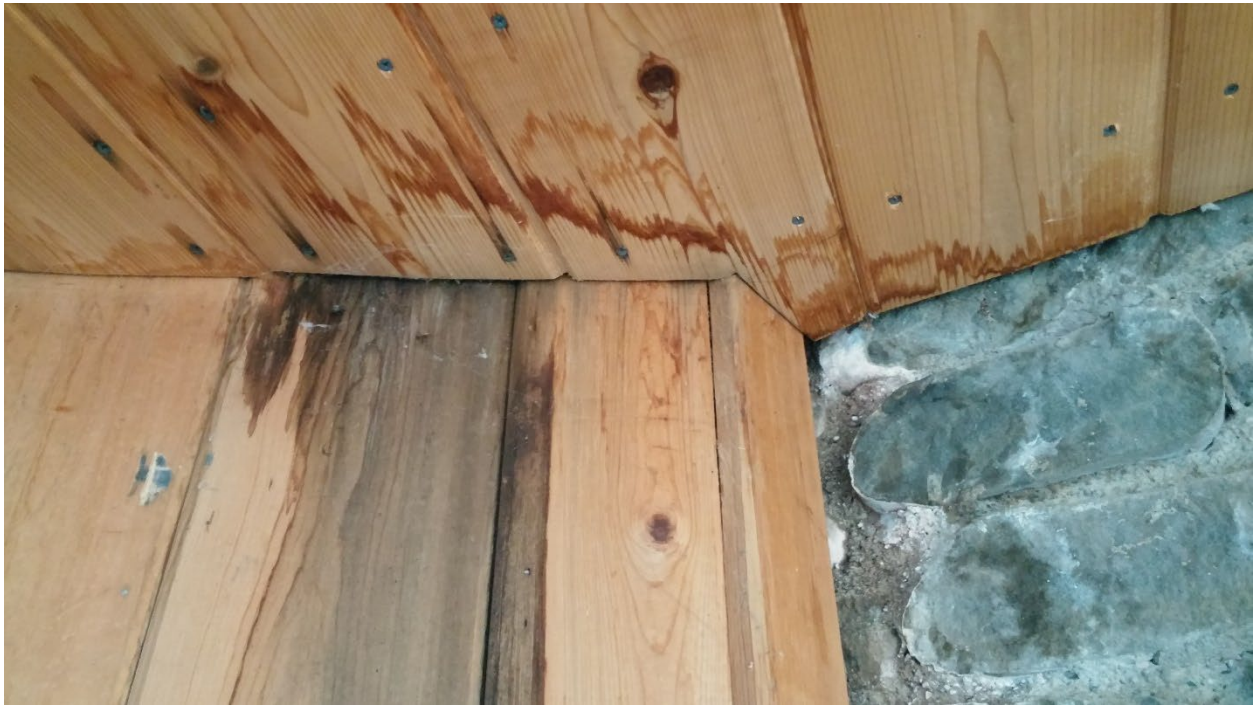
Failing roof and flashing results in deterioration to the buildings historic fabric.

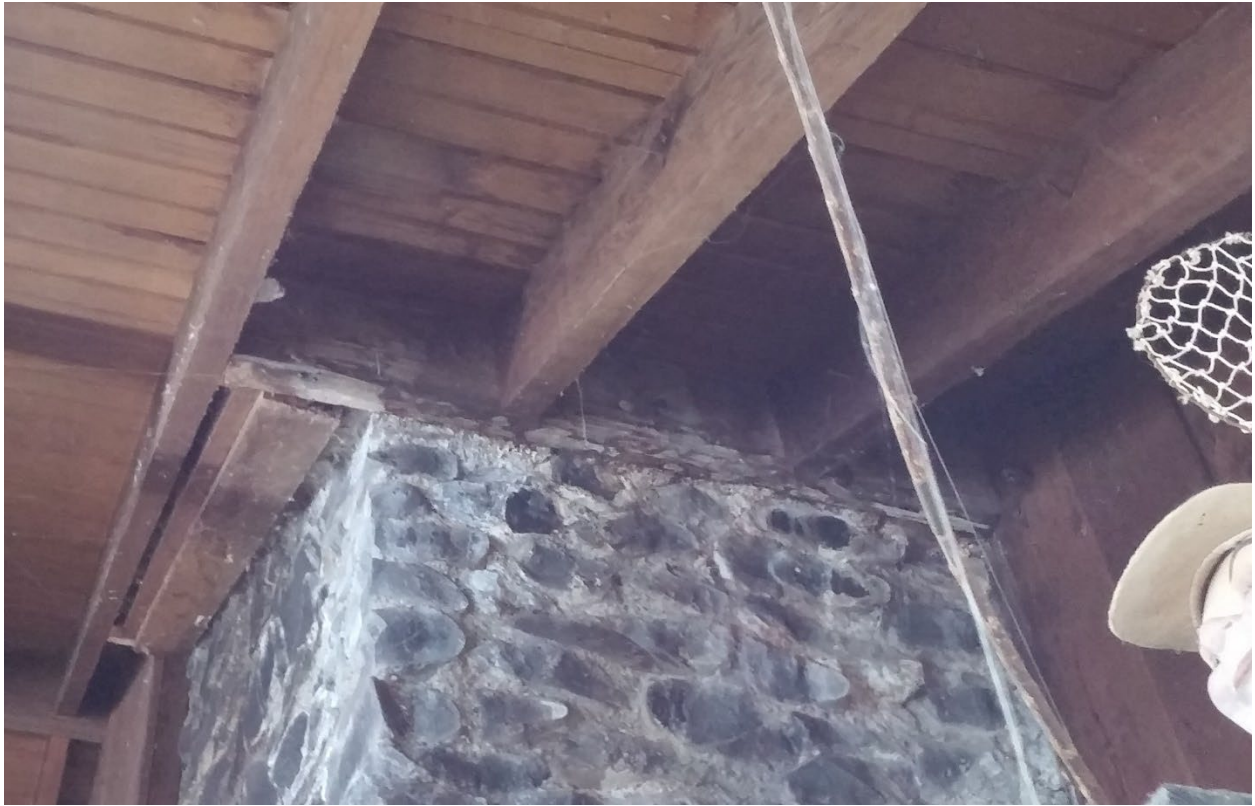
Failing roof and flashing results in deterioration to the buildings historic fabric.
