**HUMECTANTS TO AUGMENT CURRENT
FROM METALLIZED ZINC CATHODIC
PROTECTION SYSTEMS ON CONCRETE**

Final Report

SPR 384

December 2002

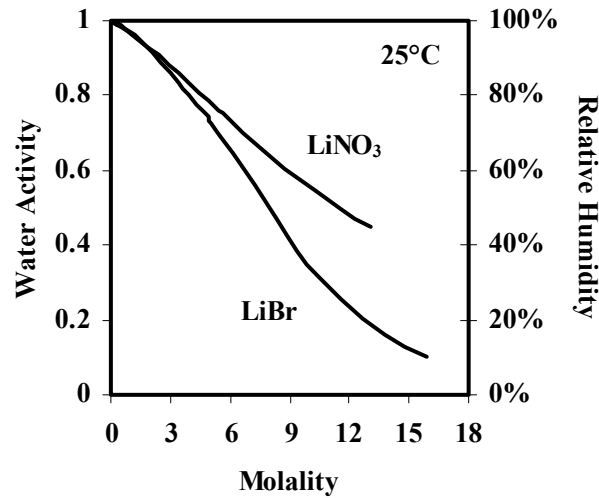
Figure 3.1: Water activity as a function of humectant molality at 25°C

Figure 3.1 shows the results of such calculations at 25°C. The gaps between the molality ranges in Table 3.1 were smoothed and interpolated. Based on cold-water solubility limits (Weast 1979) of 1.45 kg/L (16.7 *m*) for LiBr and 0.898 kg/L (13.0 *m*) for LiNO₃, the calculated RH above saturated solutions will be 8% and 45%, respectively. This value for LiNO₃ closely agrees with an experimentally determined water activity of 0.47 above saturated LiNO₃•3H₂O at 25°C (Stokes and Robinson 1949; Robinson and Stokes 1959). Figure 3.1 is useful in understanding how humectants work. For example, a saturated solution of LiBr (16.7 *m*) in an environment with a RH of 50% will absorb water until the concentration of LiBr is down to approximately 8 *m* (the concentration of LiBr in Figure 3.1 at a RH of 50%). Figure 3.1 also suggests that LiBr should be a more powerful humectant than LiNO₃, especially in dry environments, i.e., below a RH of 50%.

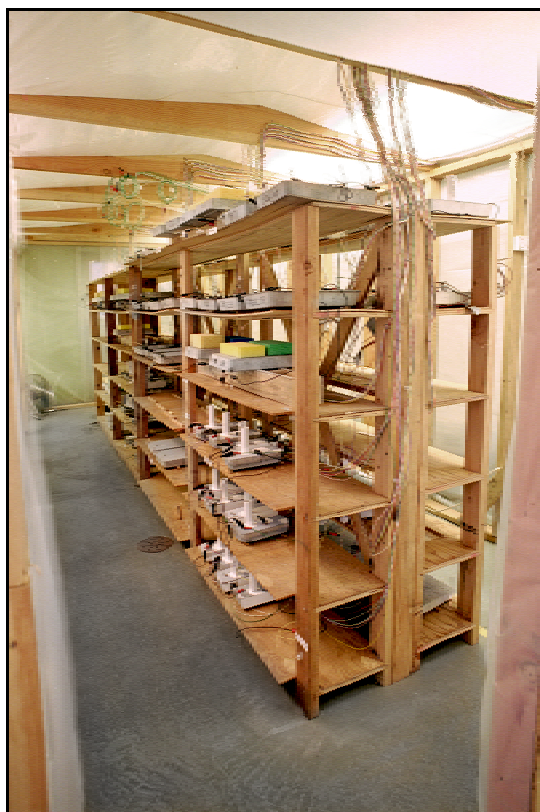
Figure 4.2: New and aged zinc slabs wired in series in the high RH enclosure

Two enclosures were used to provide either a high or a low RH environment. Humidifiers and dehumidifiers controlled the RH. Heaters and air coolers controlled the temperature. Fans also provided air circulation. Mean values in the high RH enclosure were 81±5% RH and 26±2°C (79±4°F). Mean values in the low RH enclosure were 45±4% RH and 29±2°C (84±4°F). Figure 4.2 shows the samples in the high RH enclosure.

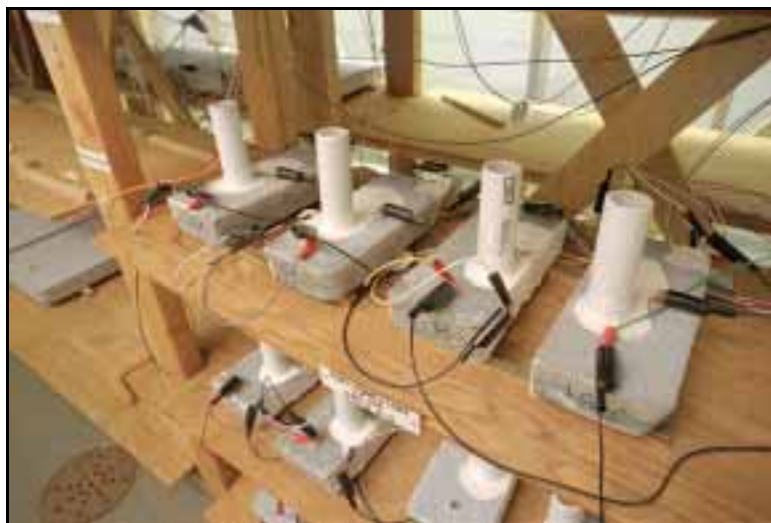
Figure 4.3: Aged zinc slabs wired in series in the high RH enclosure. Note the reference electrode holders (PVC pipe) mounted in areas without zinc left from prior adhesion strength pull tests.

Depolarization was measured on the cyclic ICCP slabs at various times throughout the experiment. Prior to depolarization, the impressed current was reduced to $0.2 \text{ mA}/\text{ft}^2$ ($2.2 \text{ mA}/\text{m}^2$) to reduce the polarization caused by the accelerated aging experiment. A Cu/CuSO_4 reference electrode was used with a wet sponge between the reference electrode and an area of bare concrete (without Zn) on the sample. For the new slabs the reference electrode was contacted to the underside of the sample. On the aged slabs the reference electrode made contact in an area without Zn left from prior adhesion strength pull tests, Figure 4.3.

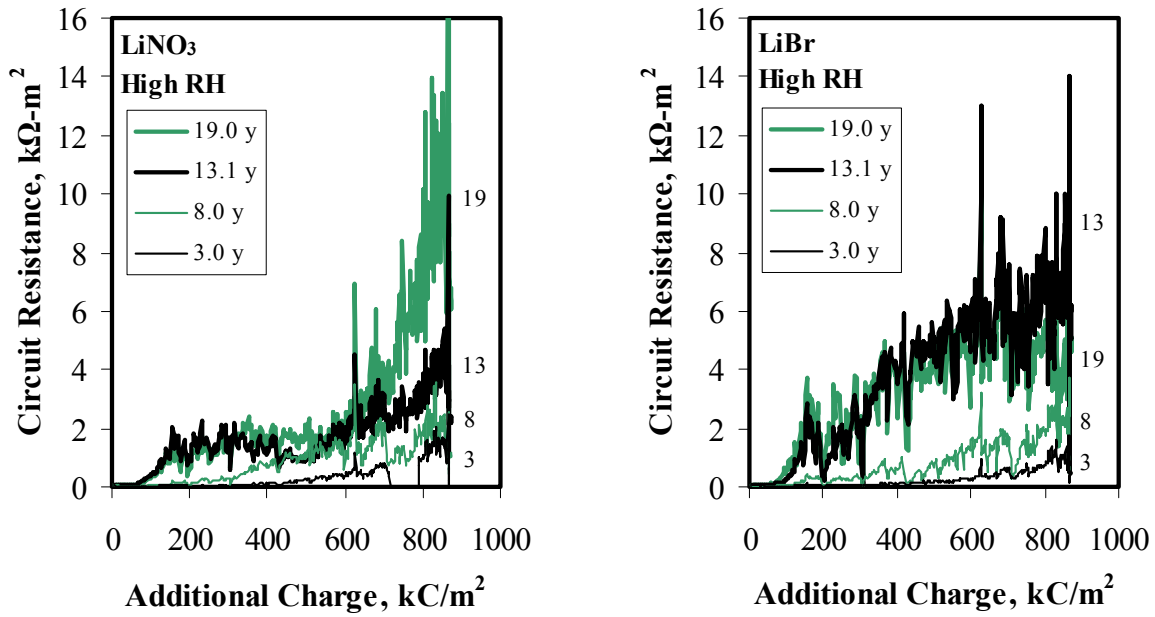
Figure 5.3: Circuit resistances of aged ICCP slabs in high RH conditions for LiNO₃ (left) and LiBr (right)

The circuit resistances of the aged ICCP slabs are shown in Figure 5.3 for high RH conditions and in Figure 5.4 for low RH conditions. In general, the higher the initial electrochemical age, the higher the circuit resistance. In high RH conditions (Figure 5.3) up to an additional charge of approximately 700 kC/m^2 the LiNO_3 -treated slabs had lower circuit resistances than the LiBr-treated slabs. In low RH conditions, Figure 5.4, the differences were similar: LiNO_3 -treated slabs had lower circuit resistances for the first 300 kC/m^2 of additional charge. Overall the circuit resistances were higher in low RH conditions than in high RH conditions.

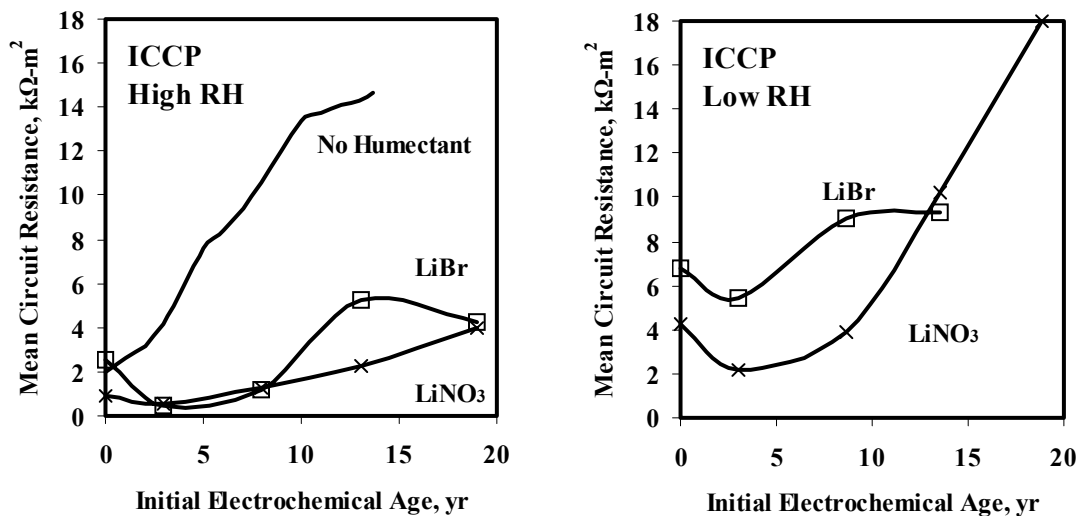
Figure 5.5: Mean circuit resistances of new and aged slabs after an additional 3 years of aging in high (left) and low (right) RH conditions. The “No Humectant” data are from an earlier study (Bullard et al. 1998; Covino et al. 2002).

Mean values of circuit resistance of humectant-treated slabs are shown in Figure 5.5 for high RH conditions (left) and low RH conditions (right). To discount the low initial circuit resistances obtained during aging (Figures 5.1-5.4), the mean circuit resistance was calculated ignoring the first 204 kC/m² of charge, equivalent to 3 years of aging at 0.2 mA/ft² (2.2 mA/m²). Thus, the mean values represent the mean circuit resistances from 3 to 11.7 years of aging in high RH conditions and from 3 to 5.1 years in low RH conditions. Results from an earlier study without humectants in a high RH environment were converted¹ to the same data format and shown in Figure 5.5 as “No Humectant” (Bullard, et al. 1998; Covino, et al. 2002). Humectant-treated slabs in high RH conditions had much lower circuit resistances than the untreated slabs. In both RH conditions the LiNO₃-treated slabs tended to have lower circuit resistances than the LiBr-treated slabs.

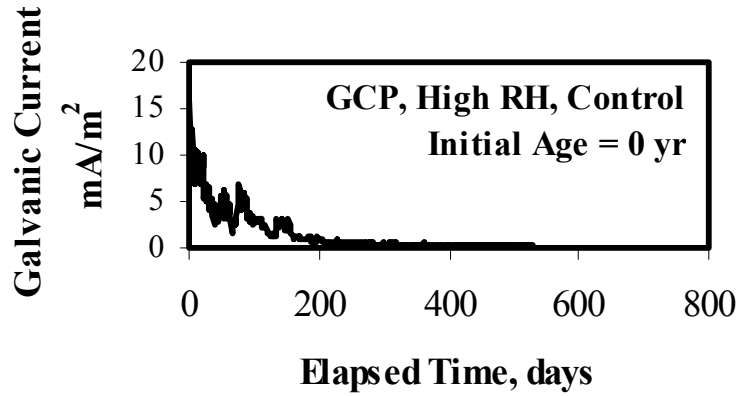
Figure 5.12: Galvanic currents for the new control slab in high RH conditions

The galvanic currents in the controls, Figures 5.12-5.13, show a faster decline in current compared to the humectant-treated slabs.

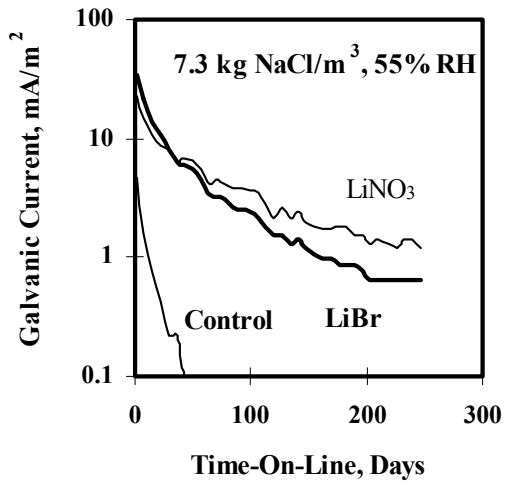
Figure 5.42: Galvanic currents for blocks with 4.9, 7.3, and 9.8 kg/m³ NaCl in 55% RH conditions

Figure 5.43: Galvanic currents for blocks with 4.9, 7.3, and 9.8 kg/m³ NaCl in 80% RH conditions

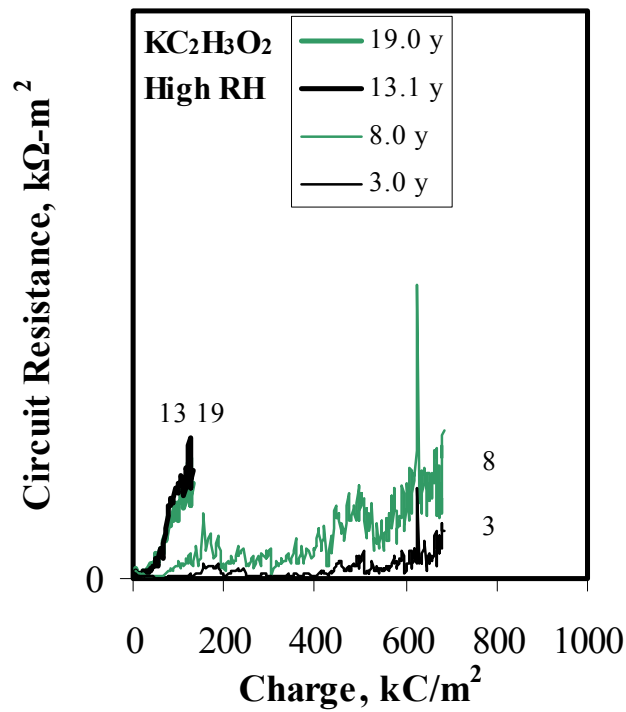
Figure A5.3: Circuit resistances of aged ICCP slabs in high RH conditions

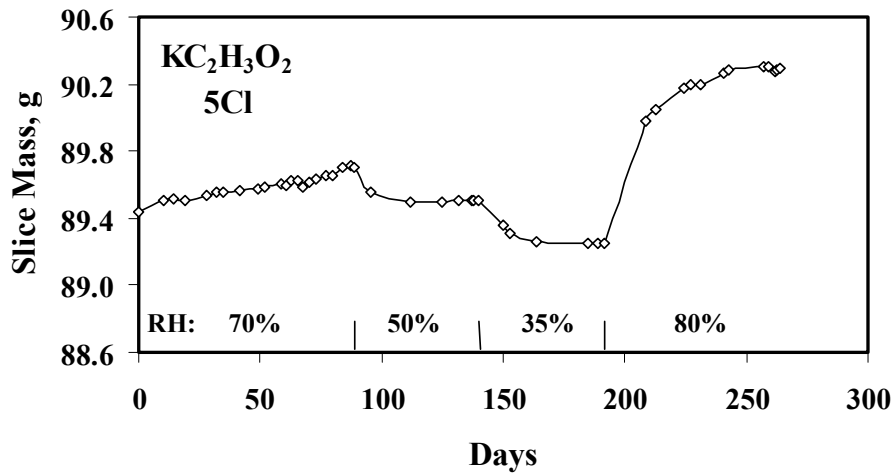
Figure A5.34: Mass change with exposure time of KC₂H₃O₂-treated slices at 90°F (32.2°C). The NaCl concentrations were 2.0, 5.0, and 10.0 lb/yd³ (1.2, 3.0, and 5.9 kg/m³).
